# Appendix 14.9 Data Interpretation Strategy

# Appendix 14.9 Draft Heritage Interpretation Strategy

## **4.2 Condition Survey**

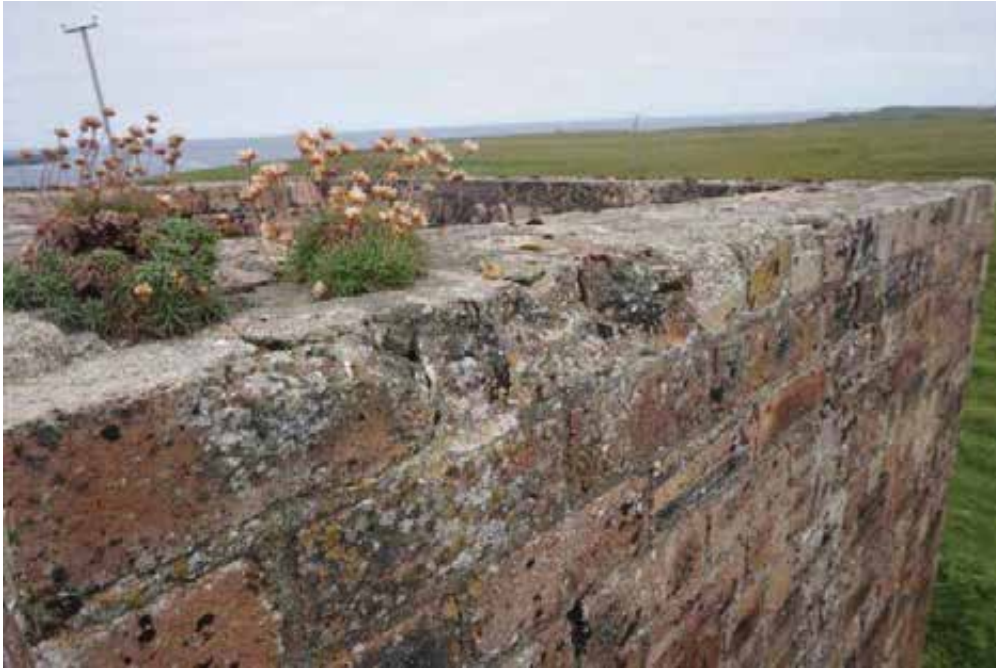
**1.**

**Localised damaged brickwork and defective joints. Vegetation growth at wallhead.**

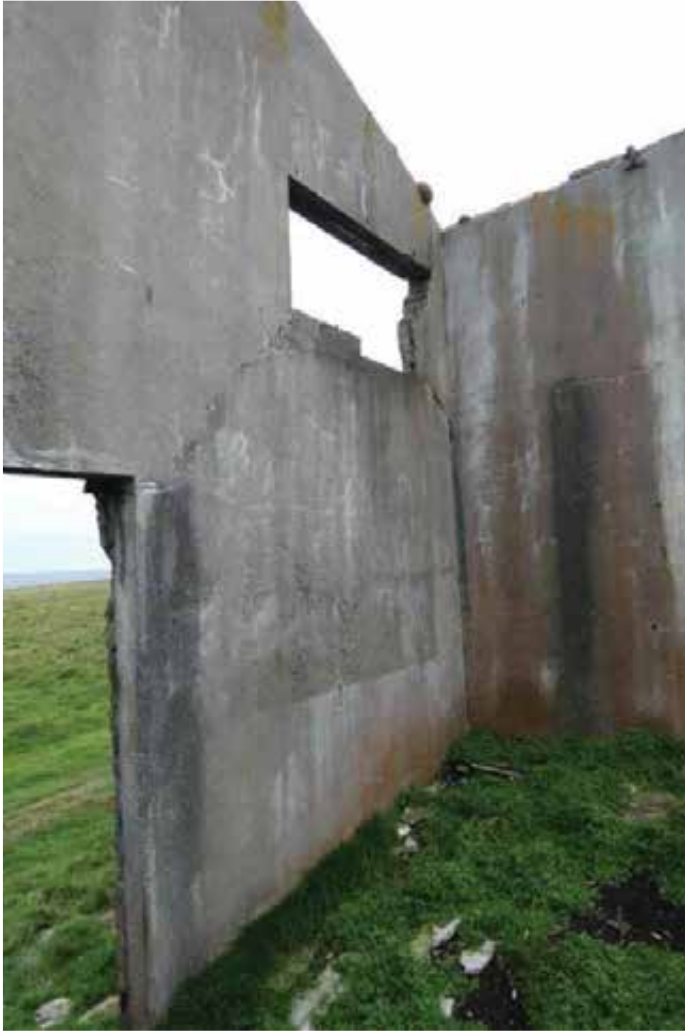
7

**Internal view of east gable. Note how the cracking is right through the masonry.**

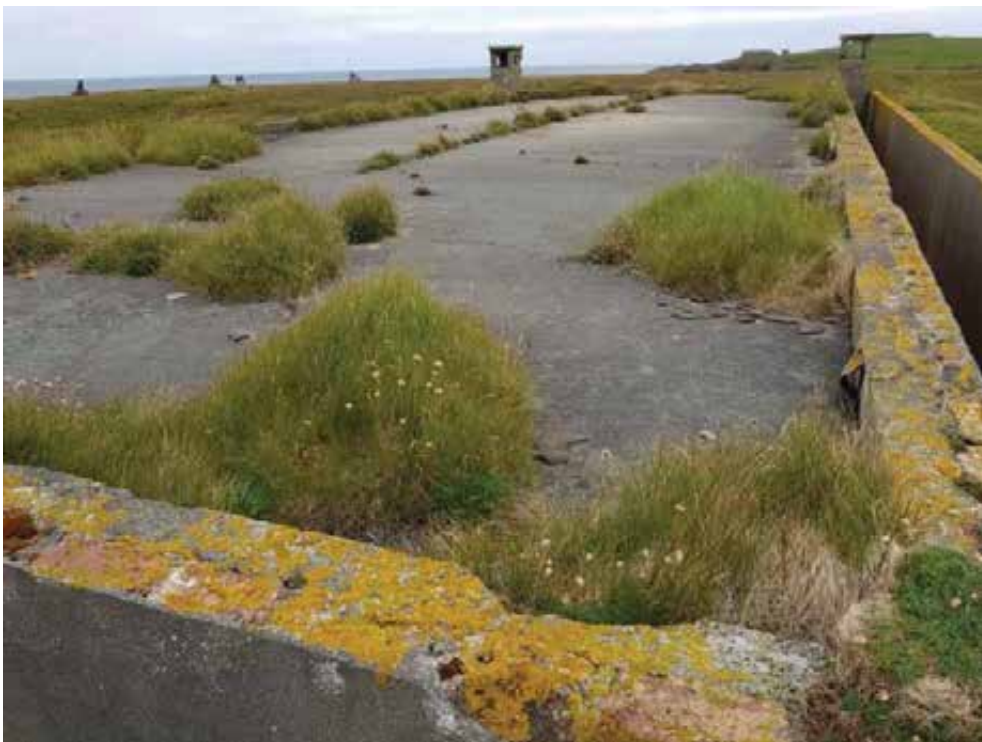
6.

Looking across the roofscape. Note cracked asphalt, vegetation and missing concrete copes from wallheads.

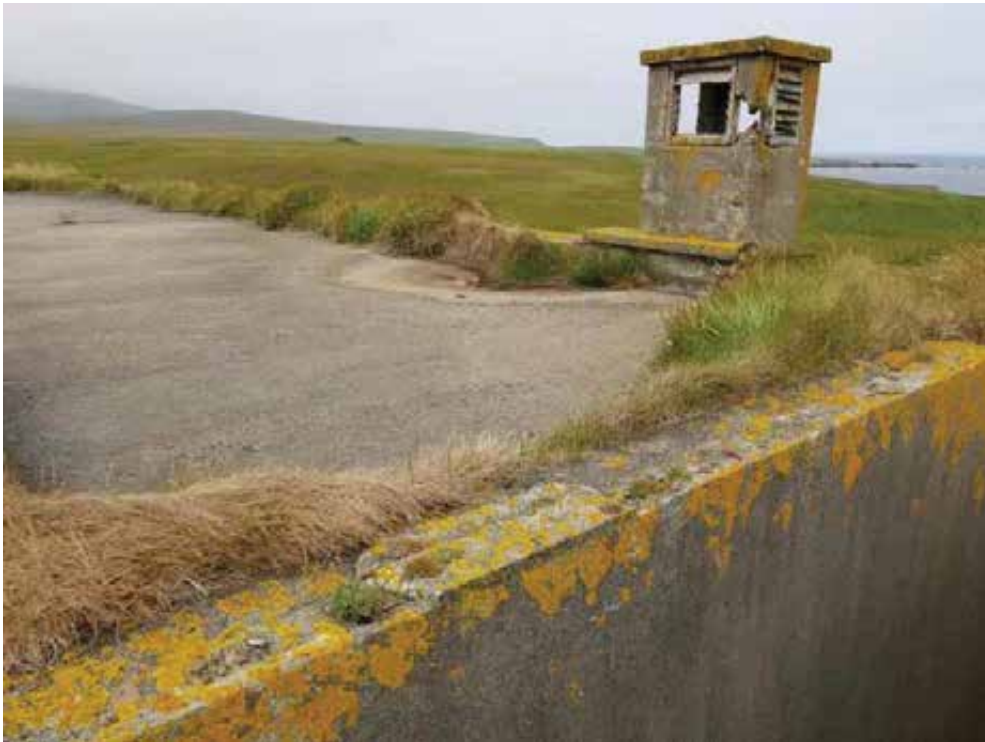
8.

As 6. Note broken leg of RC cap to chimney – see next photo.

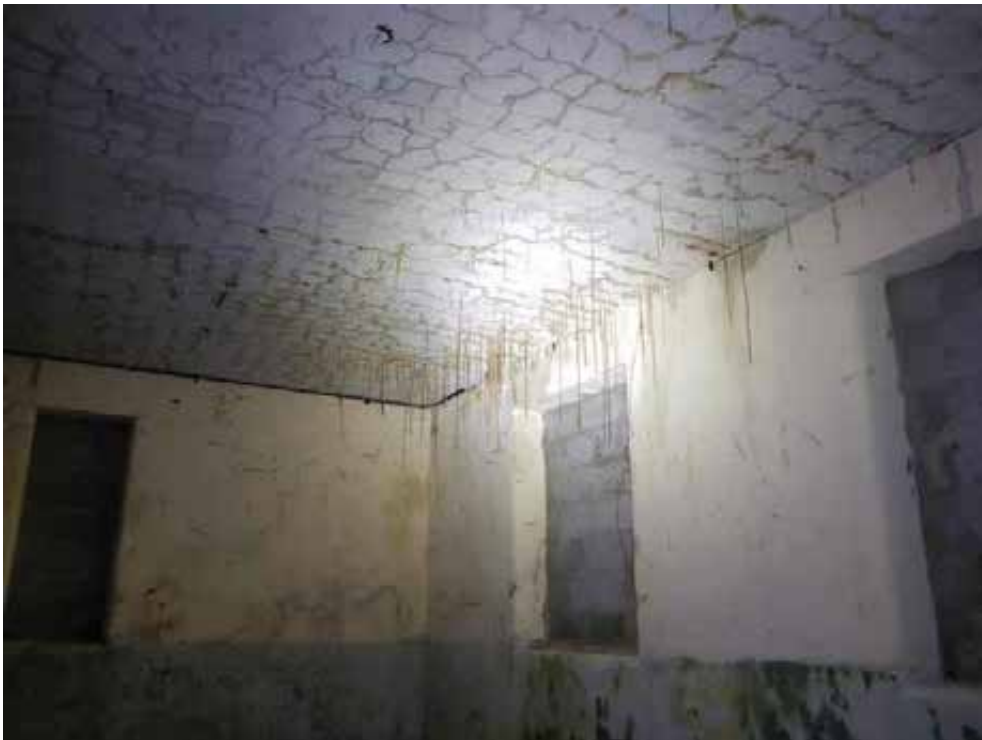
14.

Water ingress through the roof slab obvious, indicated by the stalactites from the roof and cracking of the plaster.

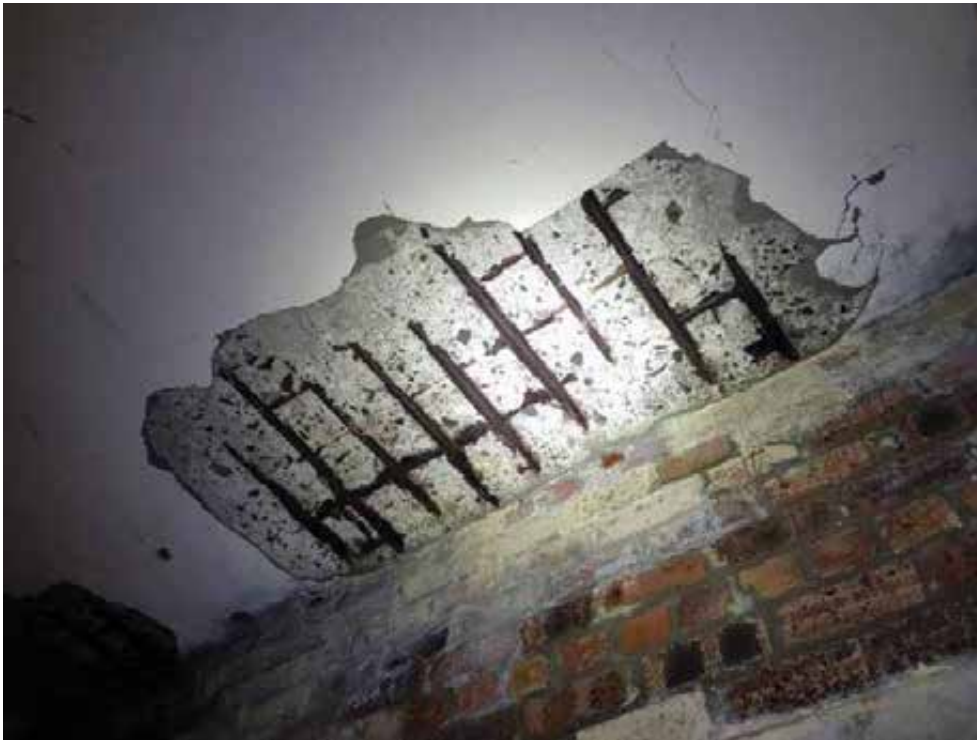
15

Spalling concrete caused by expansive corrosion of reinforcement.

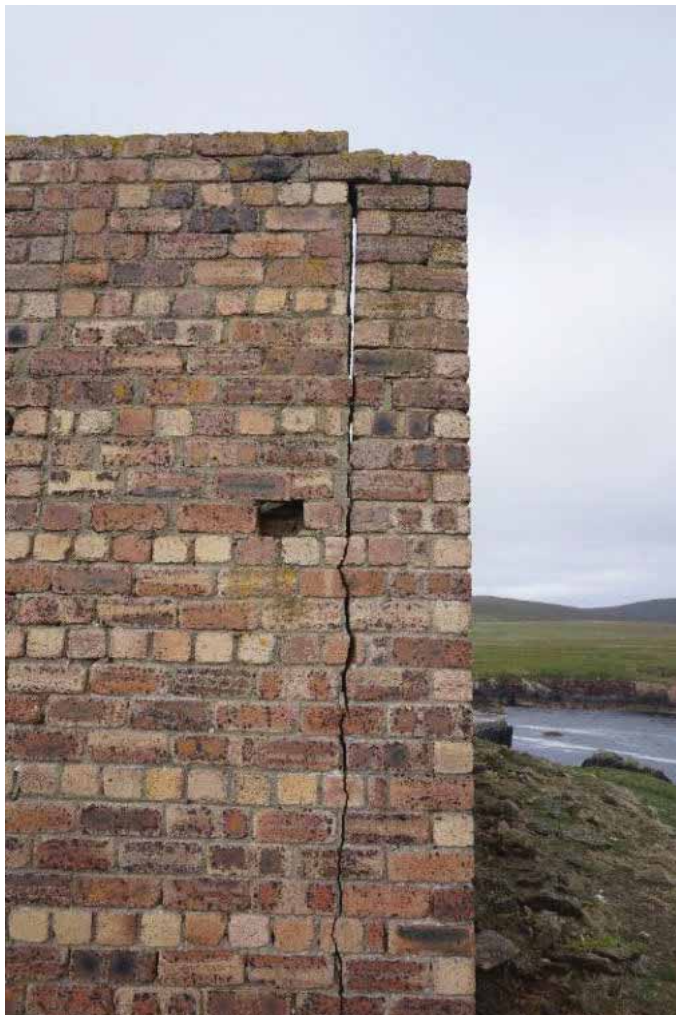
4

**Cracks at the northeast (lower image) and southeast corners where brickwork is poorly tied and are likely to be exacerbated by poor ground conditions affecting the foundations. Stitching across these cracks is recommended.**

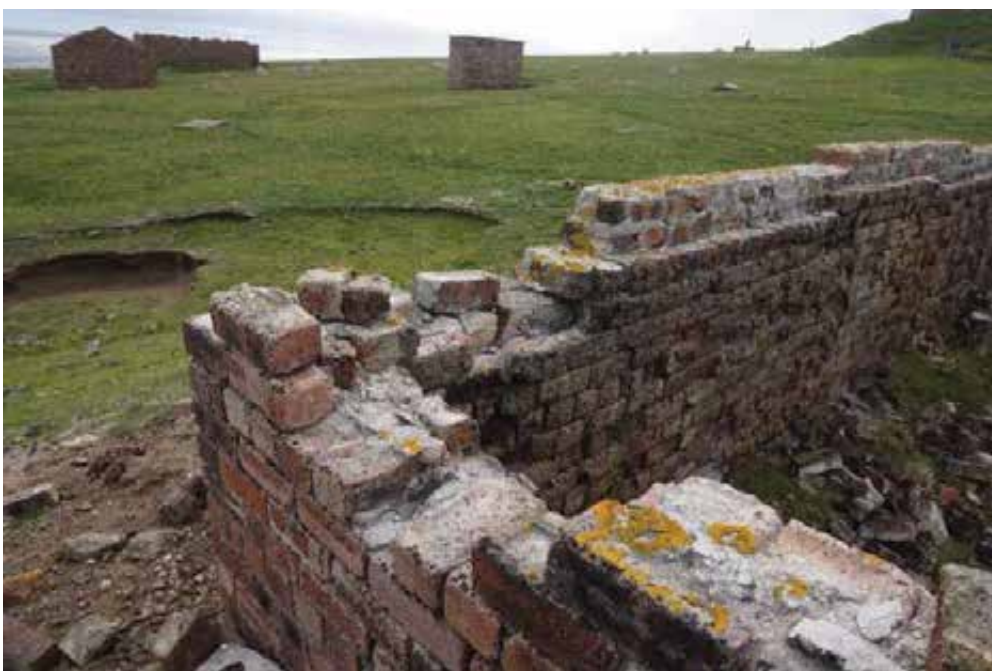
4

Loose wallhead brickwork and failing joints.

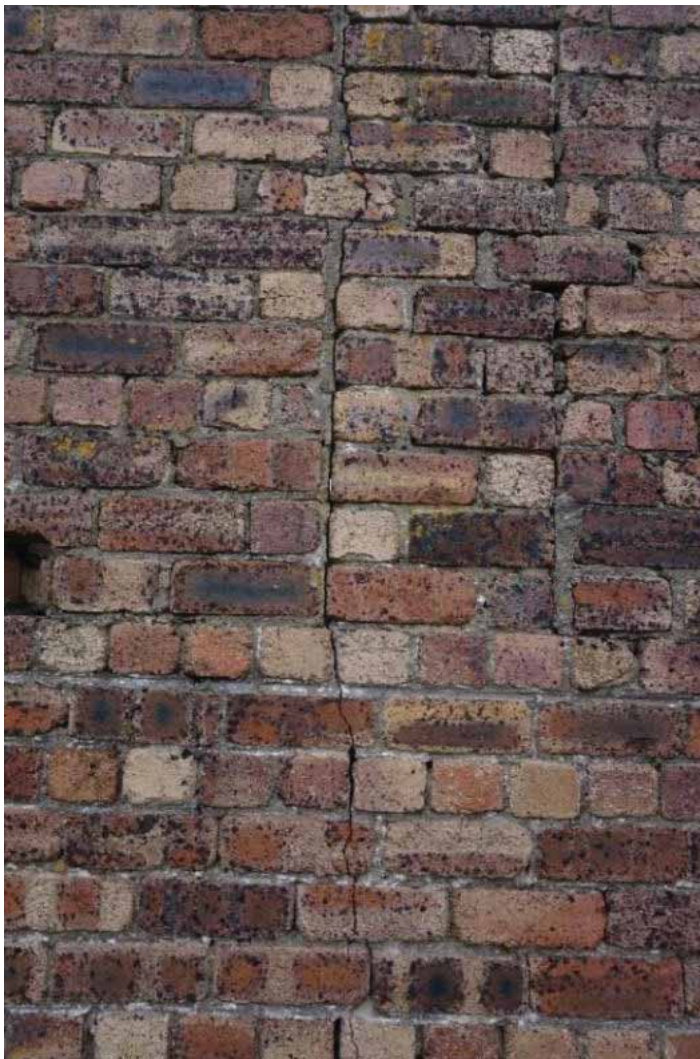
4

**A vertical crack extends from a section of missing brickwork at ground level internally on the east wall. The brickwork panels either side of the pier (seen just off-centre) are poorly tied across the pier.**

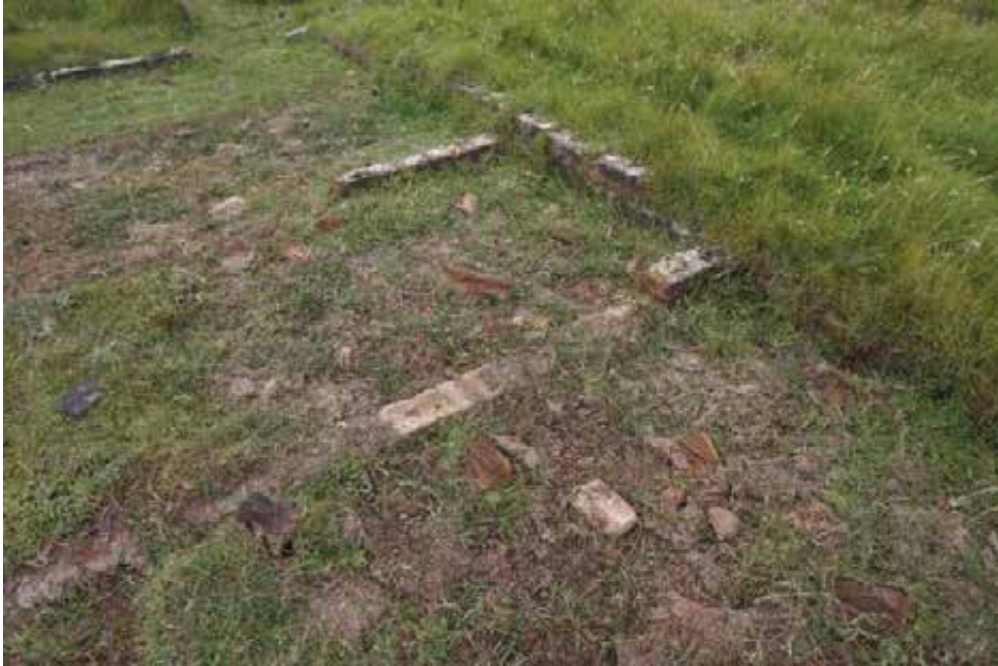
3

**There is loose and displaced brickwork throughout the east portion. Consideration should be given to burying them to protect them from exposure to weathering and from the impact of increased footfall to the site.**

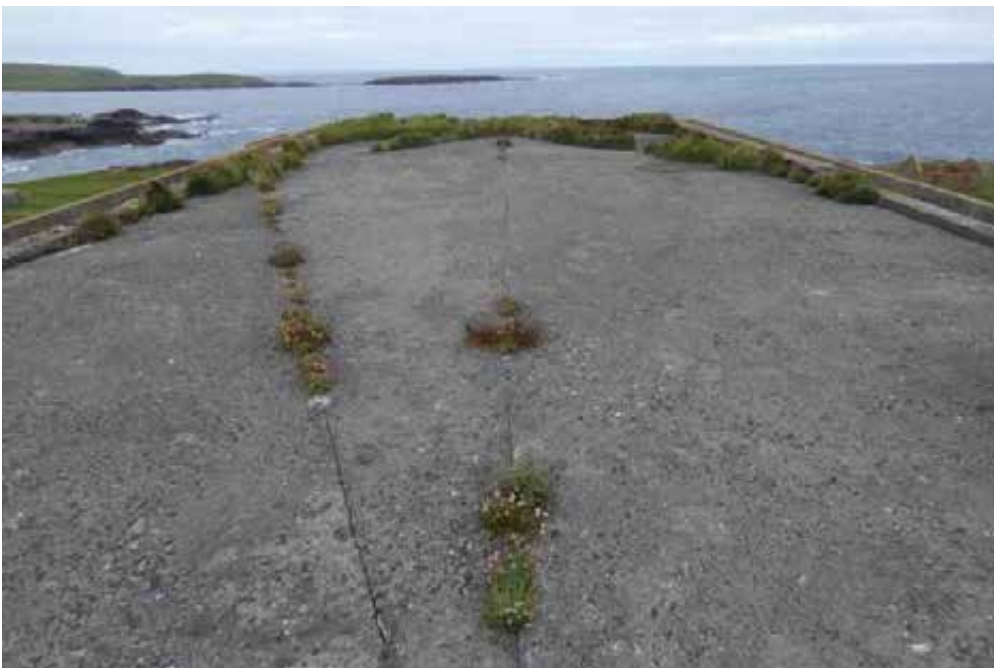
5.

**General view across the roof. Note cracking of the asphalt and vegetation growing from those cracks.**

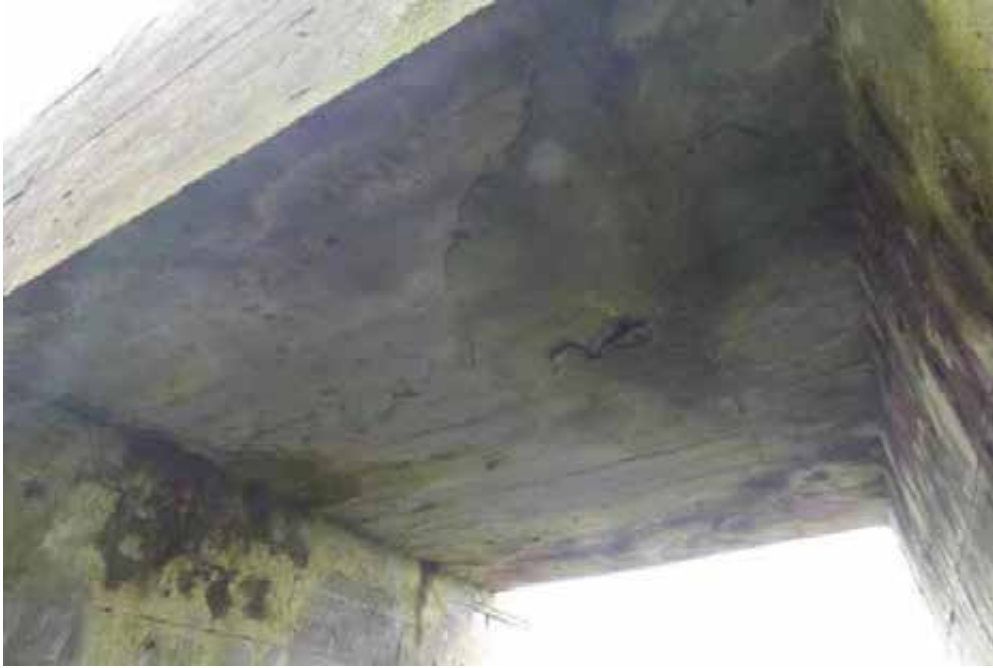
8.

Spalling concrete and render finishes from the soffit of an access tunnel roof.

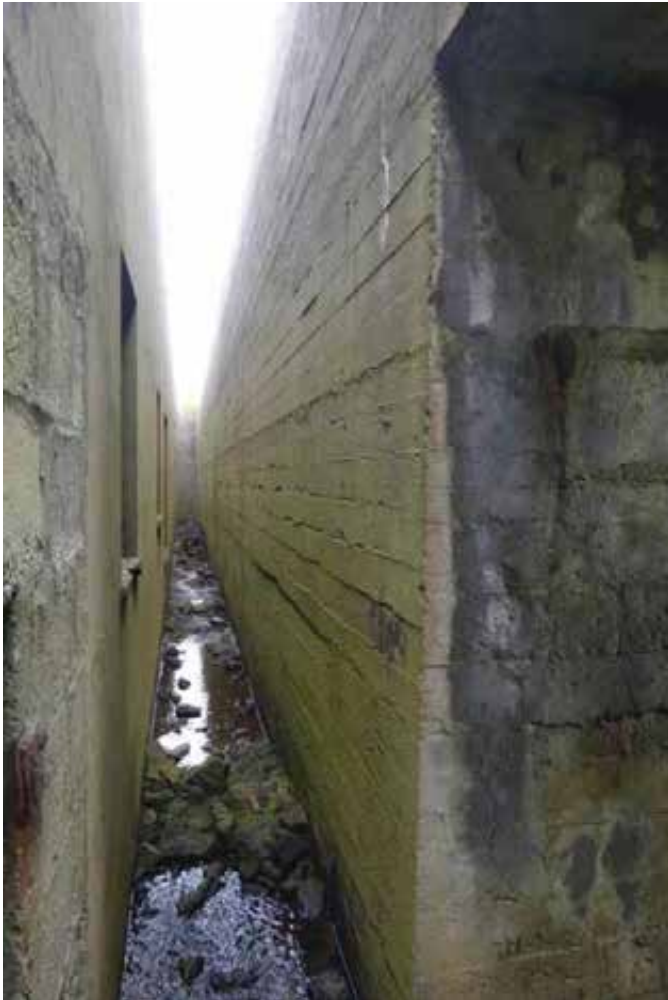
9.

Looking between the blast walls and building proper. Note build up of debris and water.

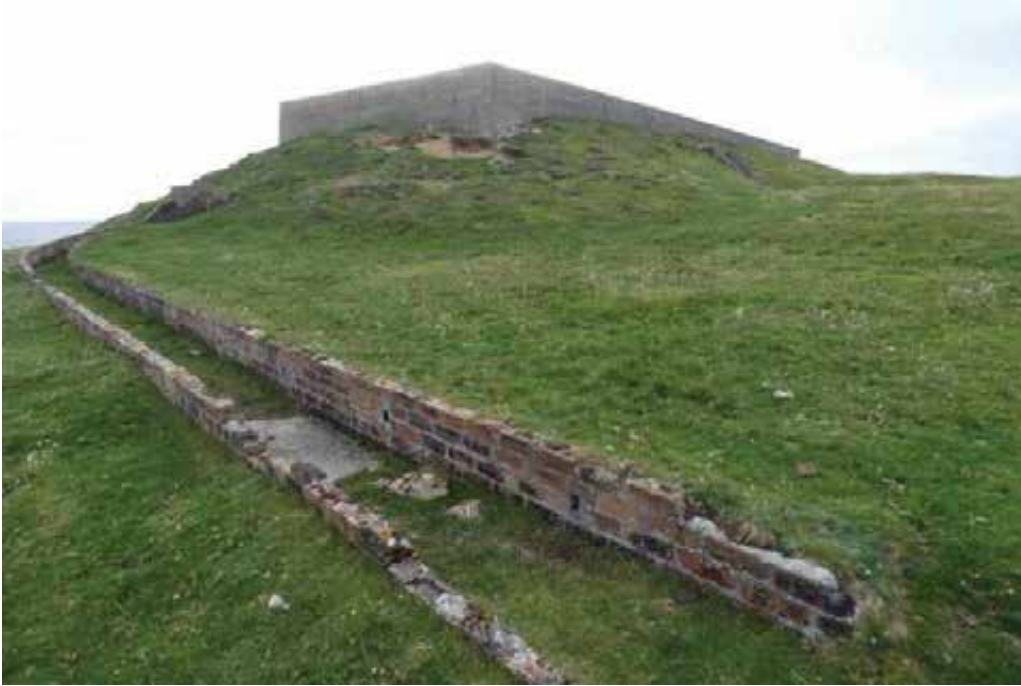
**The external brick service trench. Note general deterioration of top courses of its masonry. Note also the loss of material from the embankment about the blast walls.**

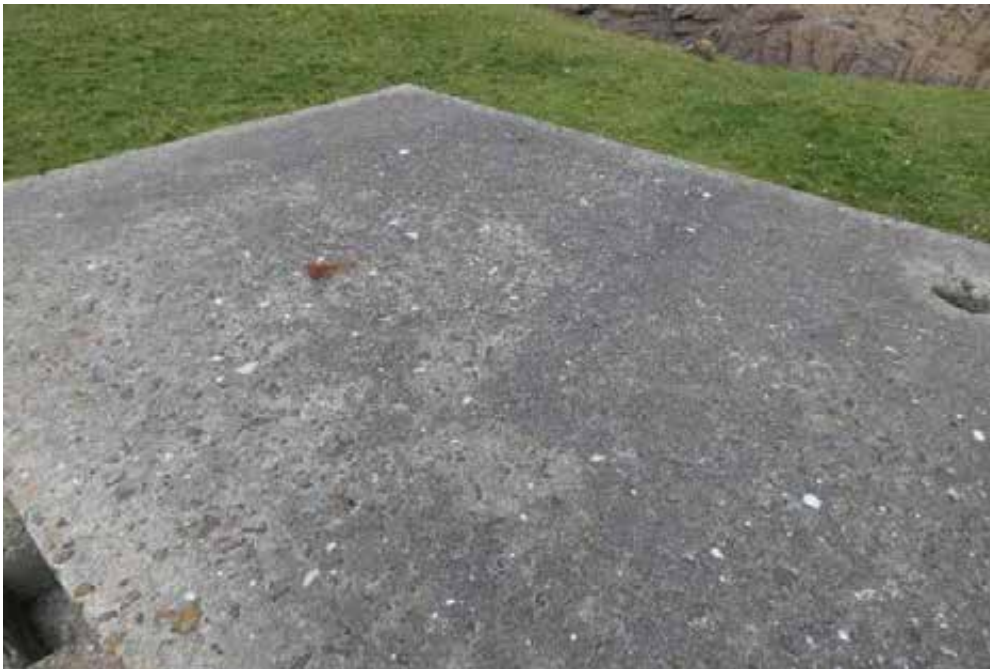
**2**

**Minor rust staining to the exterior of the roof slab.**

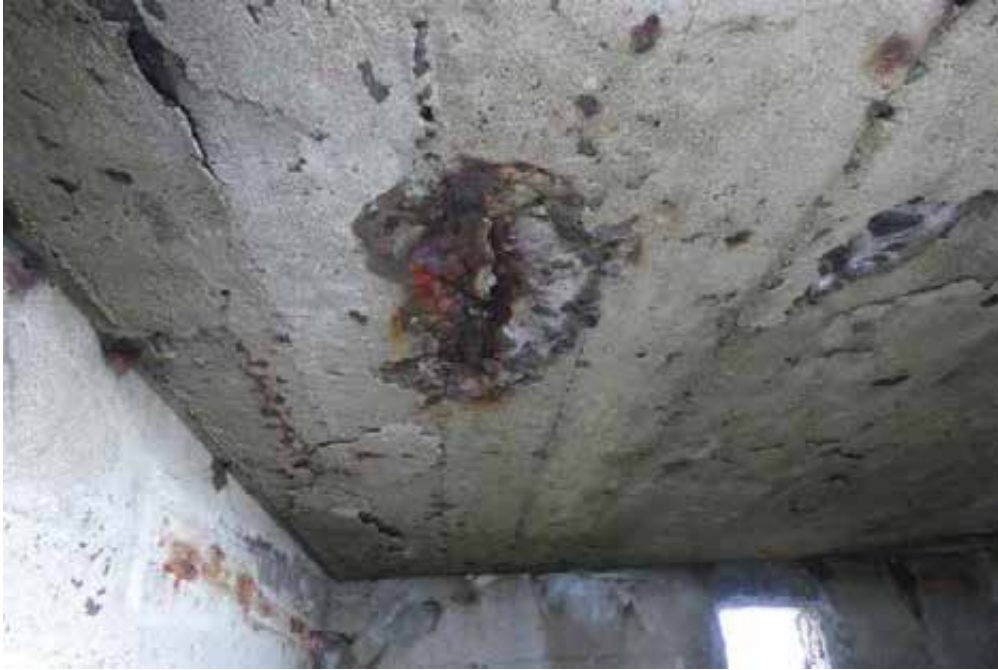
5

**Localised spalling internally exposing corroded reinforcement.**

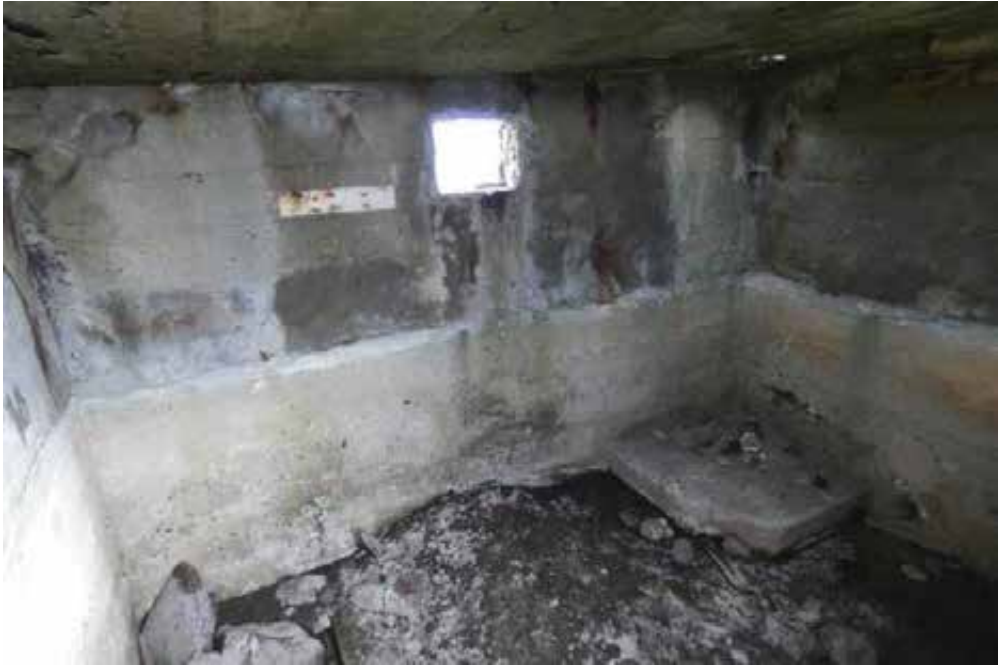
6

**Discoloured and damp stained wall. Floor obscured by accumulated debris.**

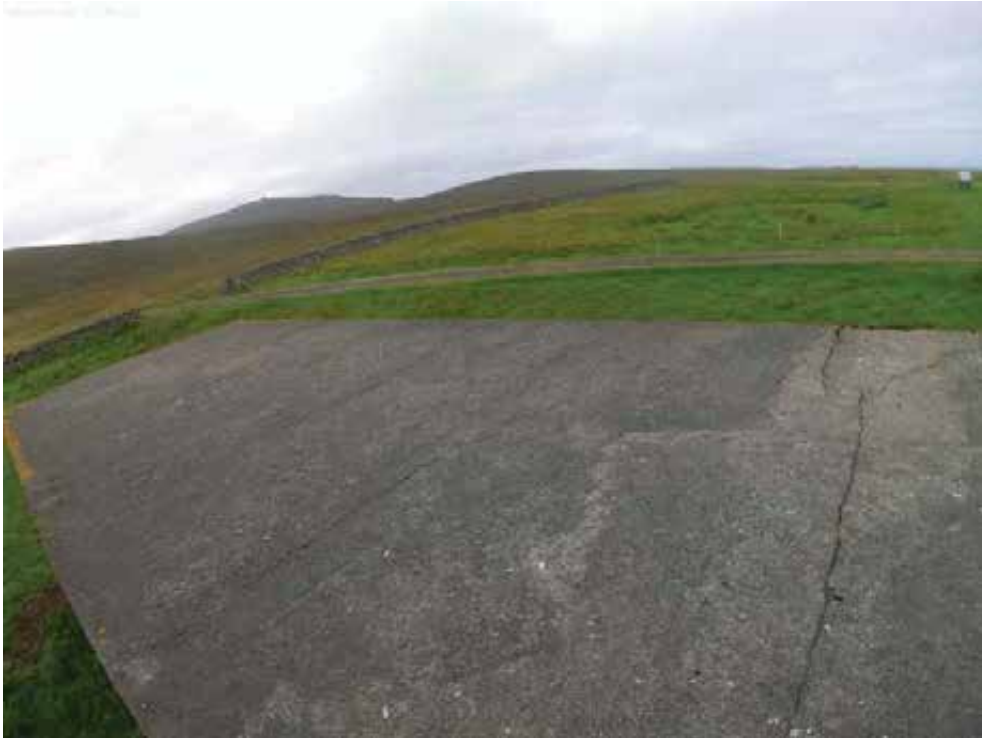
**1**

**Cracking is visible throughout the exposed concrete roof slab.**

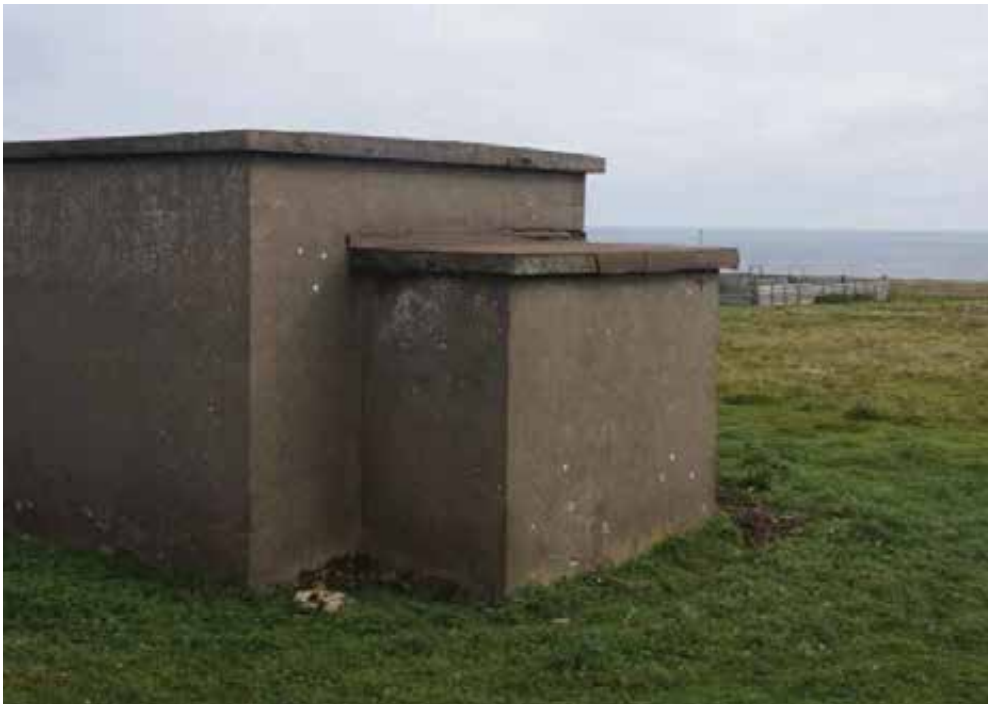
**2**

**Failing asphalt junction between the west entrance porch and main building. Only fragments survive on the main roof.**

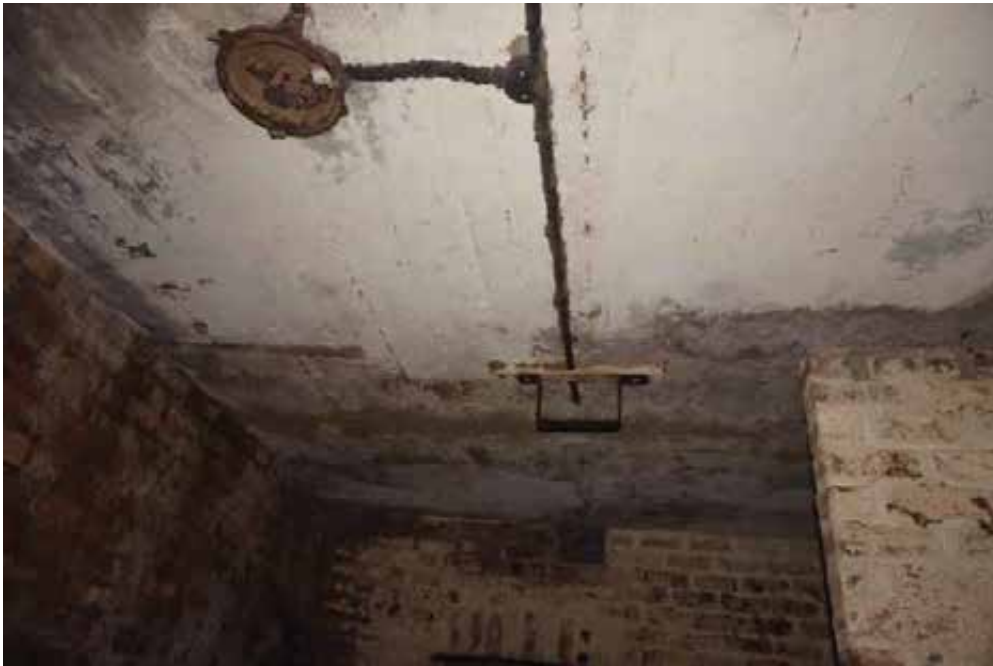
7

**Corroded surface mounted servicing.**

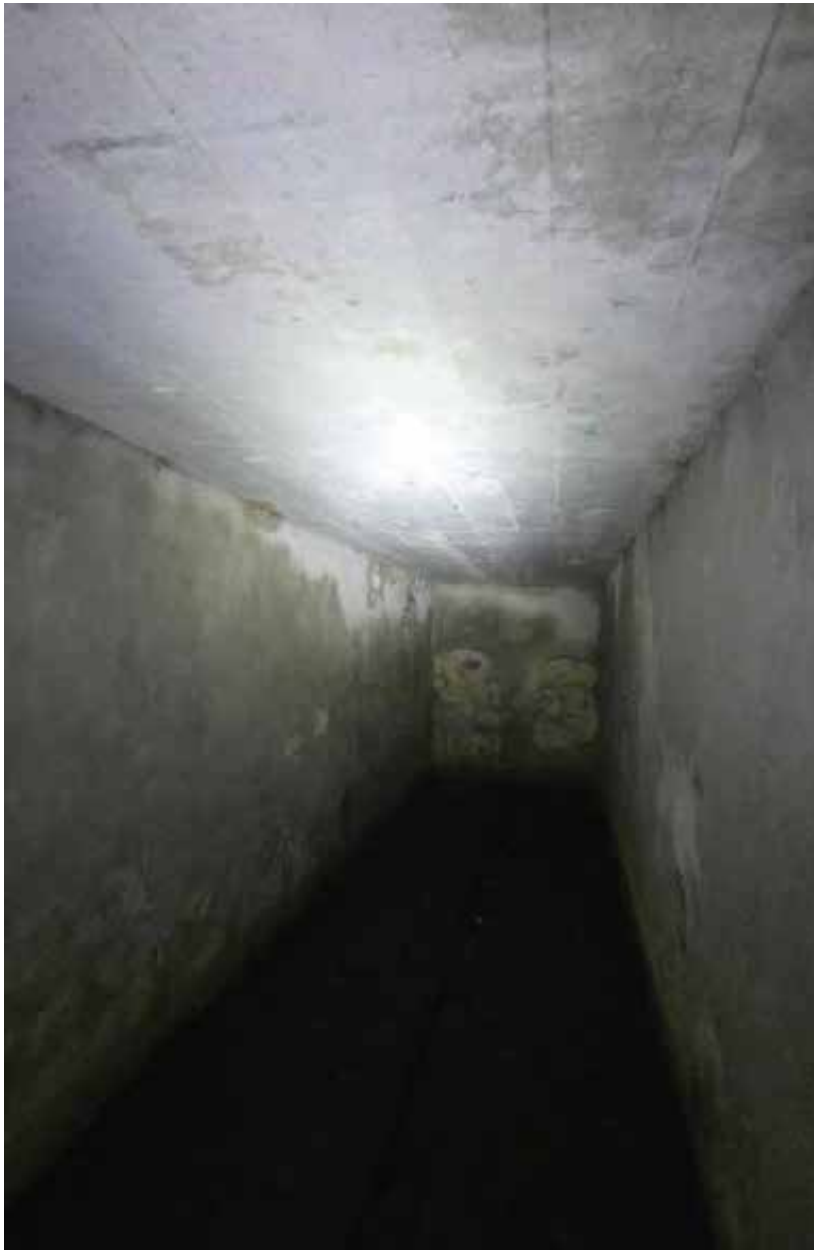
3

**Localised failing render internally.**

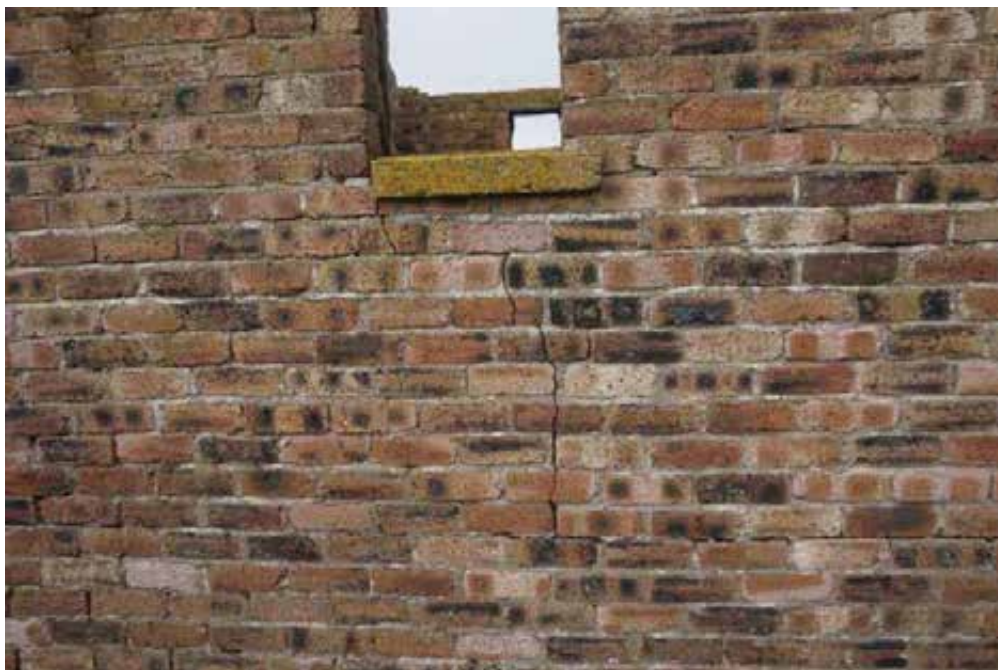
5

**Failing joints should be repointed and the crack below the east elevation window repaired with proprietary bed-joint reinforcement to reinstate continuity within masonry.**

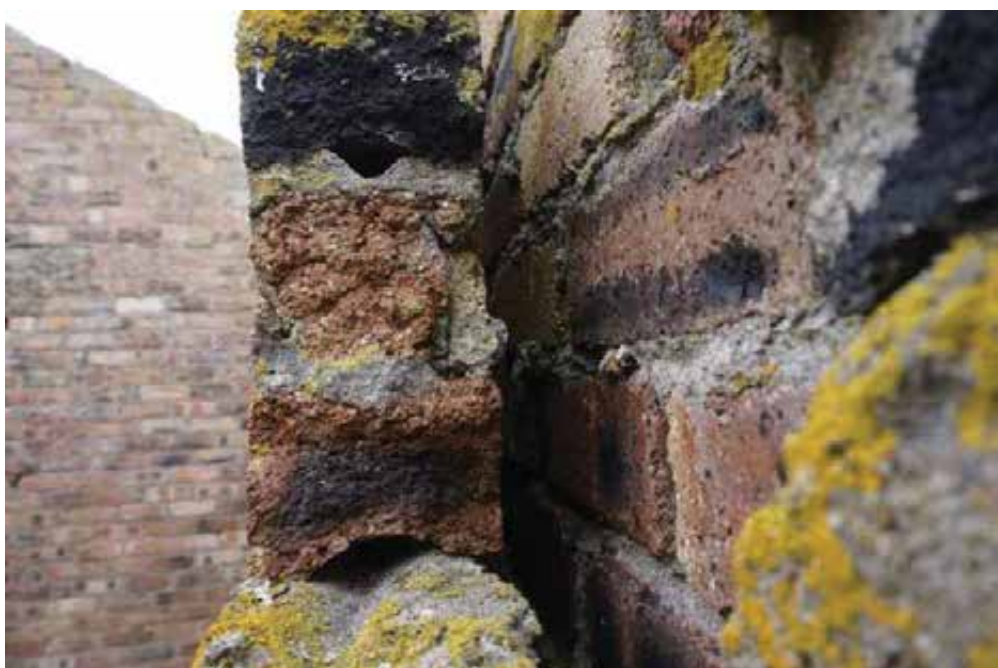
6

**The brickwork is poorly tied. Cavity ties should be retrofitted to ensure future stability.**

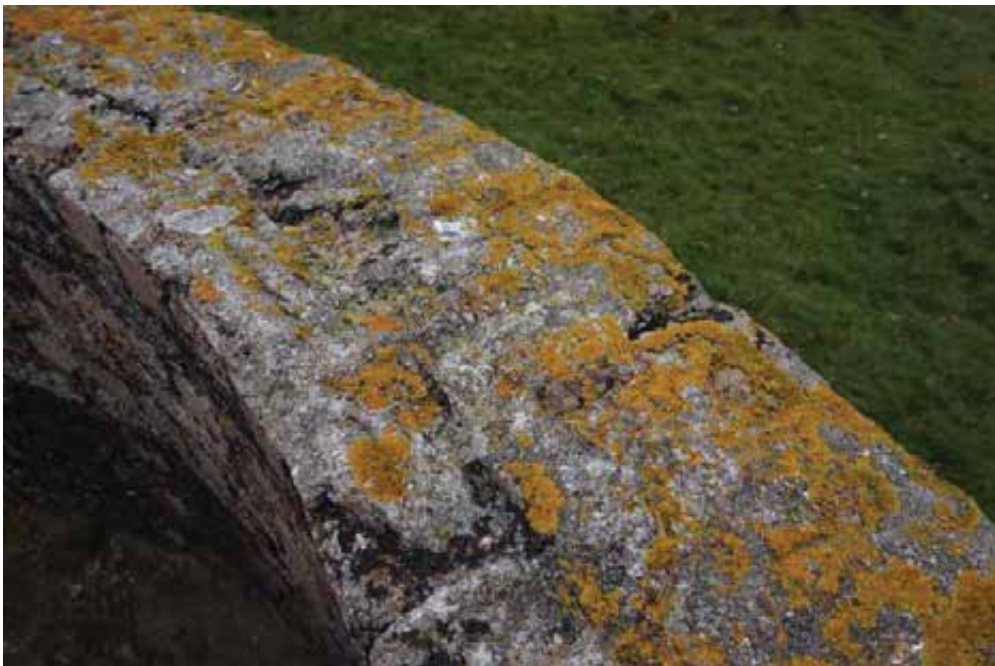
**2**

**Localised failing skyward facing wallhead joints.**

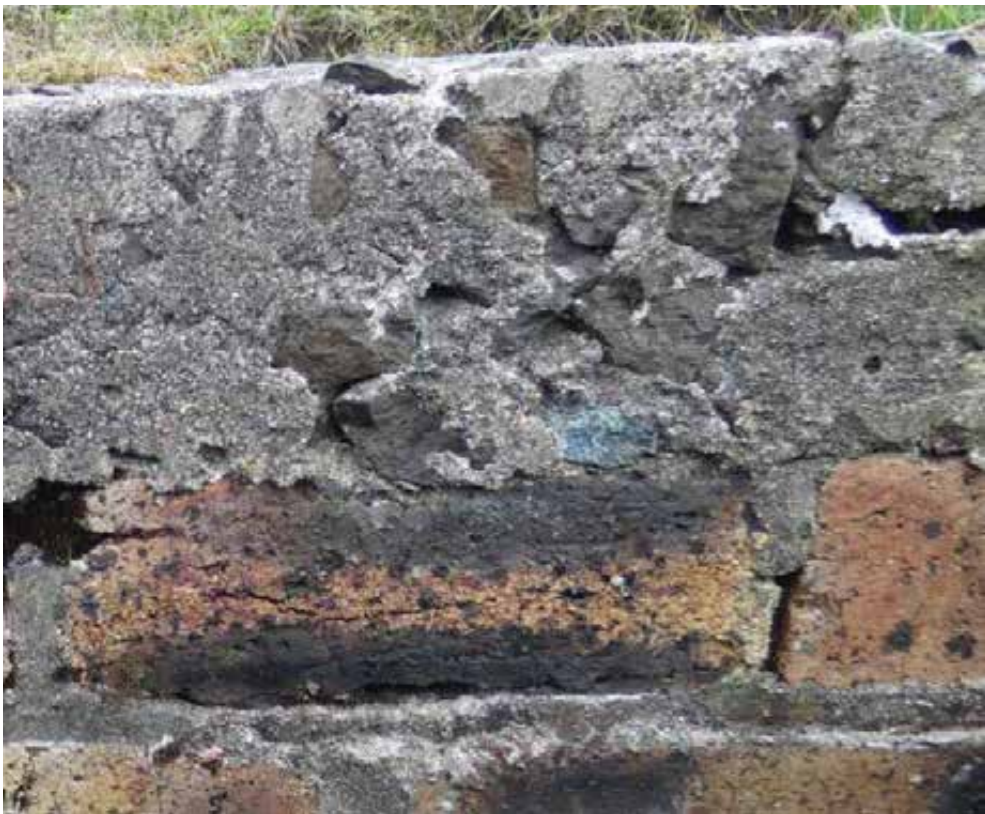
**2**

**Defective brick joints and exposed aggregate to roof slab.**

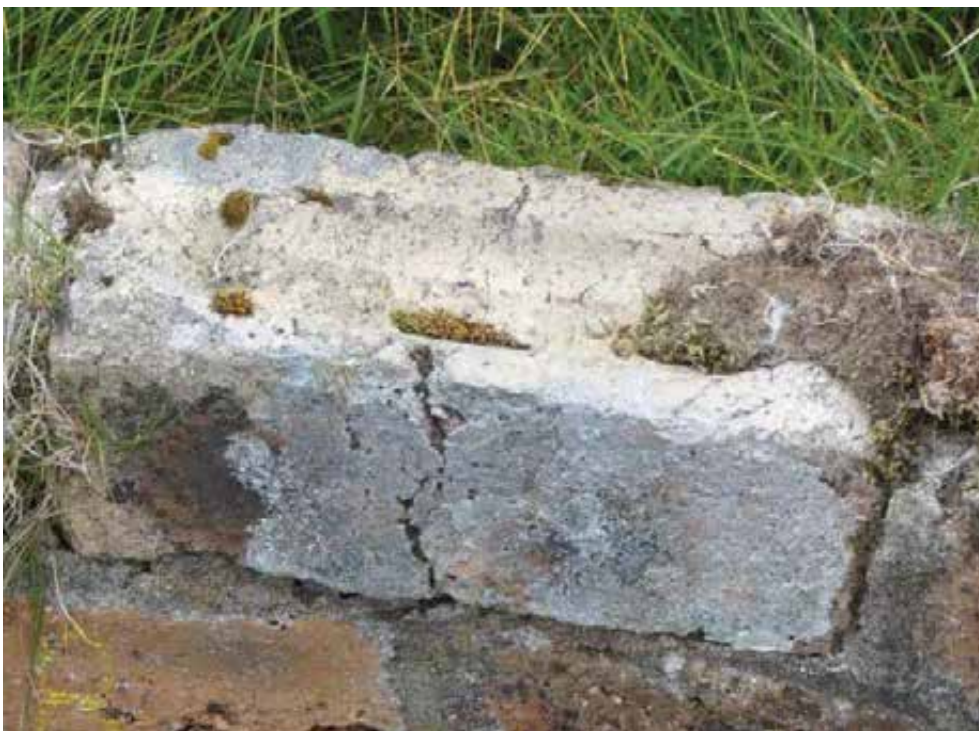
3

Localised failing joints at curved wallhead.

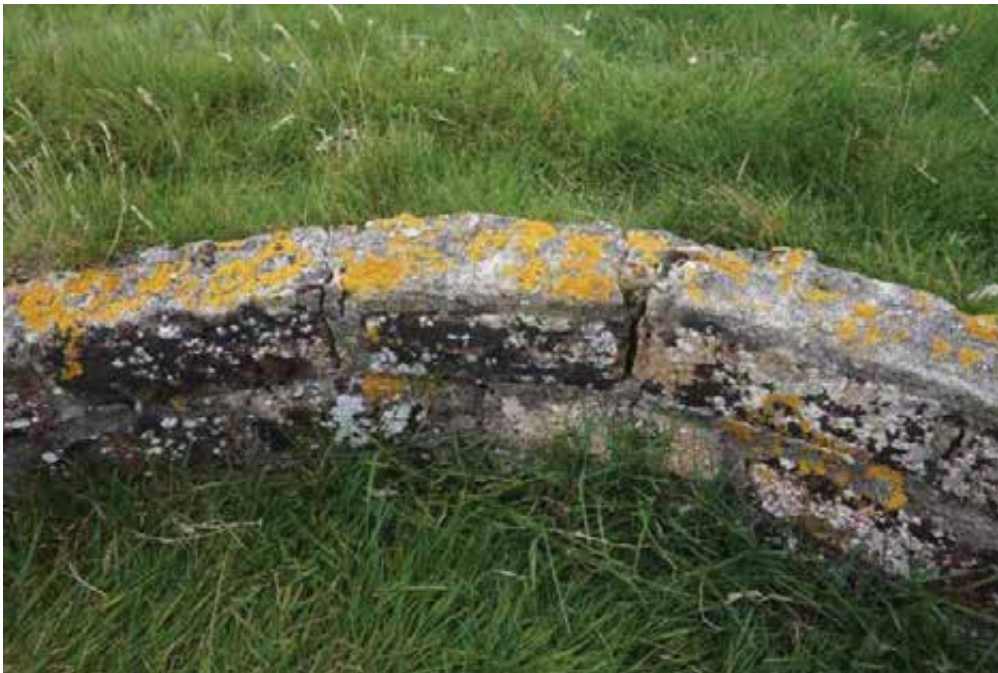
**2**

**Localised failing joints to wallhead of curved west end.**

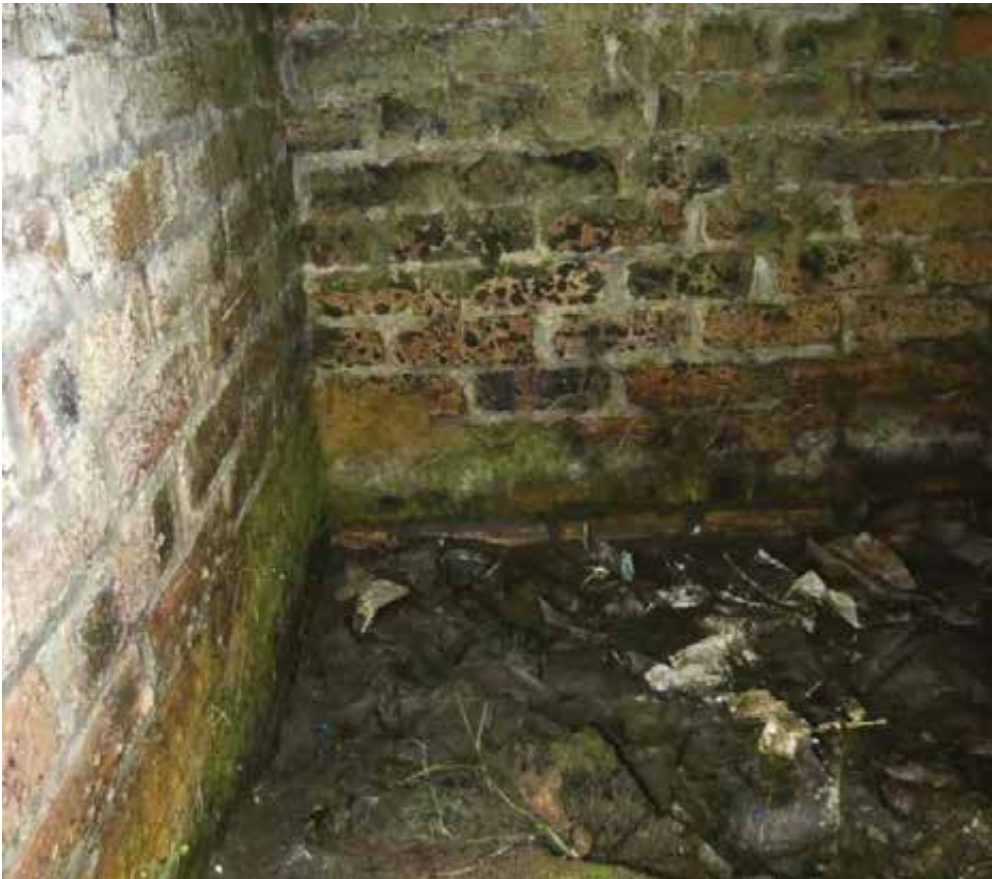
**Saturated brickwork below covered area.**

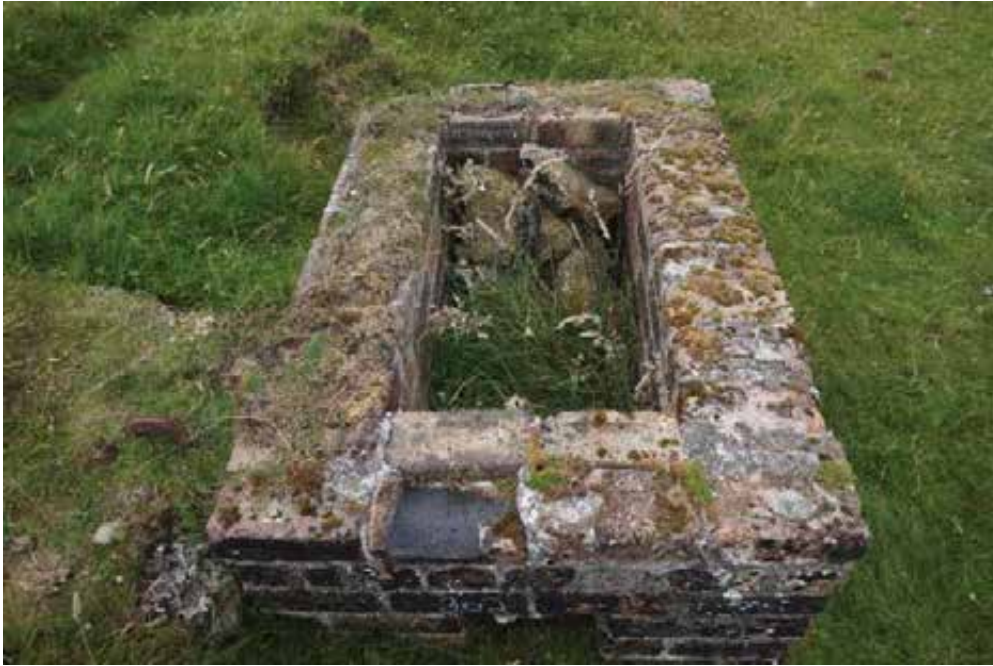
**1**

**Failing joints to wallhead supporting vegetation growth. Localised damaged bricks.**

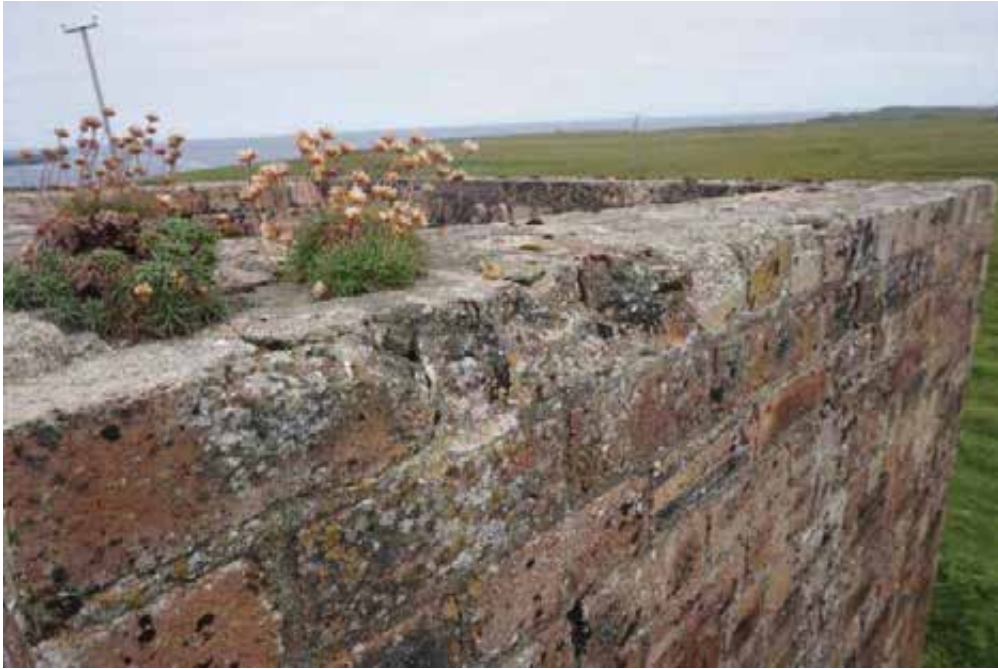
**1.**

**Localised damaged brickwork and defective joints. Vegetation growth at wallhead.**

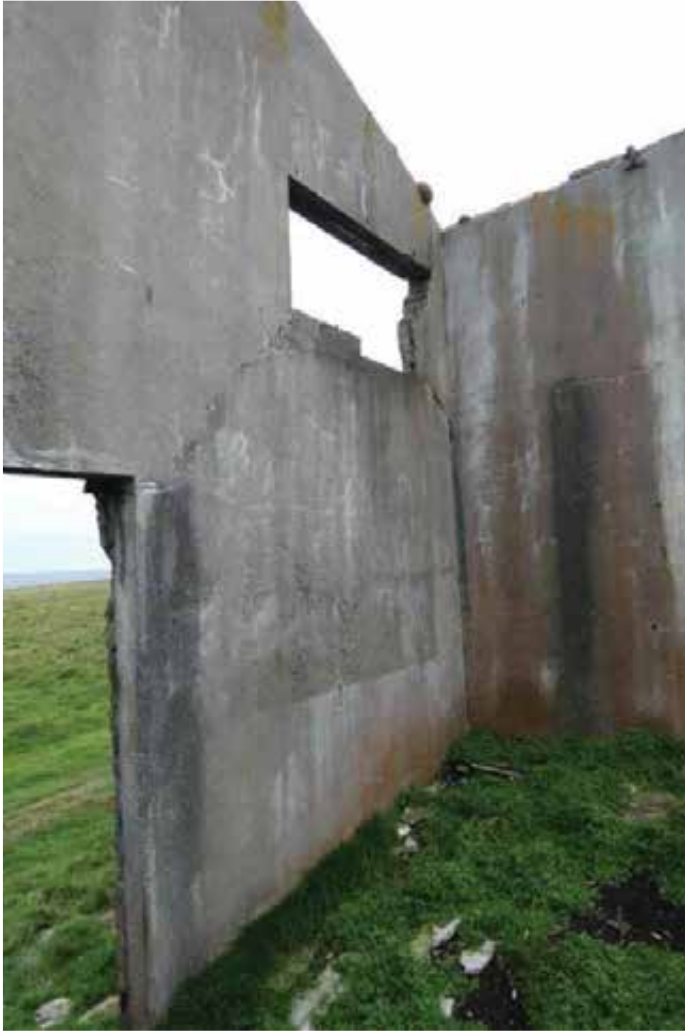
7

**Internal view of east gable. Note how the cracking is right through the masonry.**
