# Appendix 14.9 Data Interpretation Strategy

# Appendix 14.9 Draft Heritage Interpretation Strategy

## **4.2 Condition Survey**

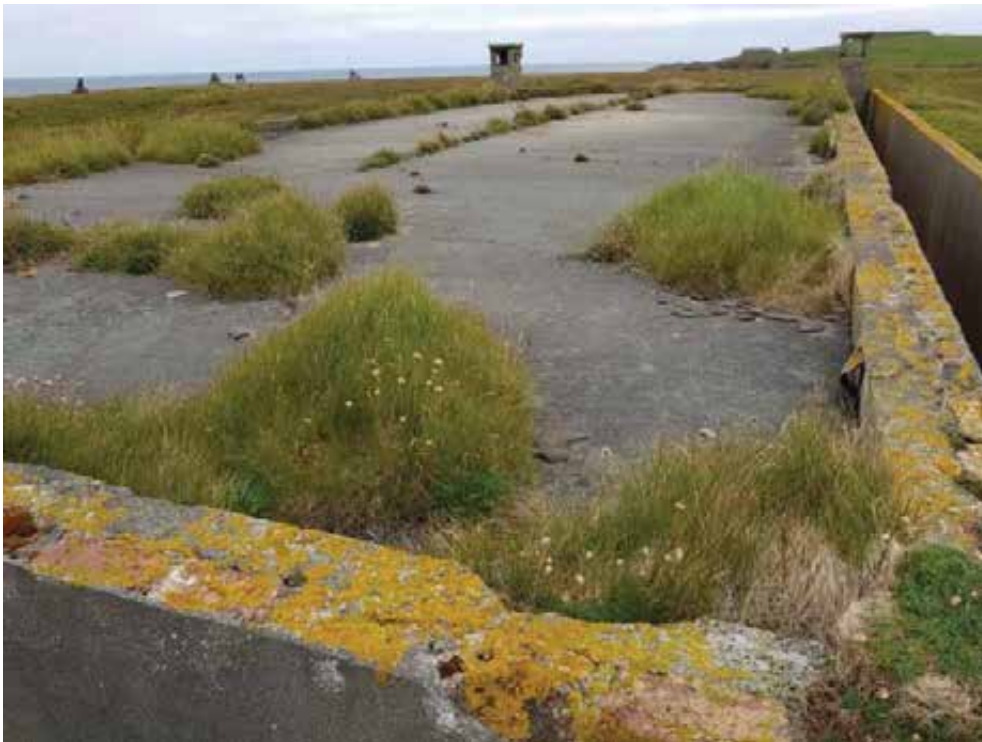
6.

Looking across the roofscape. Note cracked asphalt, vegetation and missing concrete copes from wallheads.

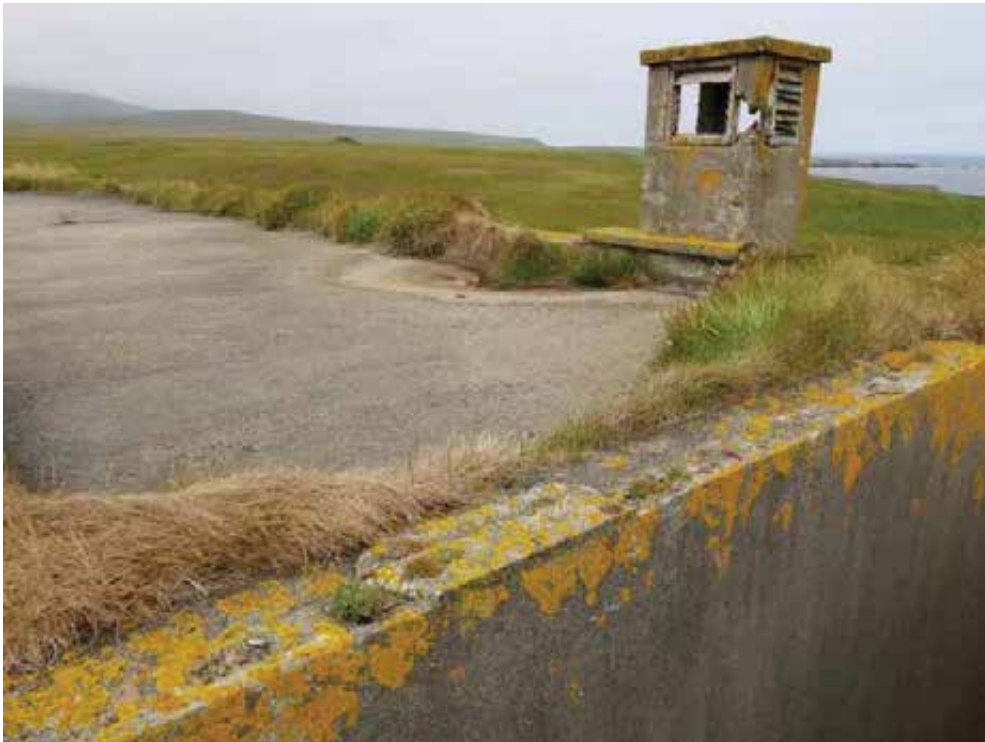
8.

As 6. Note broken leg of RC cap to chimney – see next photo.

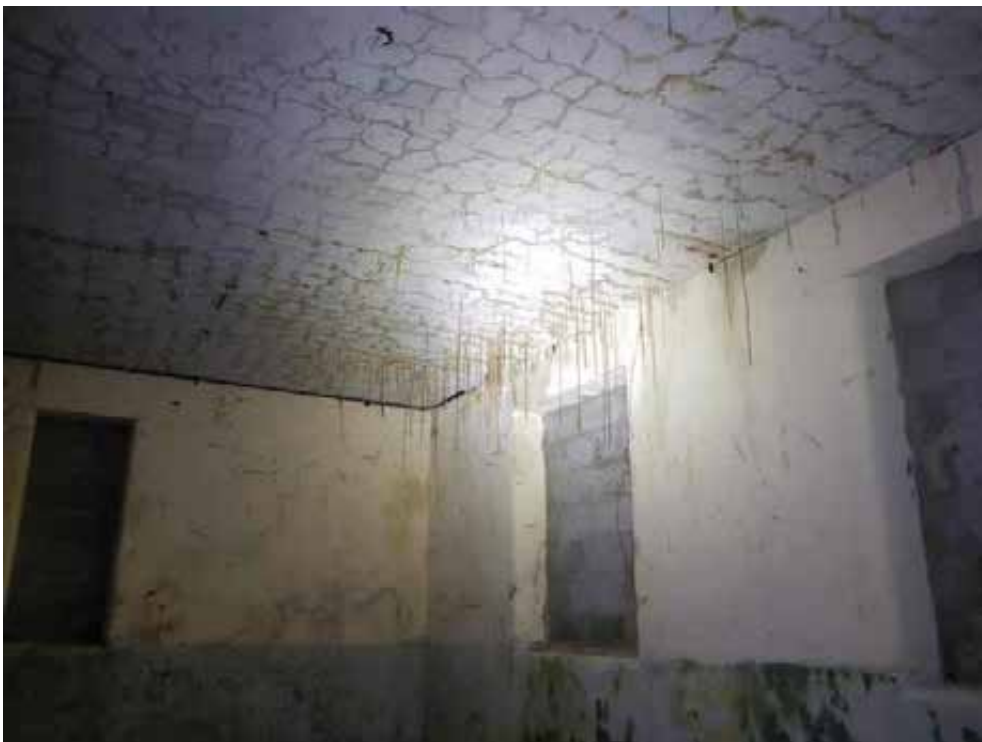
14.

Water ingress through the roof slab obvious, indicated by the stalactites from the roof and cracking of the plaster.

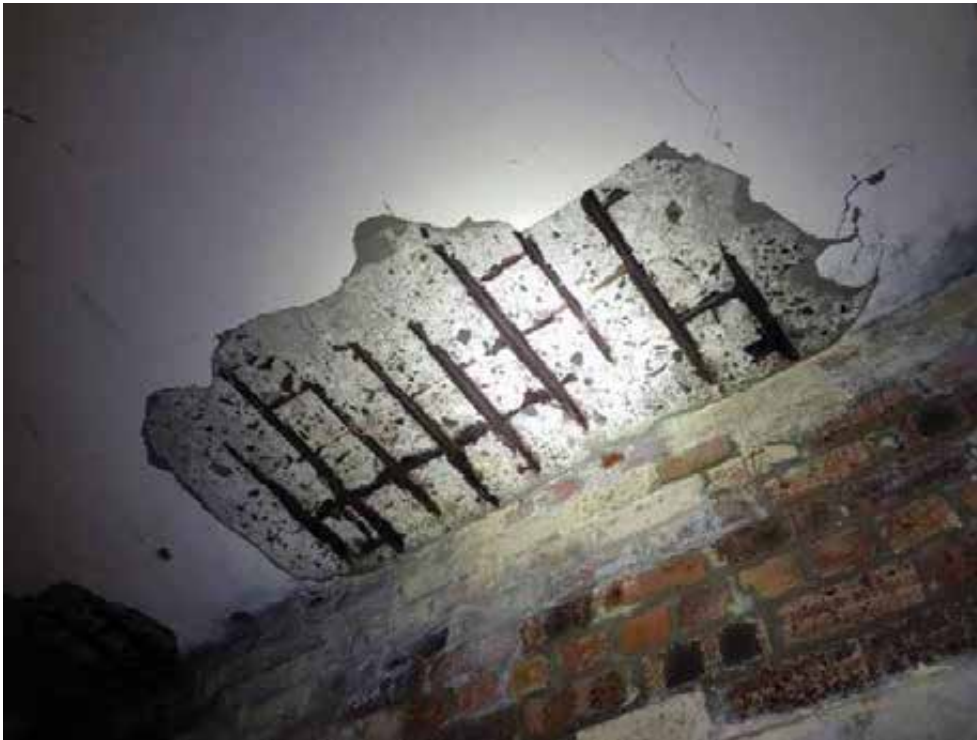
15

Spalling concrete caused by expansive corrosion of reinforcement.

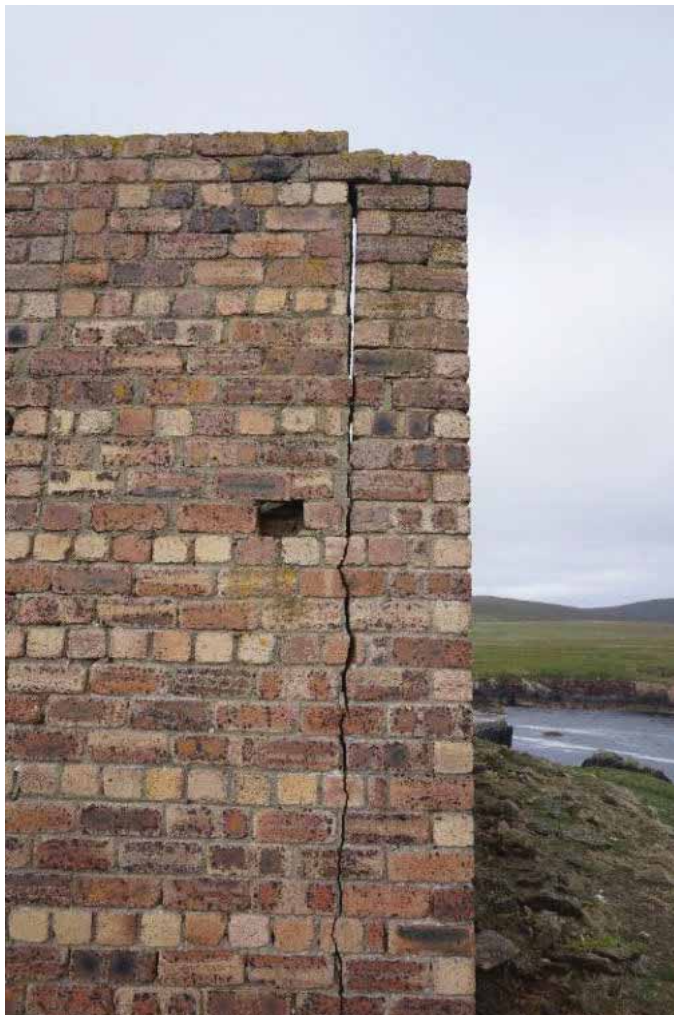
4

**Cracks at the northeast (lower image) and southeast corners where brickwork is poorly tied and are likely to be exacerbated by poor ground conditions affecting the foundations. Stitching across these cracks is recommended.**

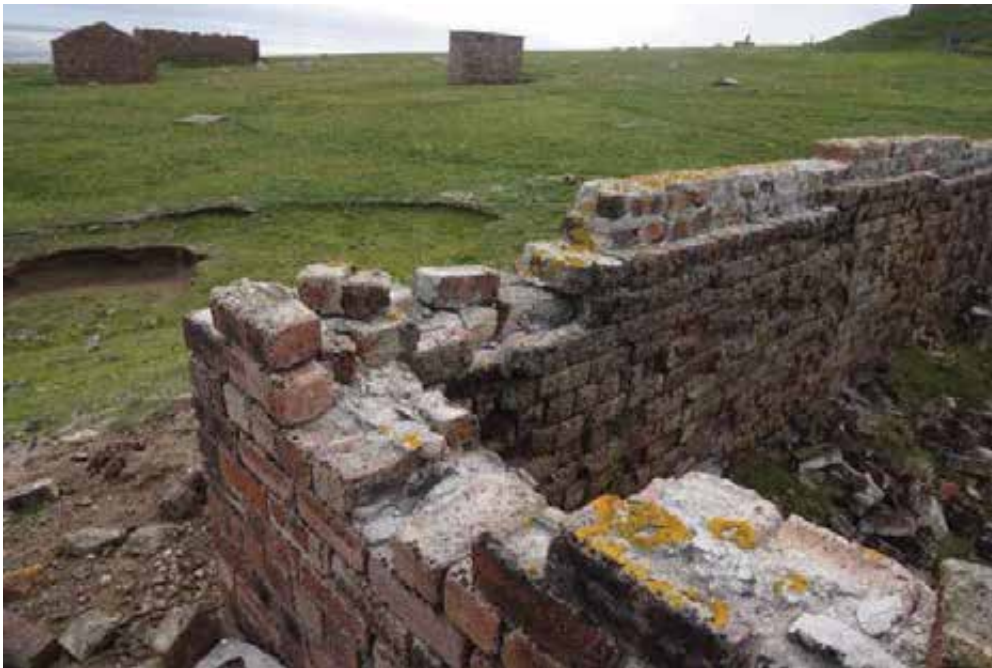
4

Loose wallhead brickwork and failing joints.

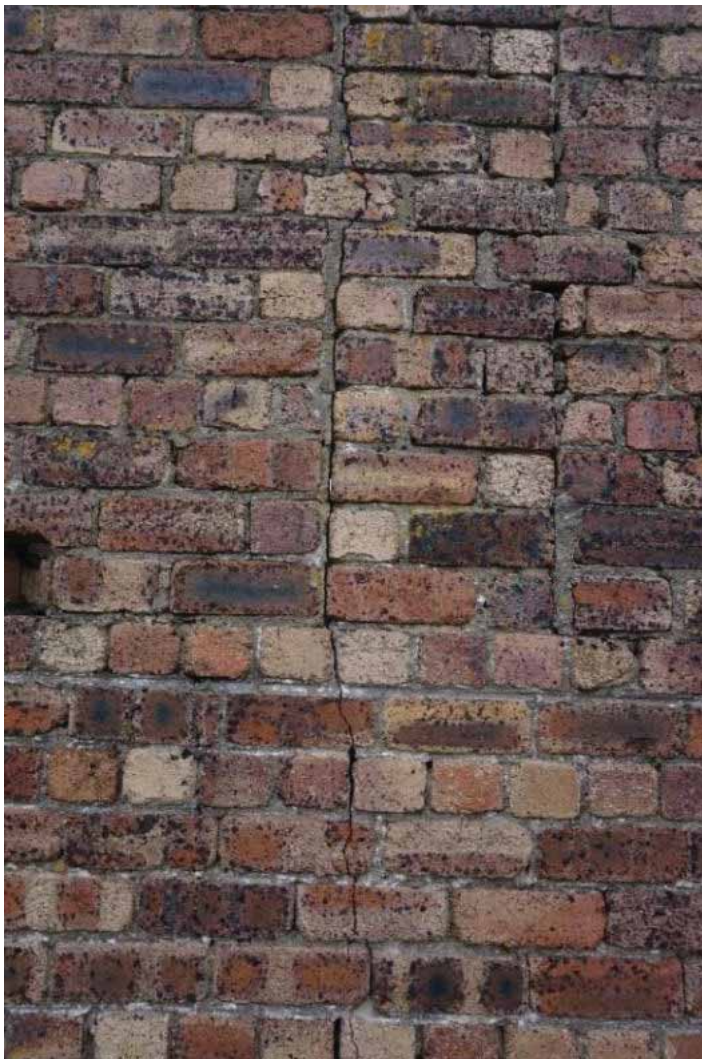
4

**A vertical crack extends from a section of missing brickwork at ground level internally on the east wall. The brickwork panels either side of the pier (seen just off-centre) are poorly tied across the pier.**

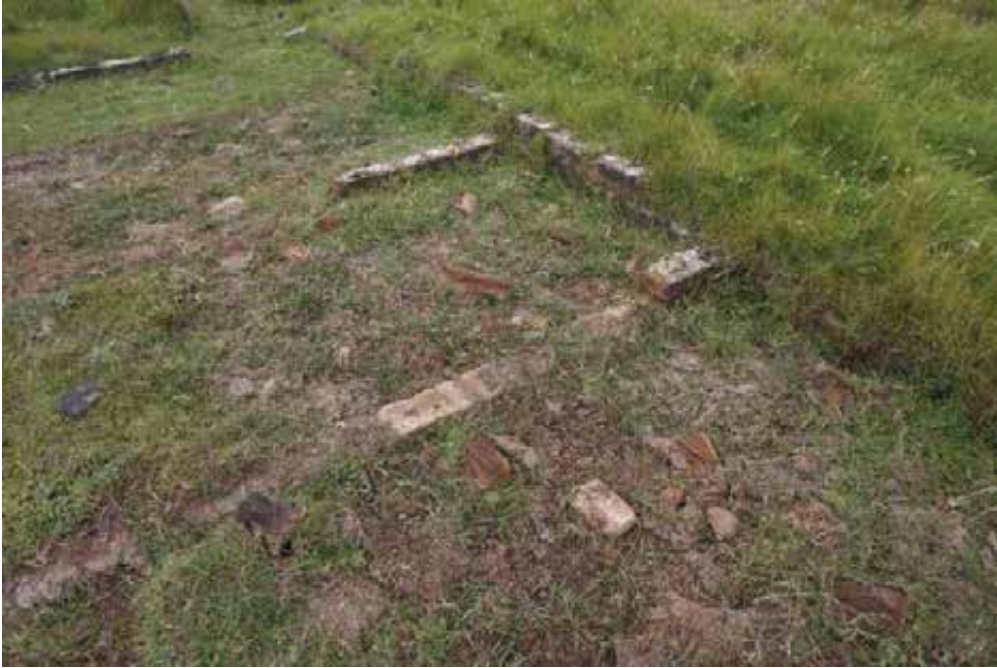
3

**There is loose and displaced brickwork throughout the east portion. Consideration should be given to burying them to protect them from exposure to weathering and from the impact of increased footfall to the site.**

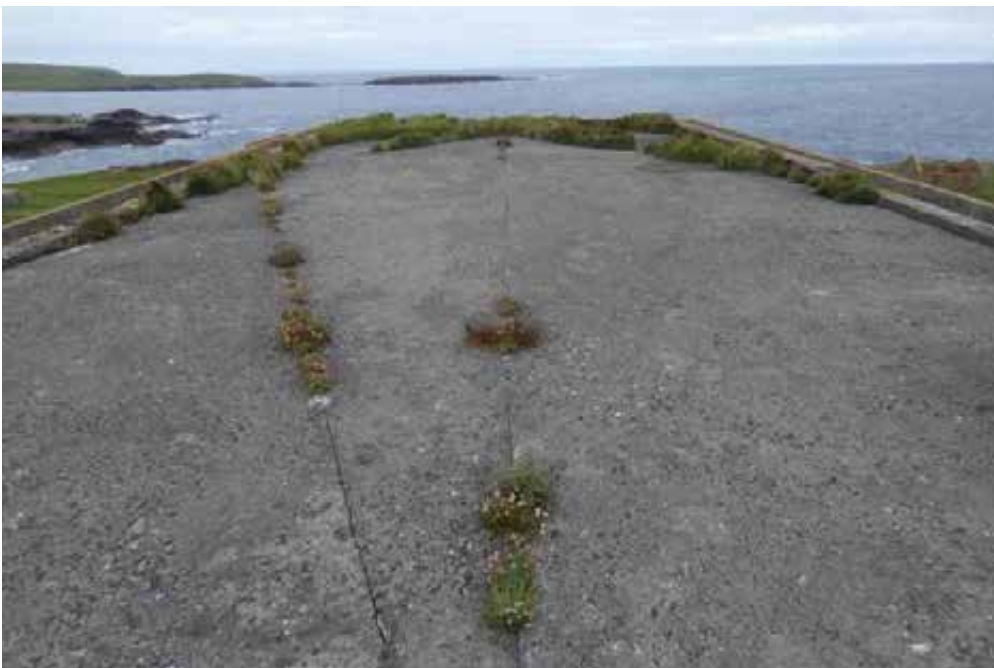
5.

**General view across the roof. Note cracking of the asphalt and vegetation growing from those cracks.**

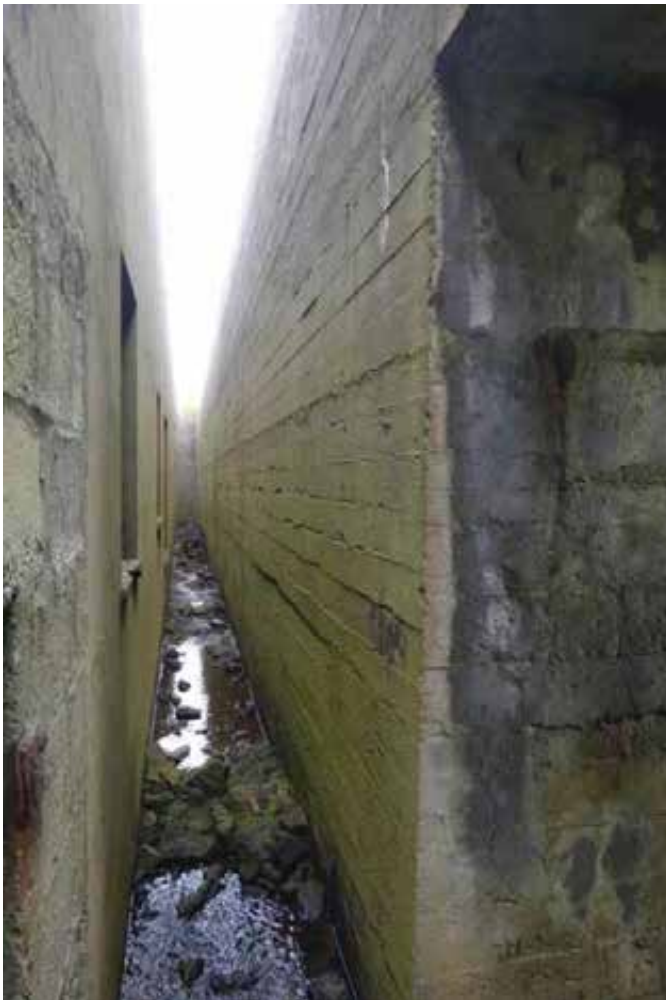
9.

Looking between the blast walls and building proper. Note build up of debris and water.

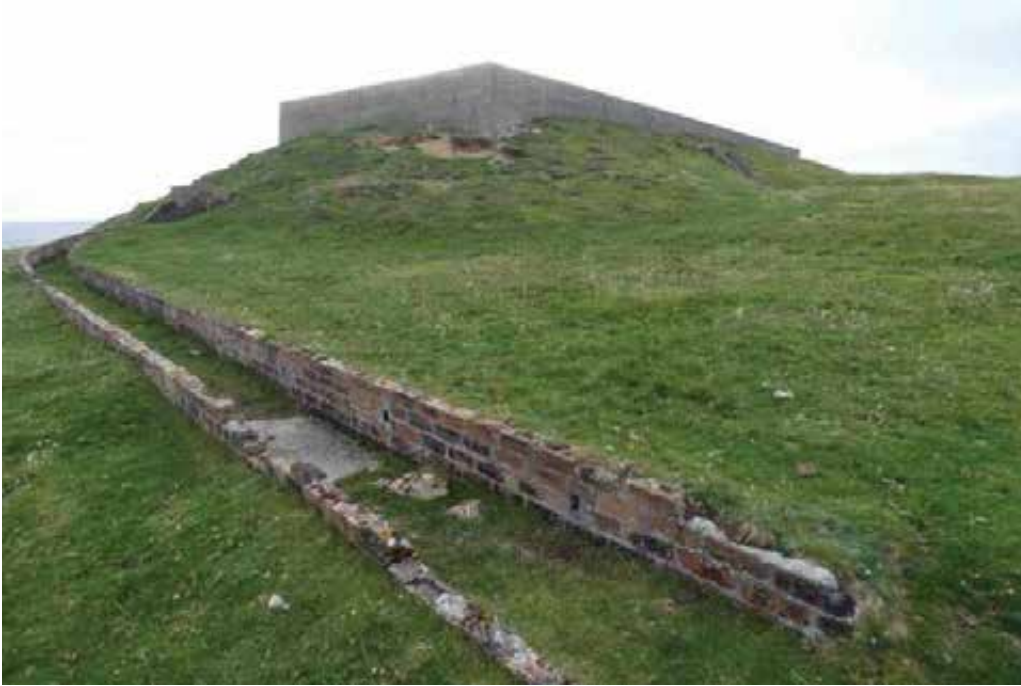
**The external brick service trench. Note general deterioration of top courses of its masonry. Note also the loss of material from the embankment about the blast walls.**

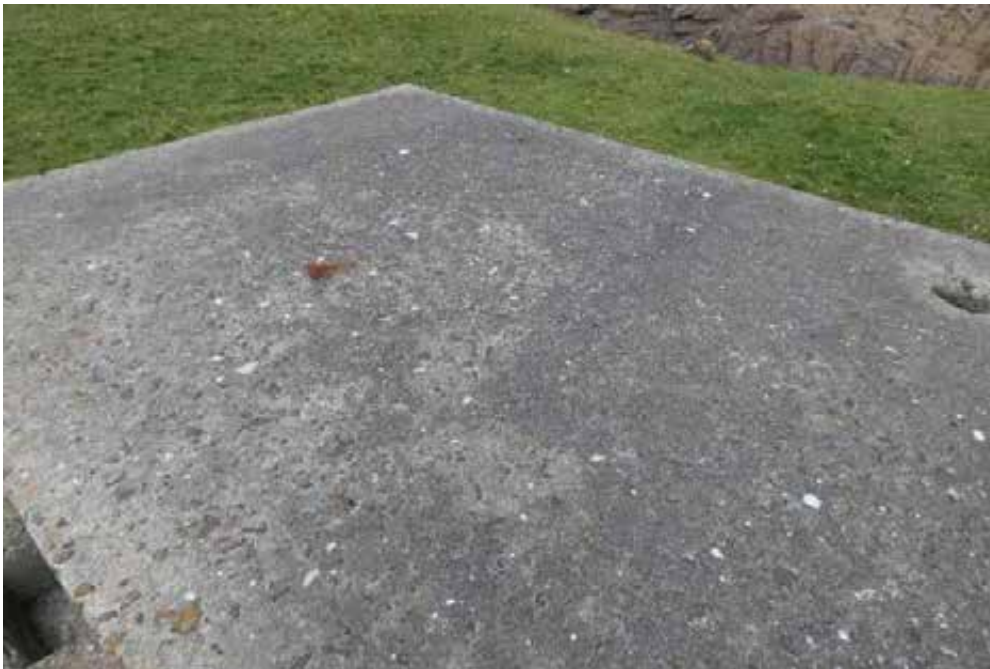
**2**

**Minor rust staining to the exterior of the roof slab.**

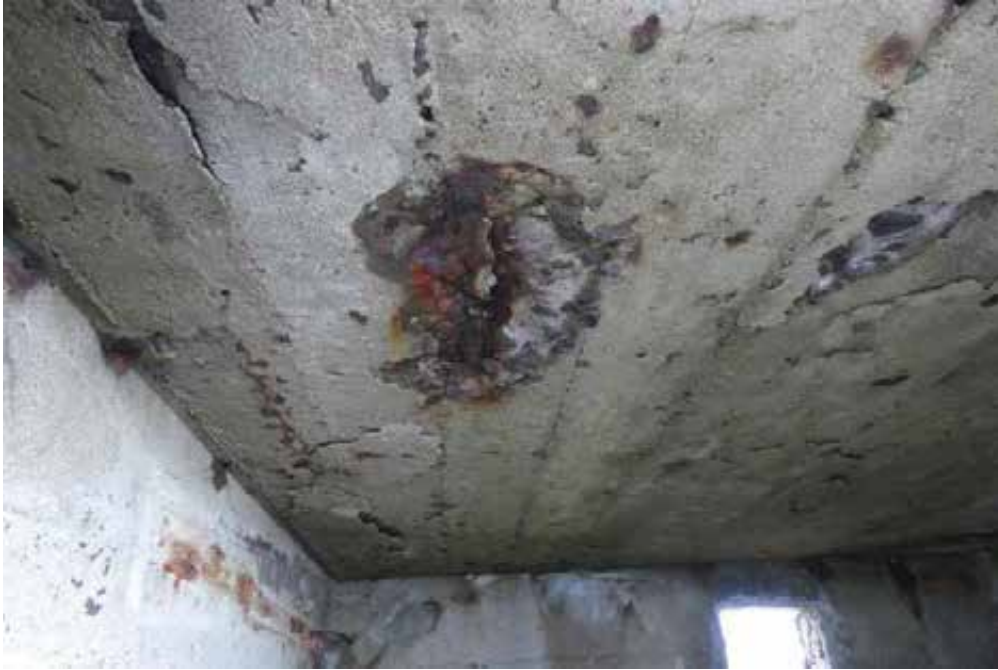
5

**Localised spalling internally exposing corroded reinforcement.**

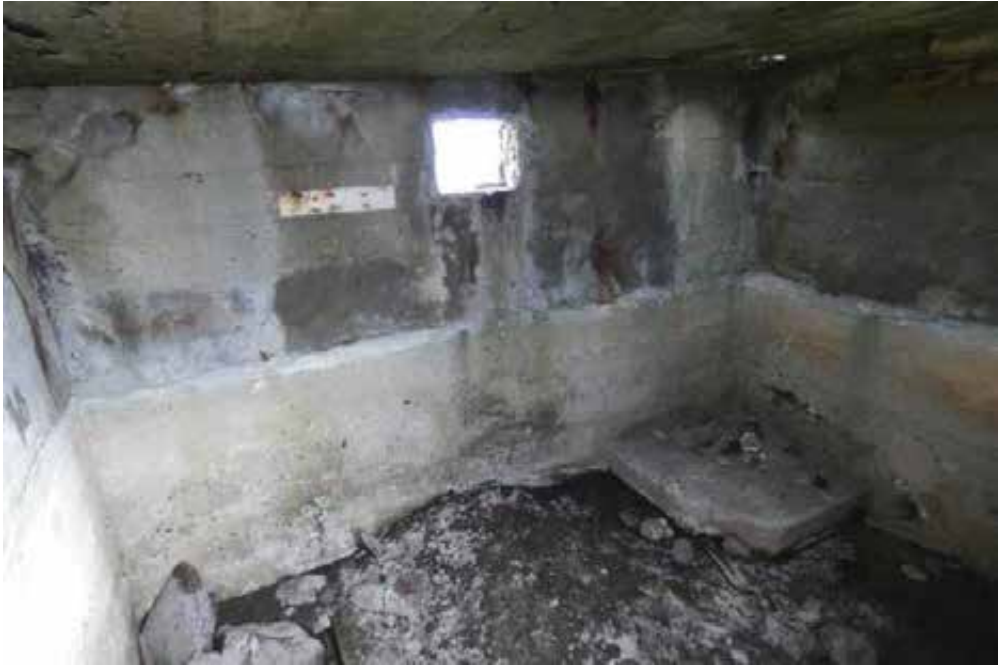
6

**Discoloured and damp stained wall. Floor obscured by accumulated debris.**

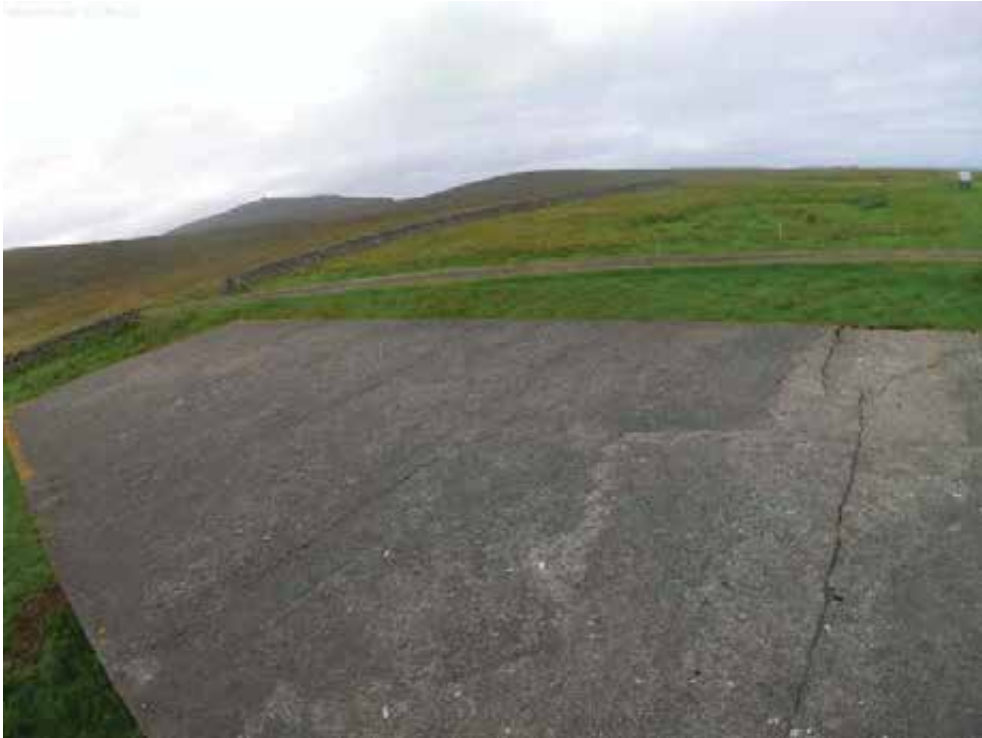
**1**

**Cracking is visible throughout the exposed concrete roof slab.**

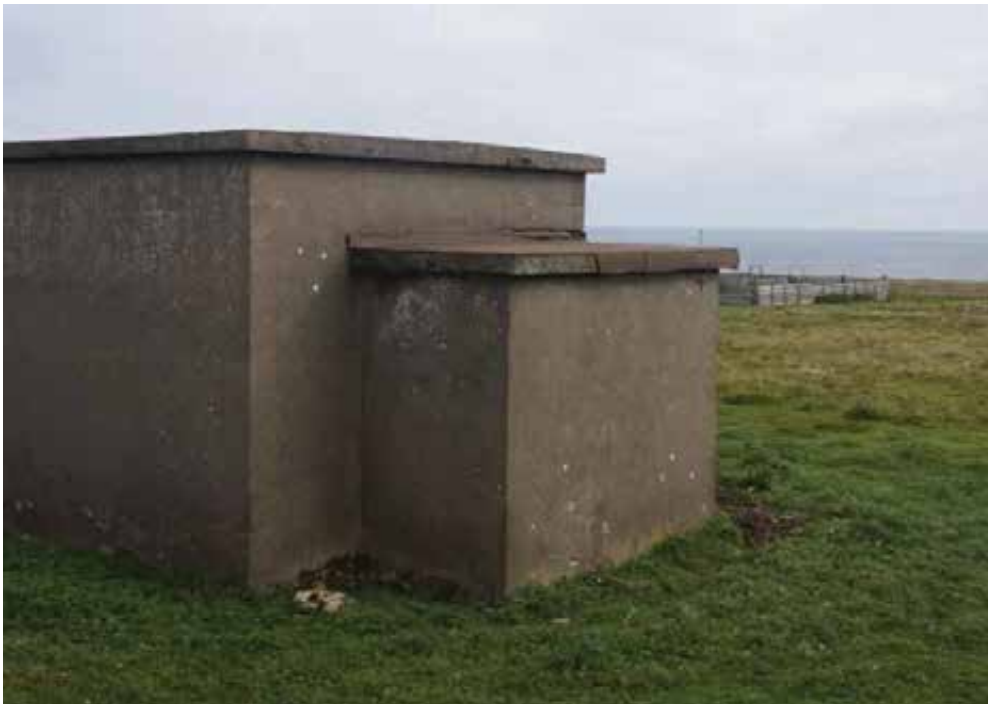
**2**

**Failing asphalt junction between the west entrance porch and main building. Only fragments survive on the main roof.**

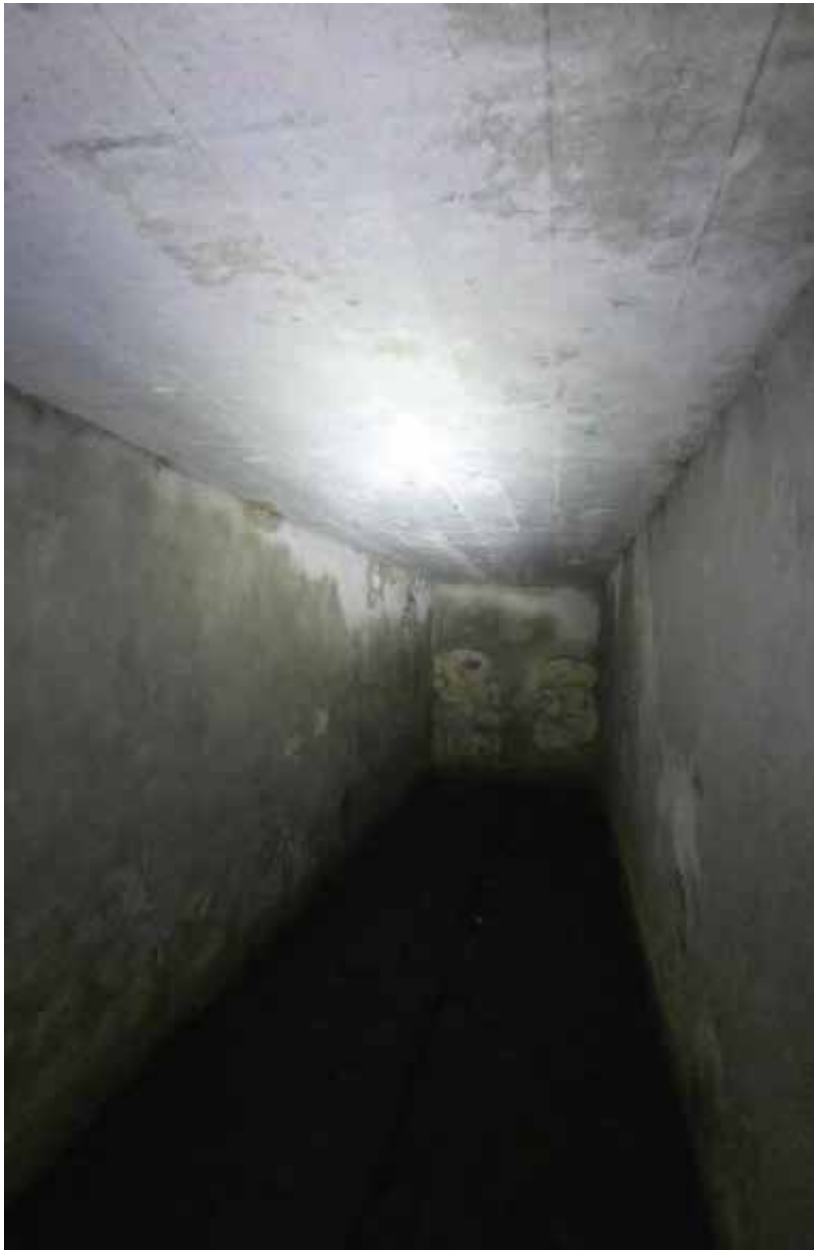
3

**Localised failing render internally.**

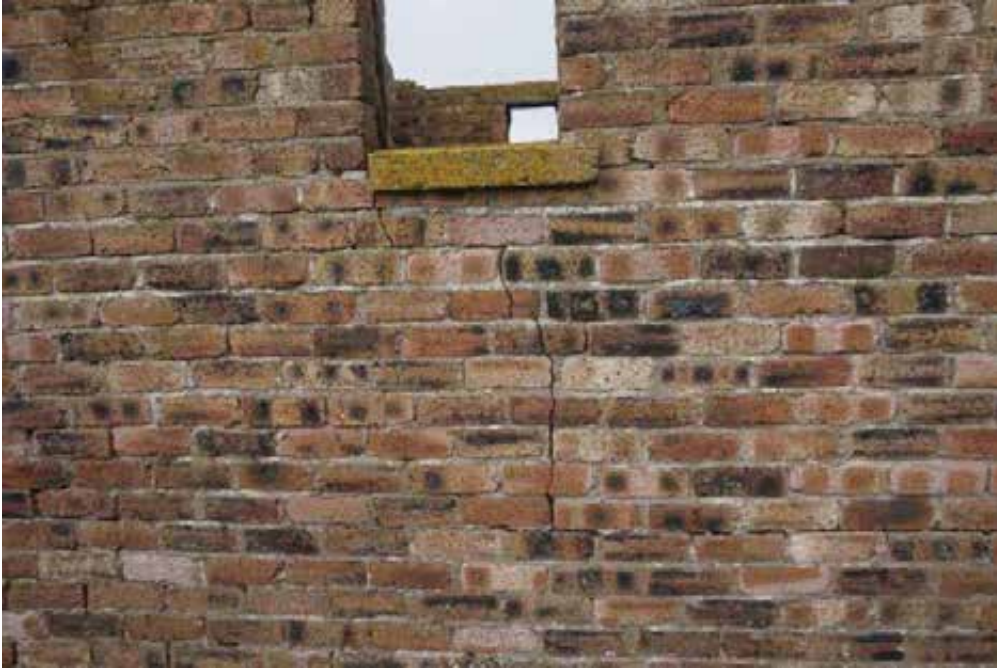
5

**Failing joints should be repointed and the crack below the east elevation window repaired with proprietary bed-joint reinforcement to reinstate continuity within masonry.**

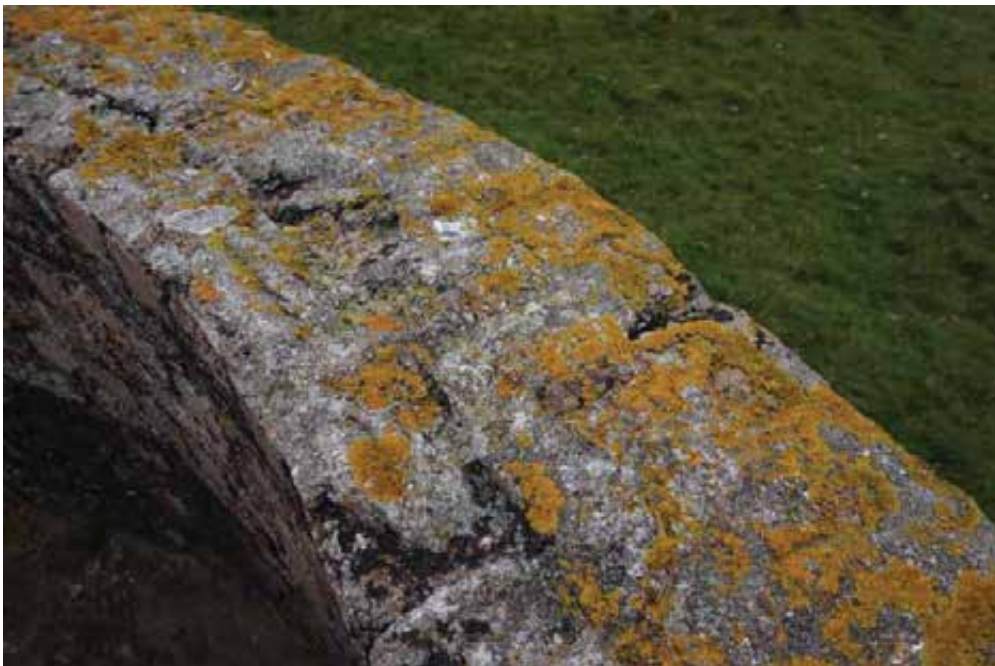
**2**

**Localised failing skyward facing wallhead joints.**

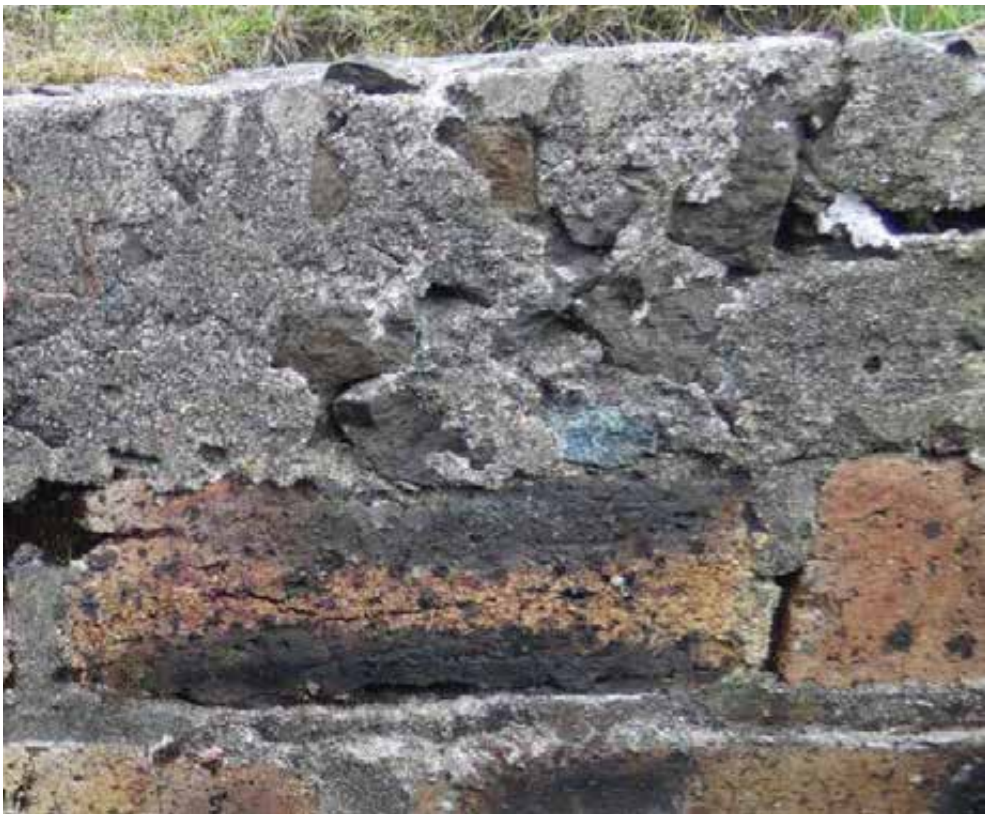
**2**

**Defective brick joints and exposed aggregate to roof slab.**

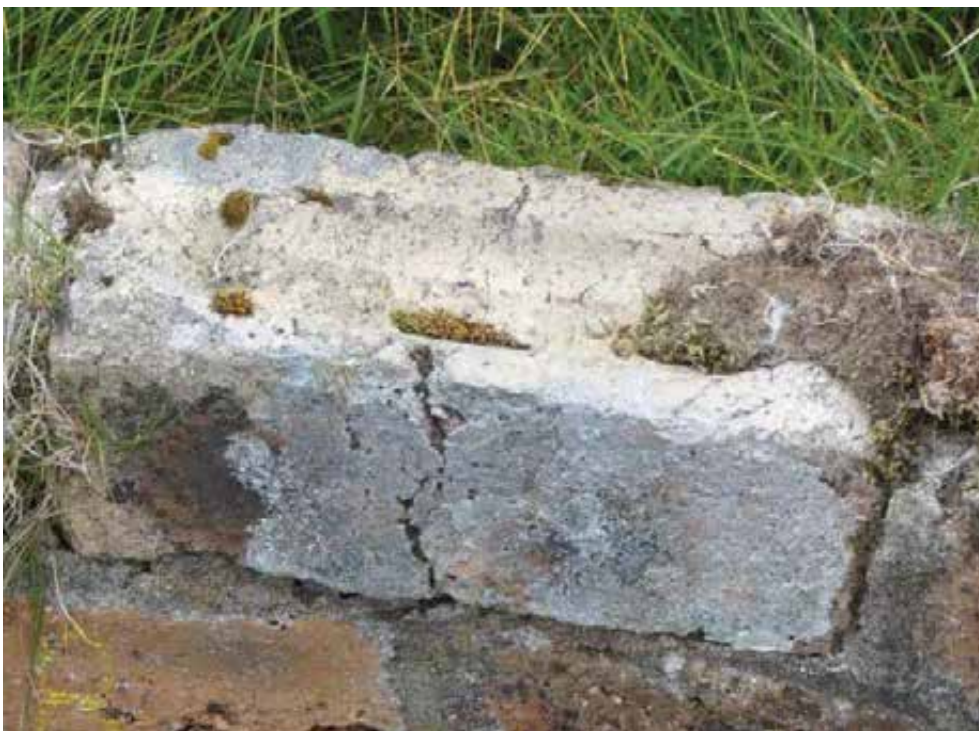
3

**Localised failing joints at curved wallhead.**

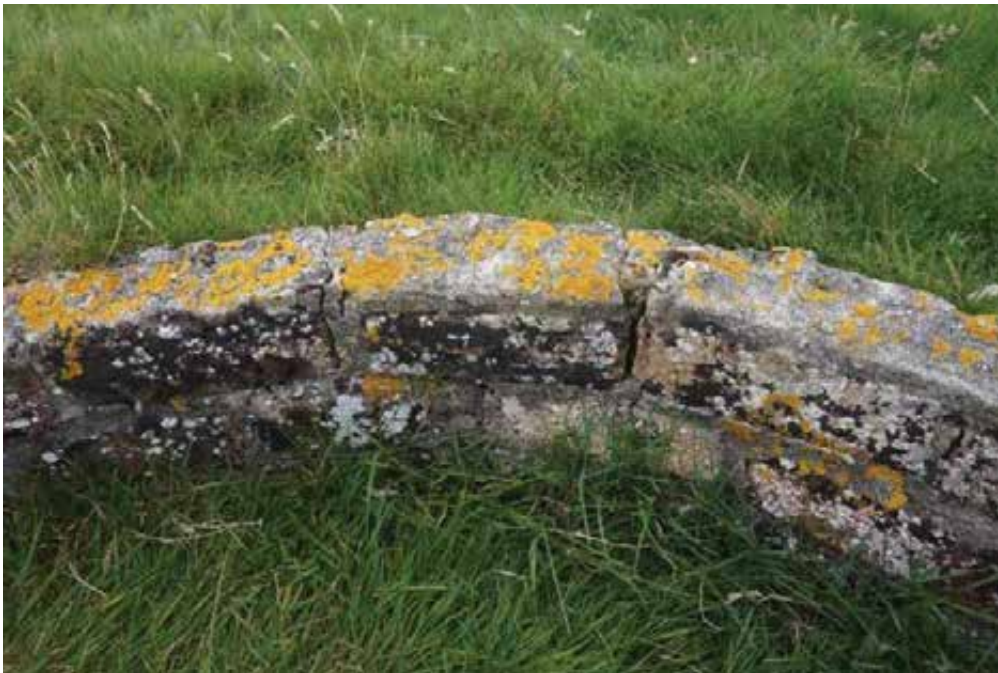
**2**

**Localised failing joints to wallhead of curved west end.**

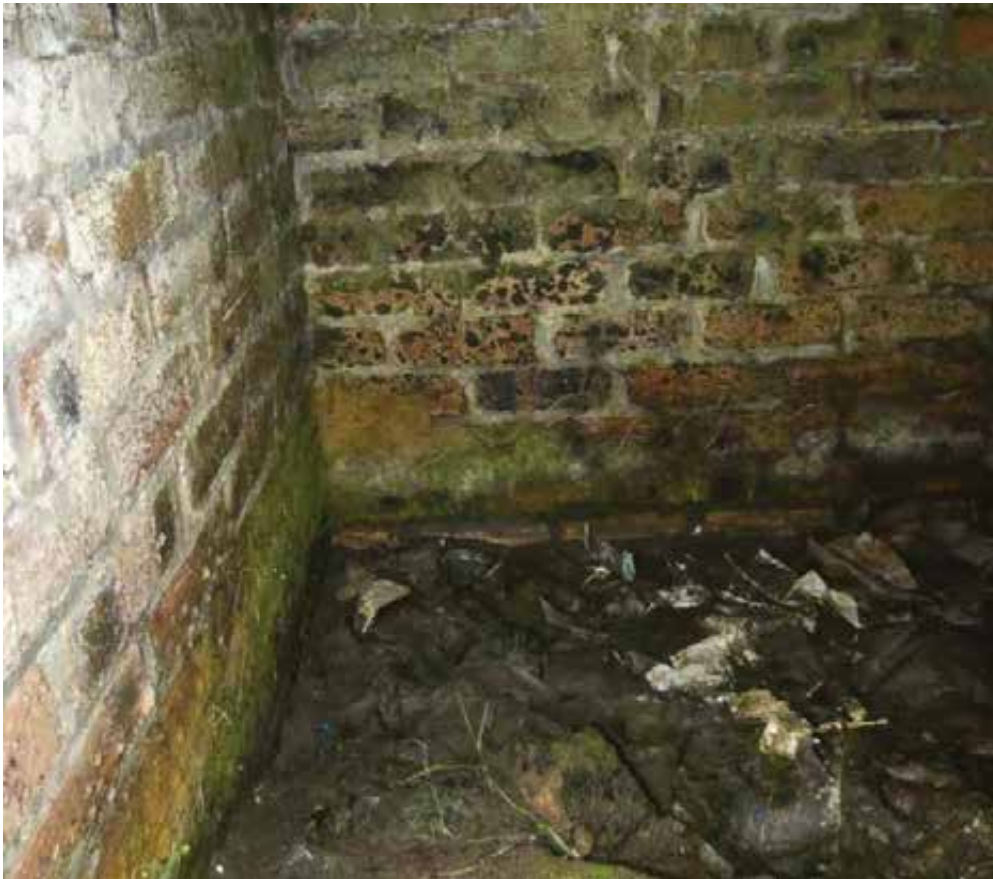
**Saturated brickwork below covered area.**
