## Appendix 14.1 Cultural Heritage Site Gazetteer

## Appendix 14.4 Cultural Heritage Viewpoints

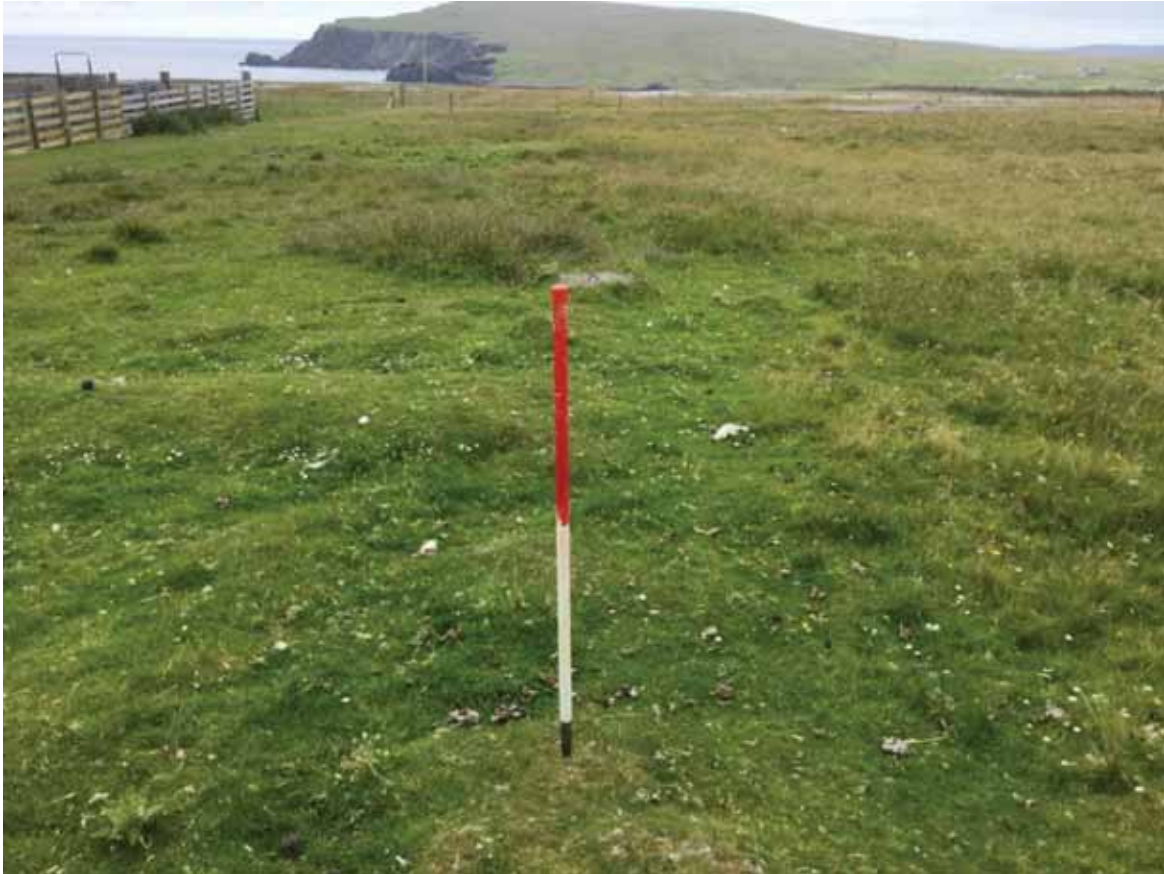
Plate 16: North facing view of a concrete foundation block. This example is Site 204a the northern most of three concrete blocks (Sites 204a-c)

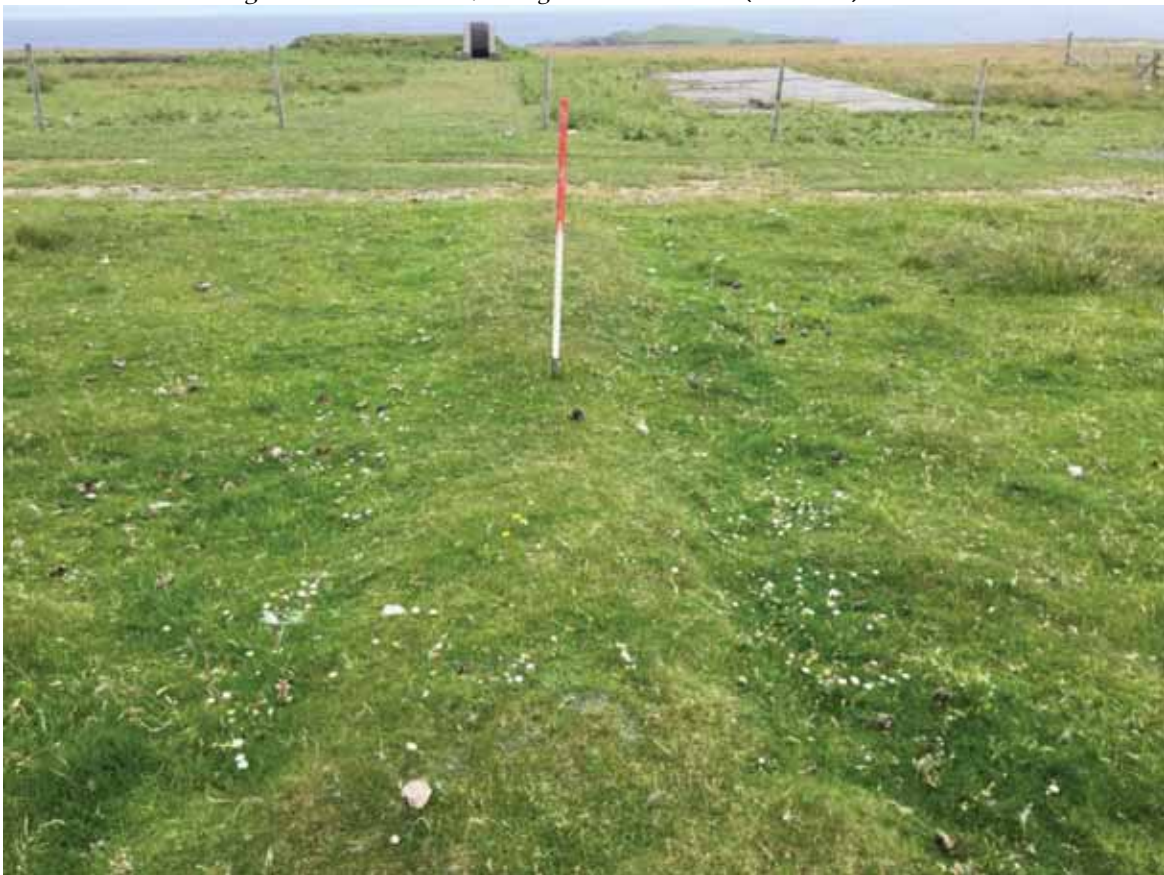
Plate 17: South facing view of a concrete block with tethering loop (Site 473), with another block (Site 471) in the rearground and a linear, overgrown earthwork (Site 472) is also visible

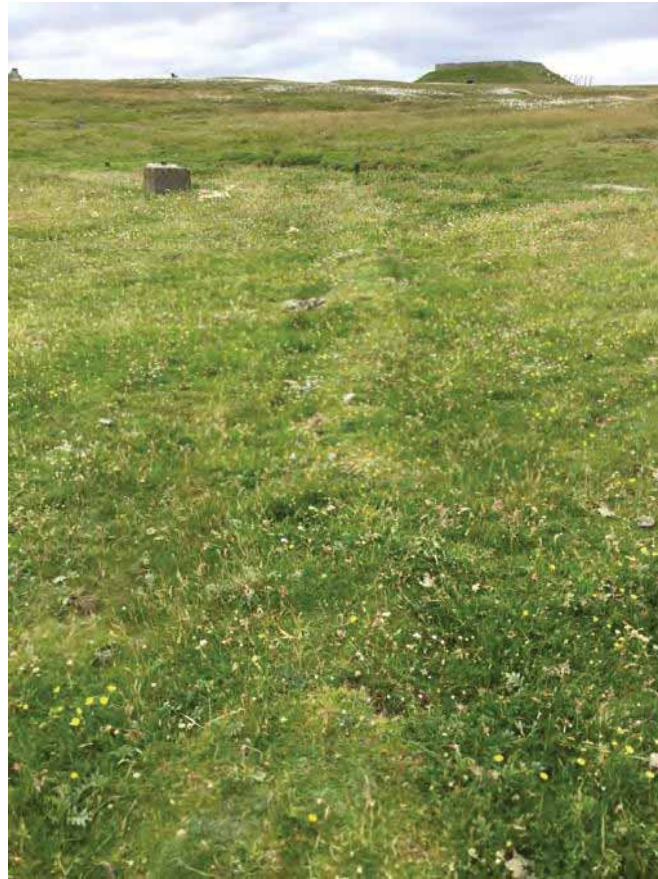
Plate 80: East facing view along Site 85b, showing larger concrete blocks at regular intervals along the wall foundation

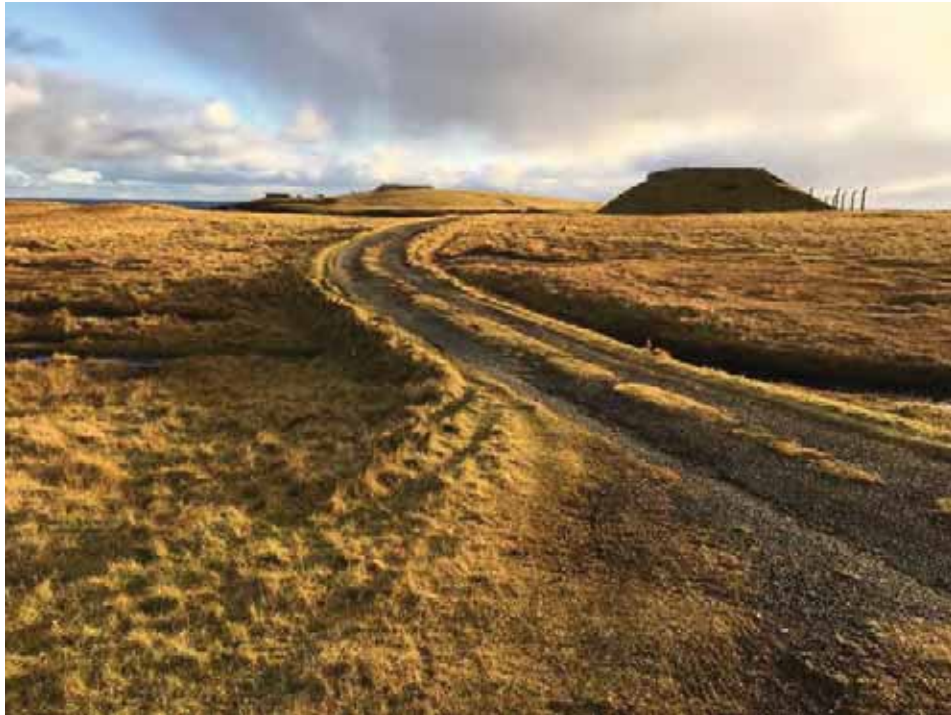
- 1.2.3 Some areas of exposed concrete road or tracks are present around existing buildings. These areas are not sufficiently exposed to review their general condition.
- 1.2.4 Some other roads and tracks are present around the site based on old maps and photographs but are not generally visible and have been overgrown. The condition of these has not been reviewed for the purpose of this report.

Typical existing road condition

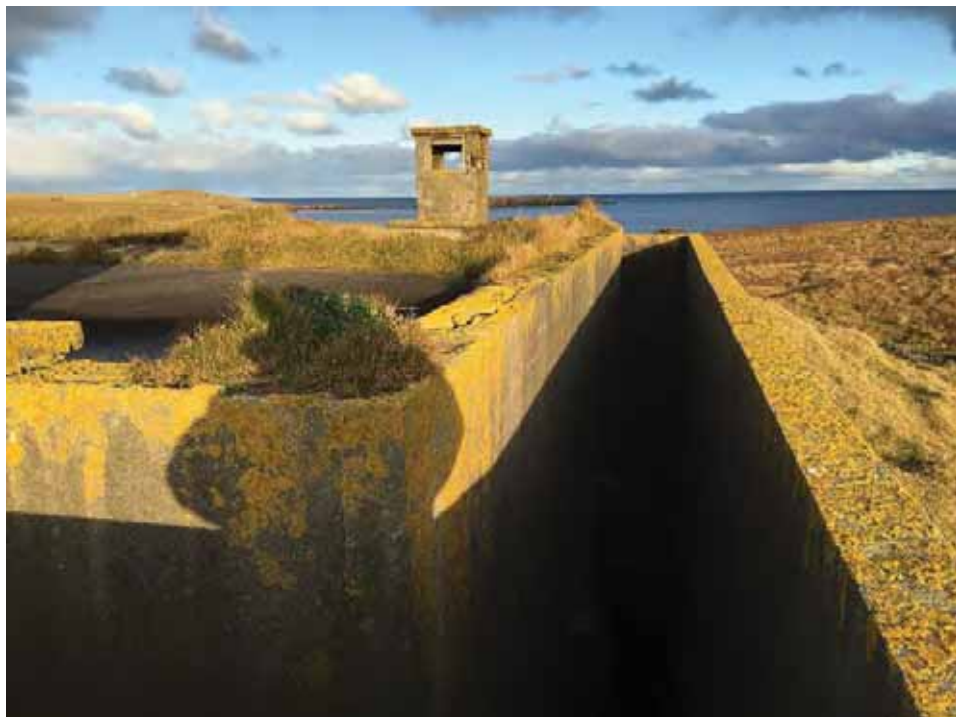
The roof consists of a flat concrete slab spanning between external walls and internal walls which has been waterproofed. Water proofing has deteriorated exposing roof slab in some areas, impacting the surface of roof and deteriorating concrete which will, in turn, impact the reinforcement of the roof slab.

Large Bunker roof and external walls (typical)

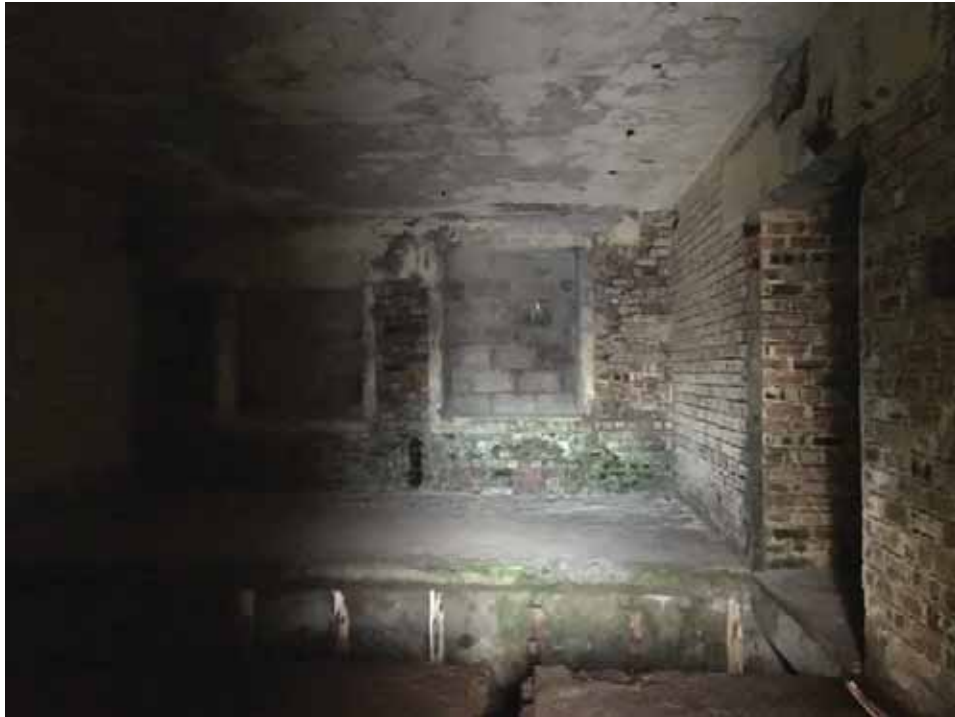
Internal and external remains are in generally good condition except at some locations where opening have been cut.

Large bunker internal (typical)

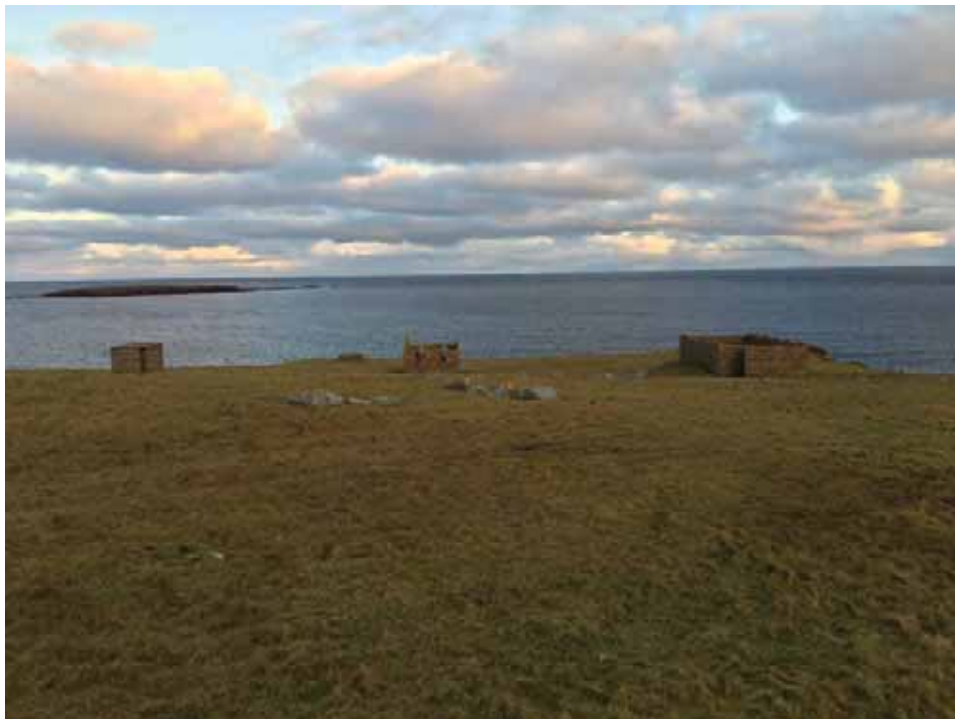
The integrity of small enclosed buildings with concrete roofs does not appear to have been compromised however buildings with former timber roofs have high level walls which are no longer supported and will be at risk of collapse in high winds

Typical Small Buildings

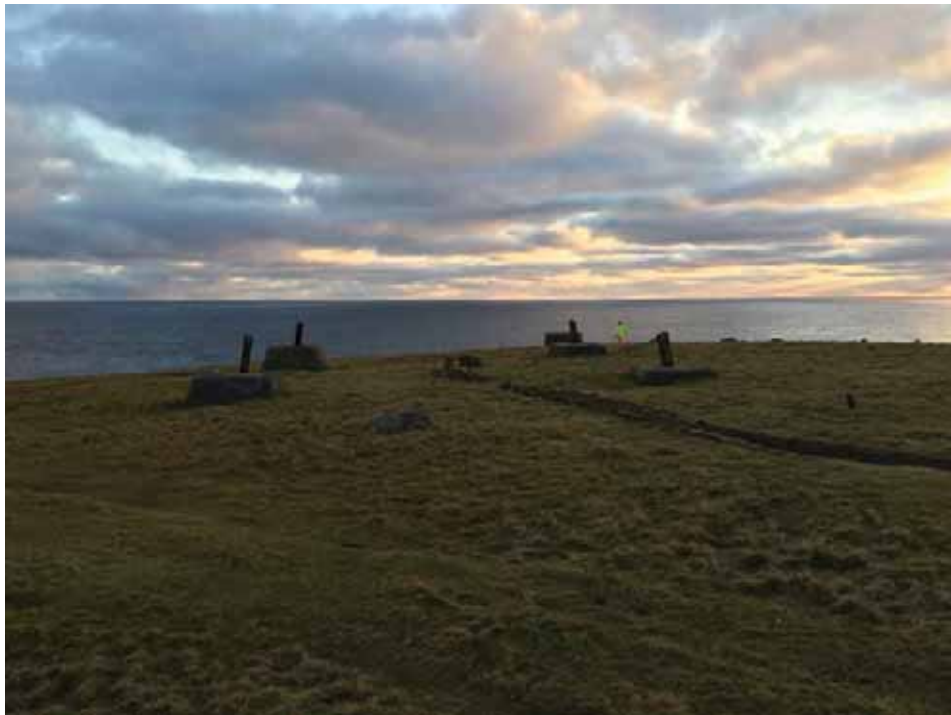
Concrete is exposed and surfaces are deteriorating due to carbonation, and weathering.

Typical remains of Mast Bases

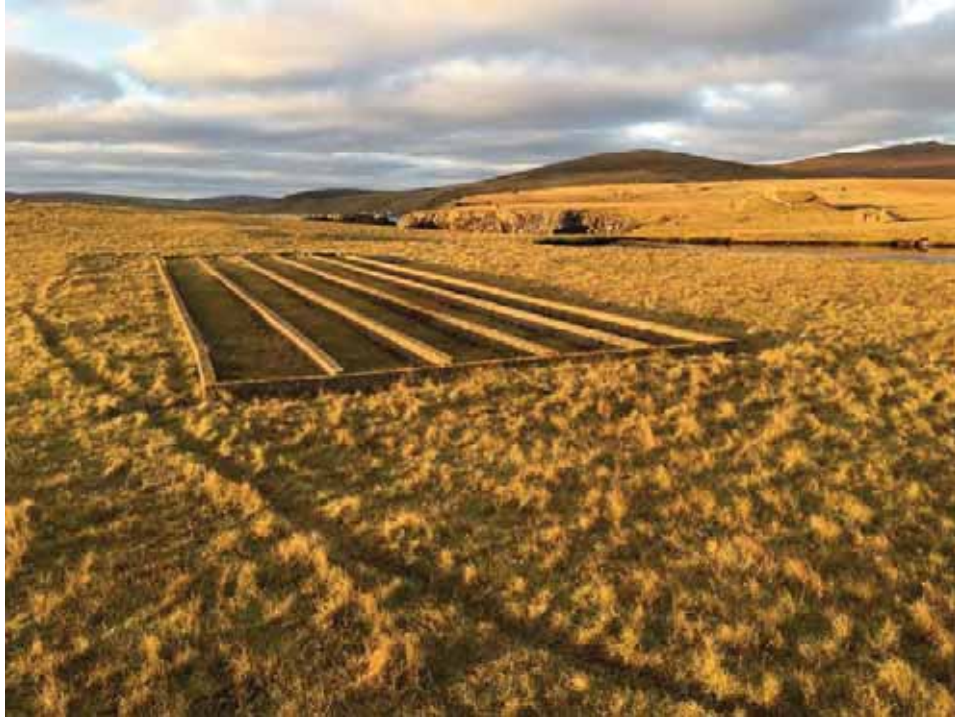
A number of small concrete slabs and bases are present which formed the foundations for wooden hut structures. These mainly consist of exposed concrete slabs with lines of brickwork. Brickwork and concrete surfaces are deteriorating due to carbonation and weathering.

Small building foundations for former huts

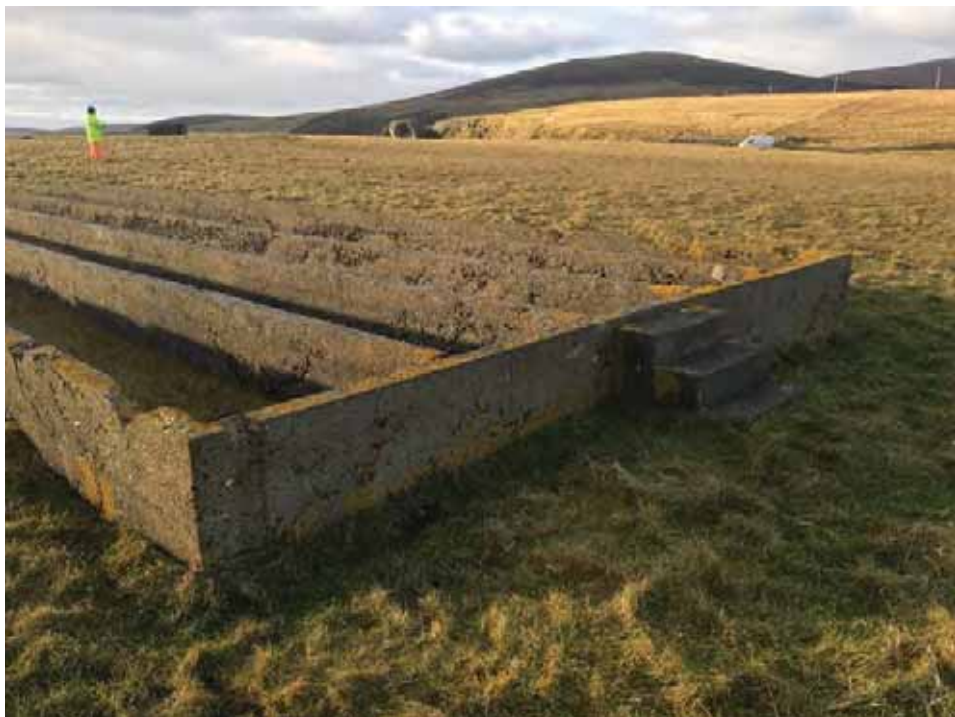
Former building foundations

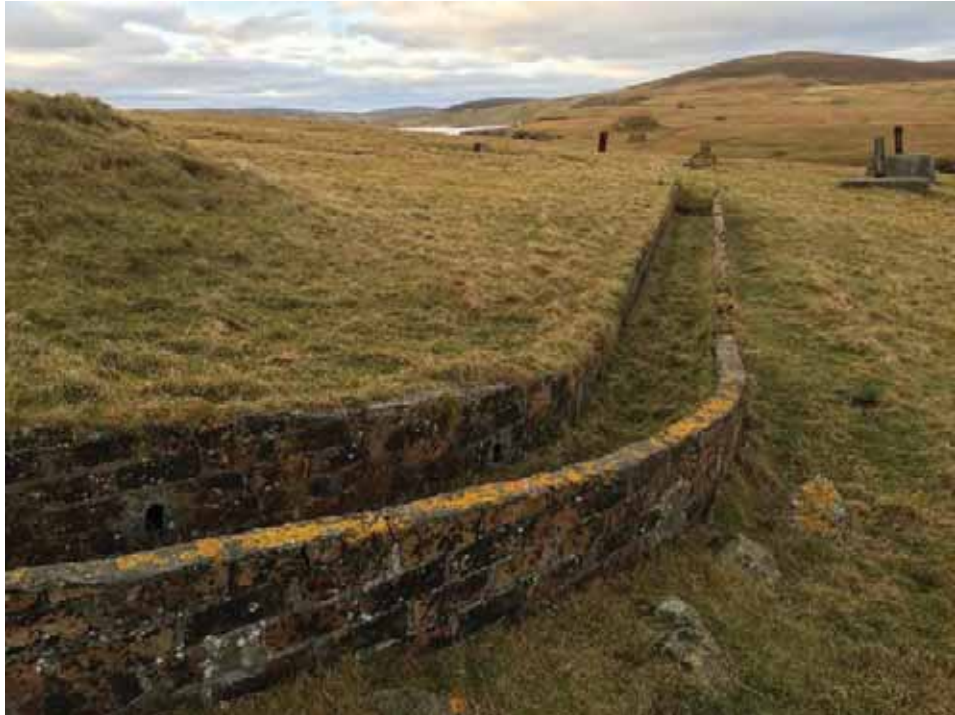
External service trenches and ducts are known to be present at shallow cover below ground in various locations. The condition of these is not known and the structural integrity of covers cannot be confirmed.

Typical external service trench
