# Appendix 14.9 Data Interpretation Strategy

# Appendix 14.9 Draft Heritage Interpretation Strategy

## **4.2 Condition Survey**

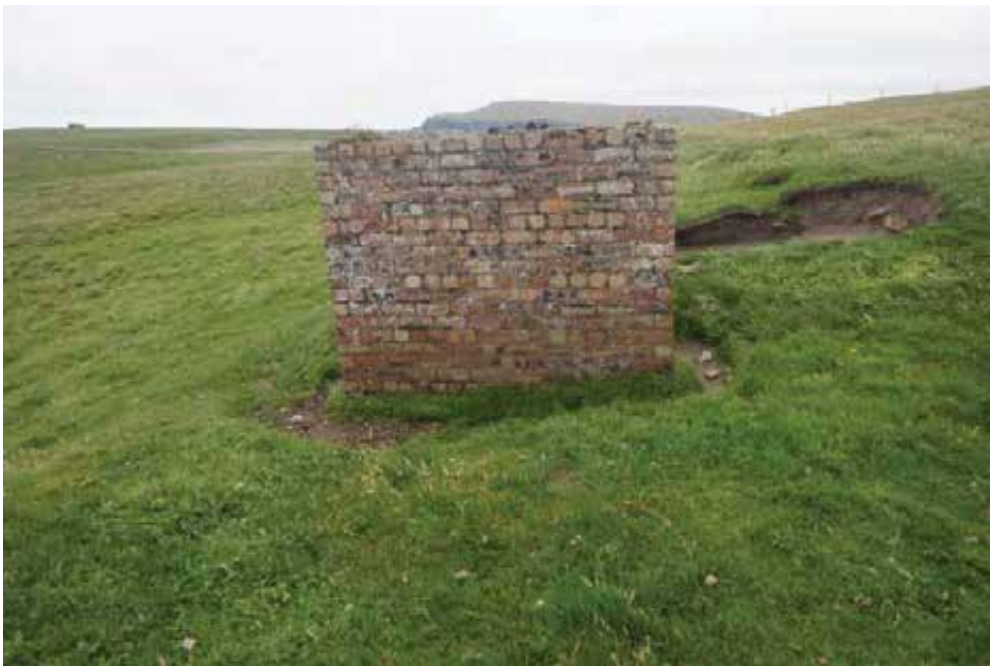
**2**

**No structural cracking was observed despite the walls not being plumb or level.**

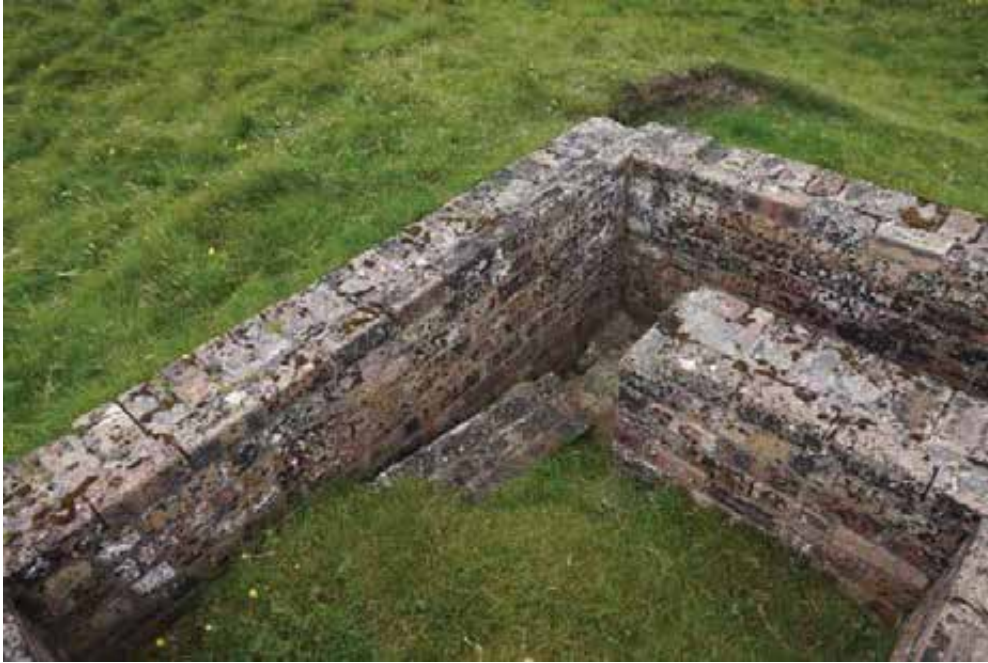
3

**Significant soil and grass accumulations internally and displaced brickwork and concrete.**

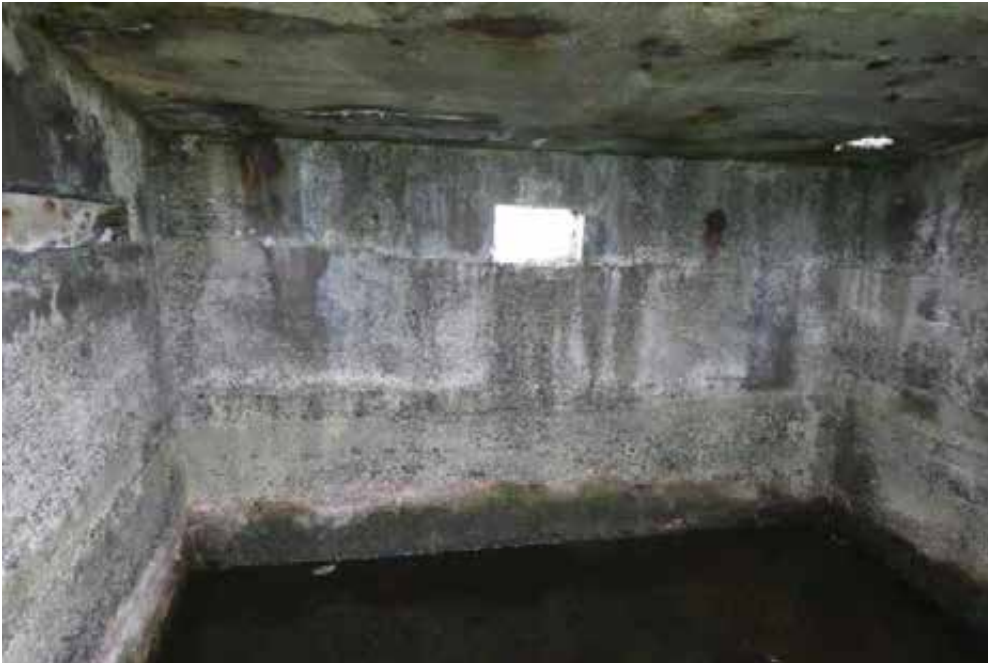
**Hairline cracking, rust staining, leaching and discolouration to the walls exacerbated by flooding internally.**

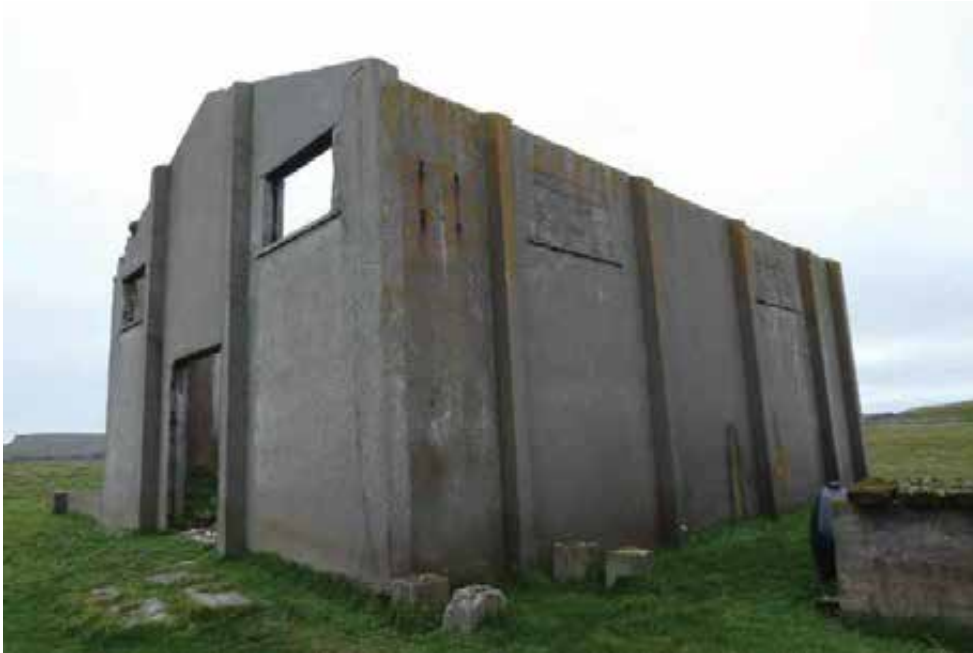
**1**

**The northeast corner of the building. Note the vertical crack in the east elevation at the corner: there is no continuity between the west or south walls – they are free-standing elements.**

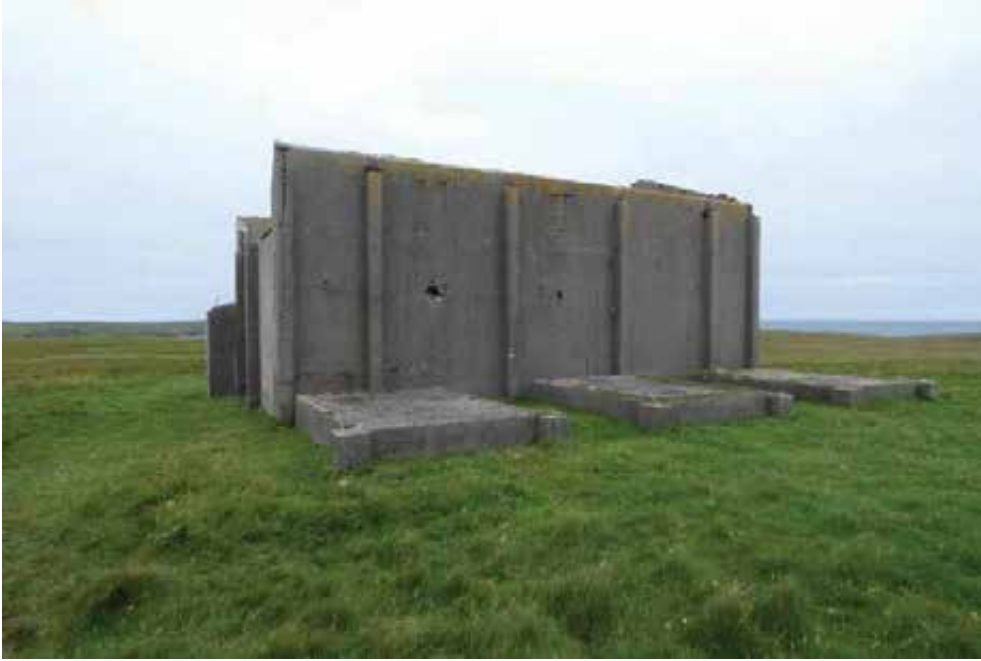
3

South elevation. See photos 2 and 4. This wall is a tall, thin, free-standing element.

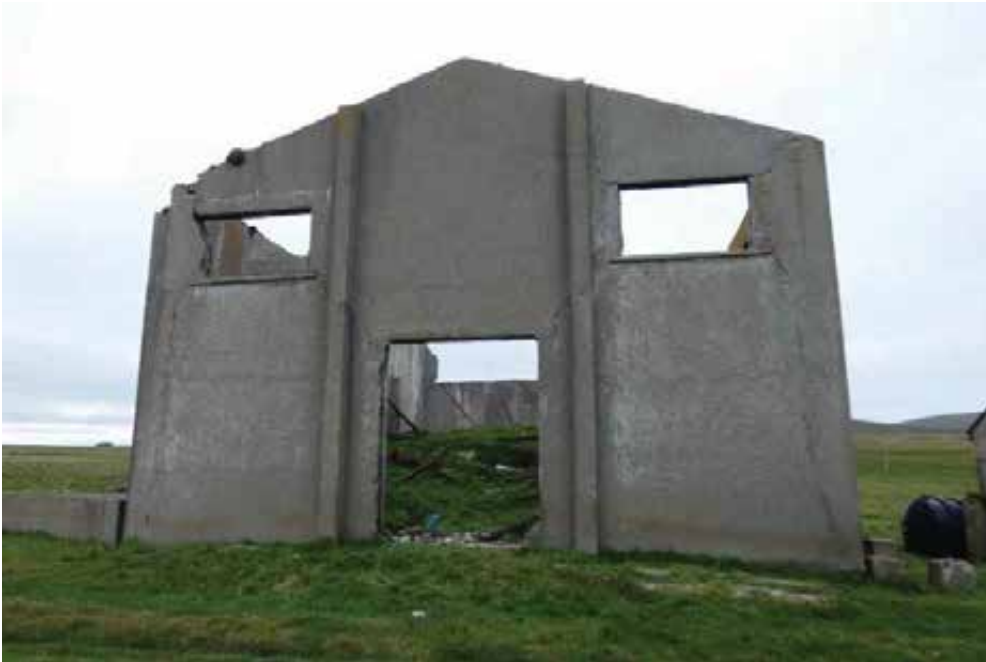
4

East elevation. Note the vertical cracking at each corner. Note the diagonal cracking between the entrance opening and both window openings and how this cracking continues up to wallhead: this elevation is a stack of independent, thin, tall, wall panels sitting atop each other.

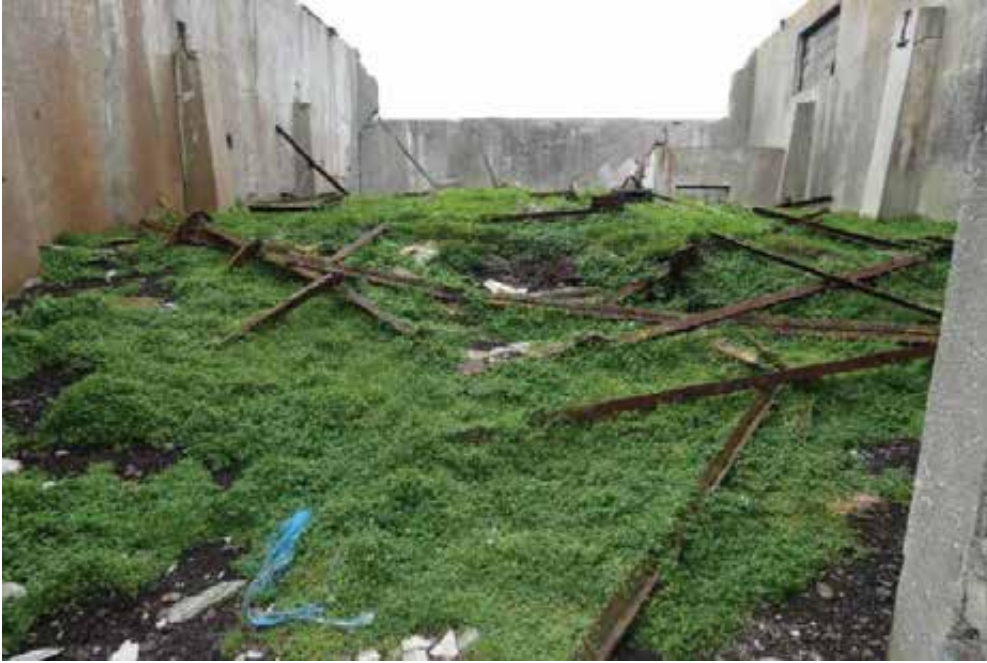
5

Inside the building. Note remains of the roof structure and asbestos roof tiles.

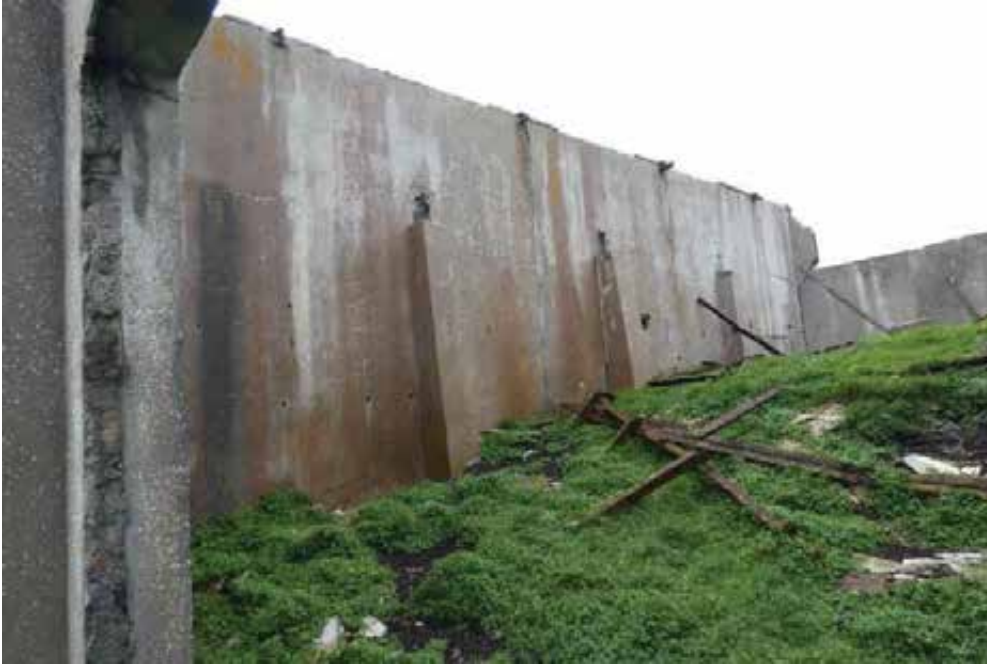
6

The internal piers do not appear to be fully or properly bonded to the masonry of the external walls.

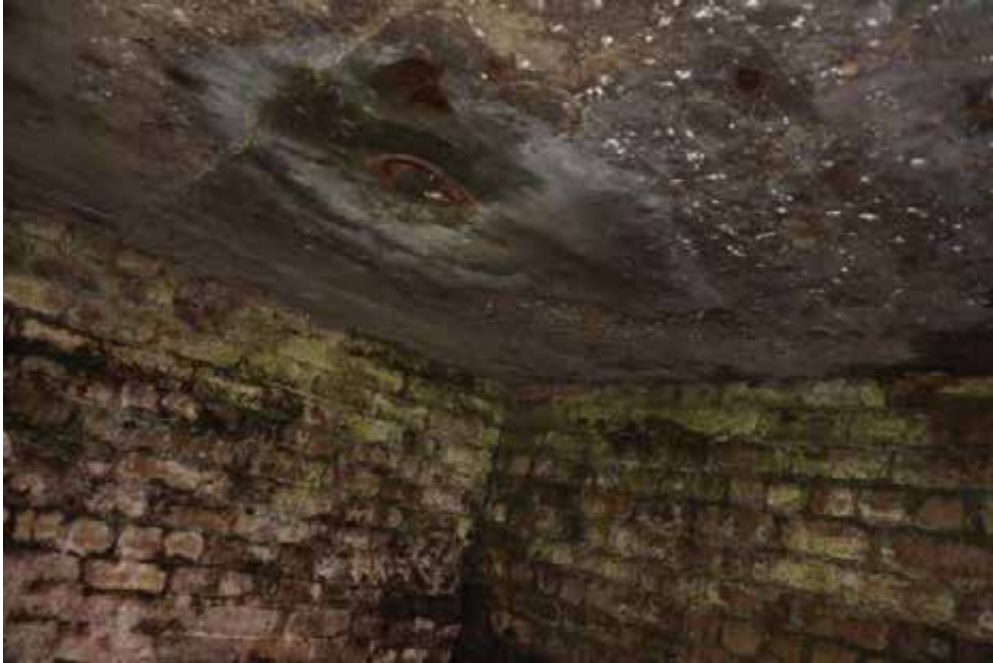
5

The vent pipe is blocked from above by soil and grass. Localised rust staining was observed on the soffit of the roof slab. No obvious spalling of the concrete.

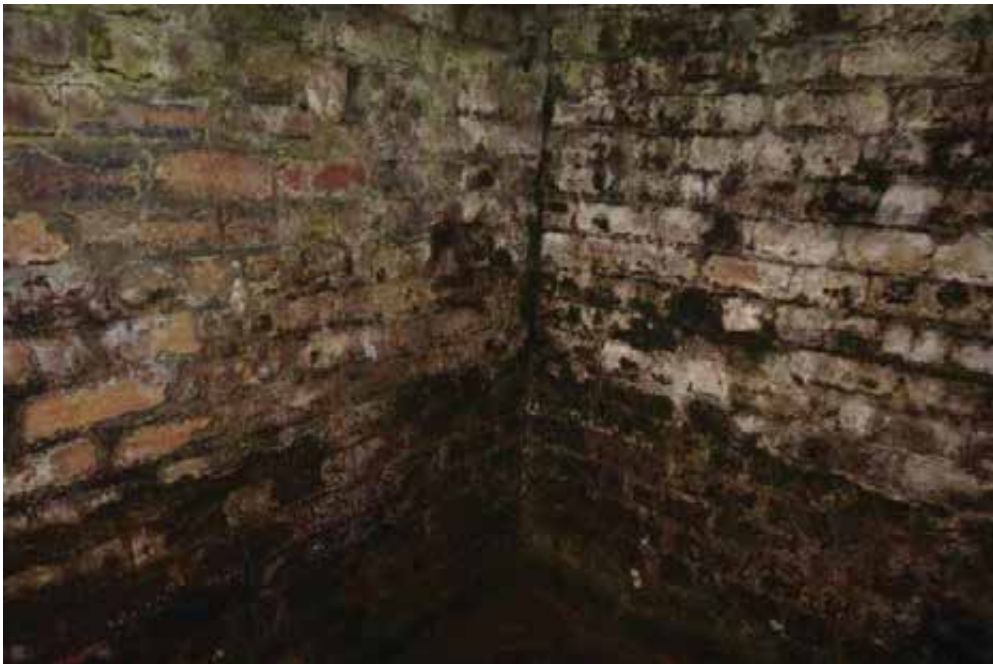
6

Damp stained brickwork internally from saturated ground conditions.

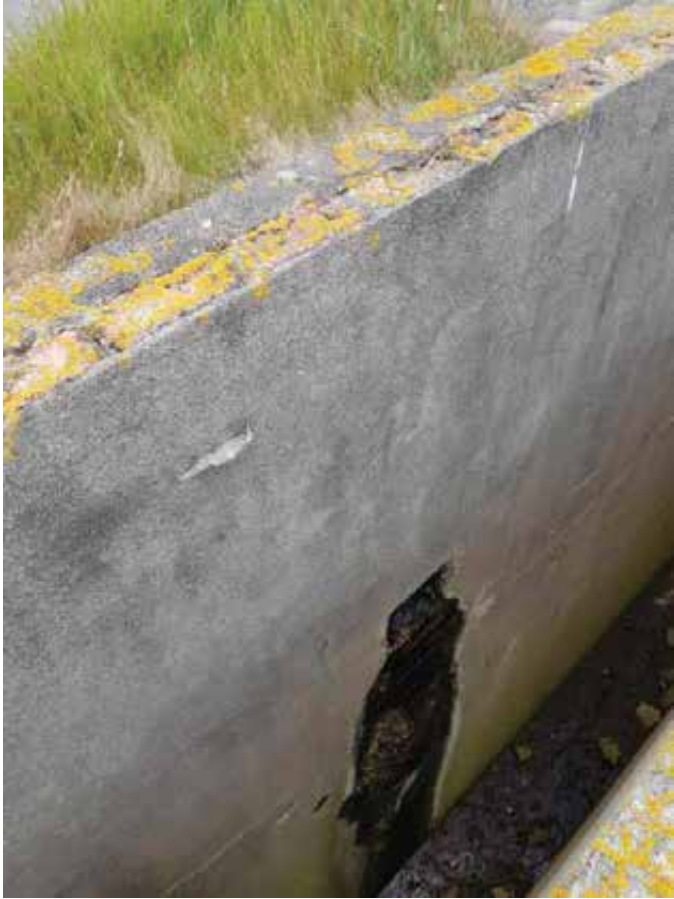
7.

The outlet from the roof runs down into the wall and discharges part-way up it. Outlet is blocked by vegetation. Not loss of render from below the discharge point.

4.	Renew asphalt roof membrane in its entirety, unblock all roof outlets and drainage channels from external building perimeter. Cost £15,000.00 (provisional) Improved protection against rainwater ingress will reduce the rate at which the RC substrate deteriorates.	Desirable

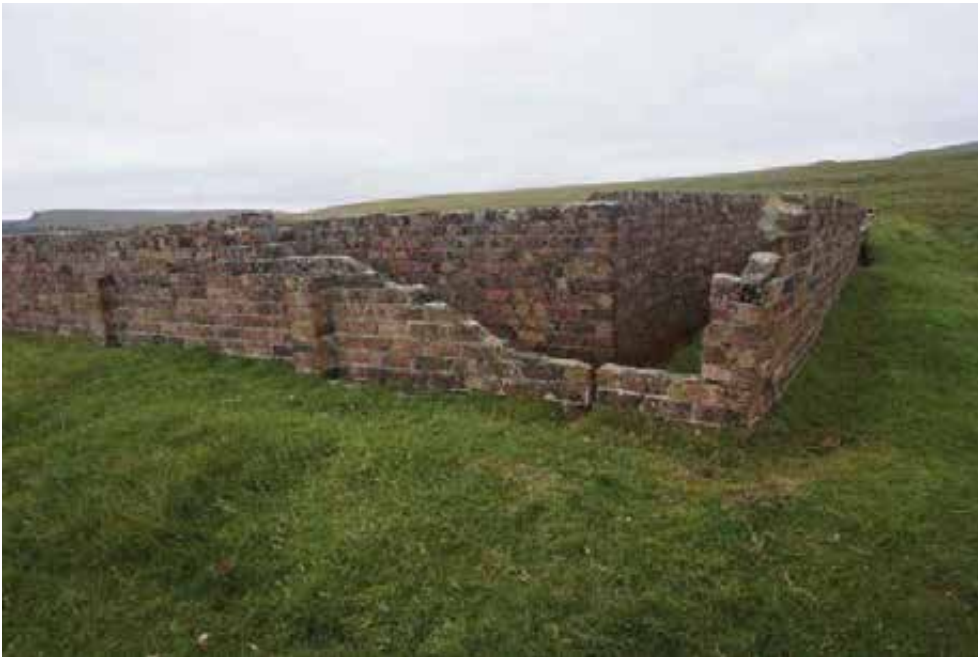
4

Structural issues in the northeast corner. Vertical cracks on the east elevation of the inner and out skins and a pronounced lean to the north wall of the outer skin. Cracks should be repointed and monitored to assess ongoing movement. The leaning outer skin should either be made safe by extending the earth banking eastwards to prevent further outward rotation or taken down to a safe height. The external wall generally does not have inherent stability generally. This issue should be addressed if increased footfall is expected.

<b>Recommendations:</b>			<b>Priority:</b>
<b>1.</b>	<p>Structural – Options for the leaning north outer skin following recording:</p> <ol style="list-style-type: none"> <li>Take down brickwork to approximately three or four courses above ground level or to the cracked bed-joint (whichever is lowest) and retain at this level to allow structure still to be understood. <b>£300.00</b></li> <li>Take down brick work to approximately three or four courses above ground level or to the cracked bed-joint (whichever is lowest) and rebuild to plumb. Rebuilt wall to existing height will not have adequate inherent stability so will need additional support (informed by trial pits to assess ground conditions and through discussion with HES). (Not costed)</li> <li>Extend earth banking to support leaning brickwork. Final design subject to further investigations. <b>(Provisional cost - £1500.00)</b></li> </ol>	<p>Necessary (assuming no increased footfall)</p>

4.	General – repoint vertical cracks to allow structural monitoring. <b>£500.00</b>	Necessary
5.	Remove fallen brickwork to reduce health and safety risk if increased footfall anticipated. (not costed)	Necessary (assuming no increased footfall)

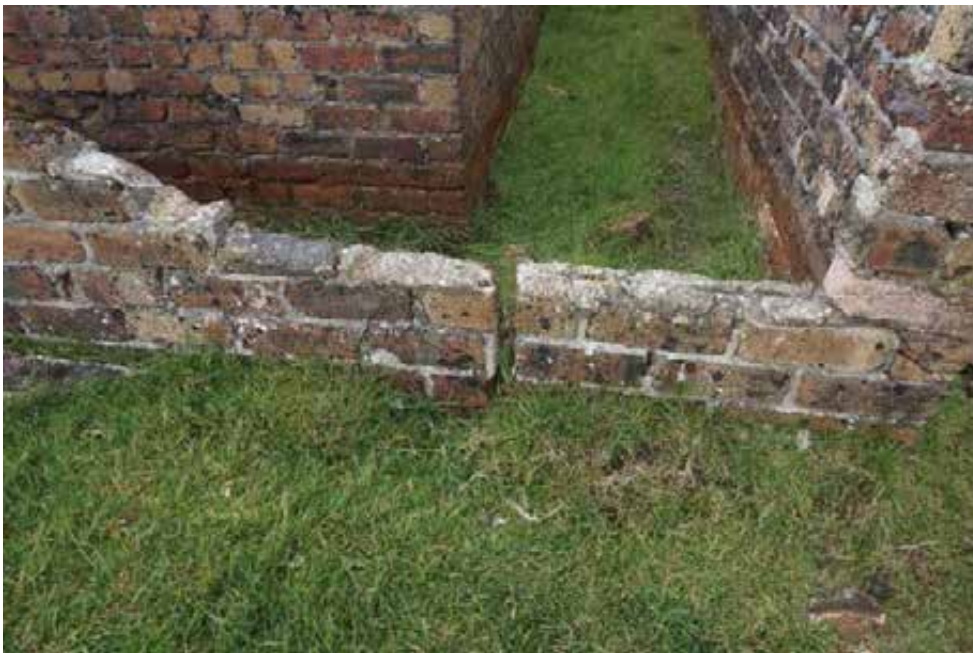
5

**Cracked brickwork to the east facing half brick thick outer skin adjacent to the leaning north wall.**

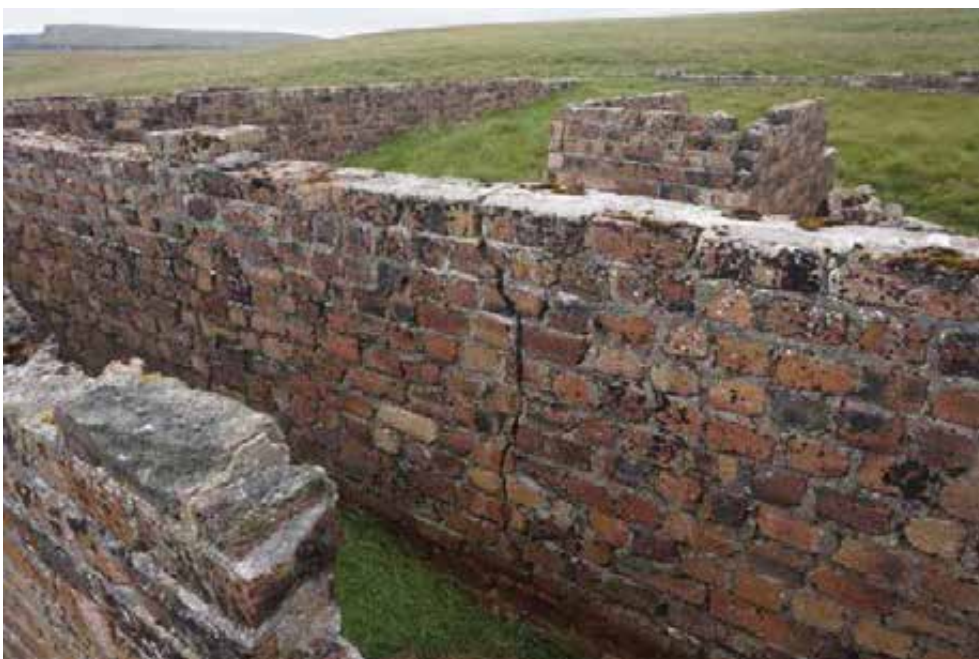
6

**Cracked brickwork to the single brick thick east facing inner skin. Cracks should be repointed to allow future monitoring.**

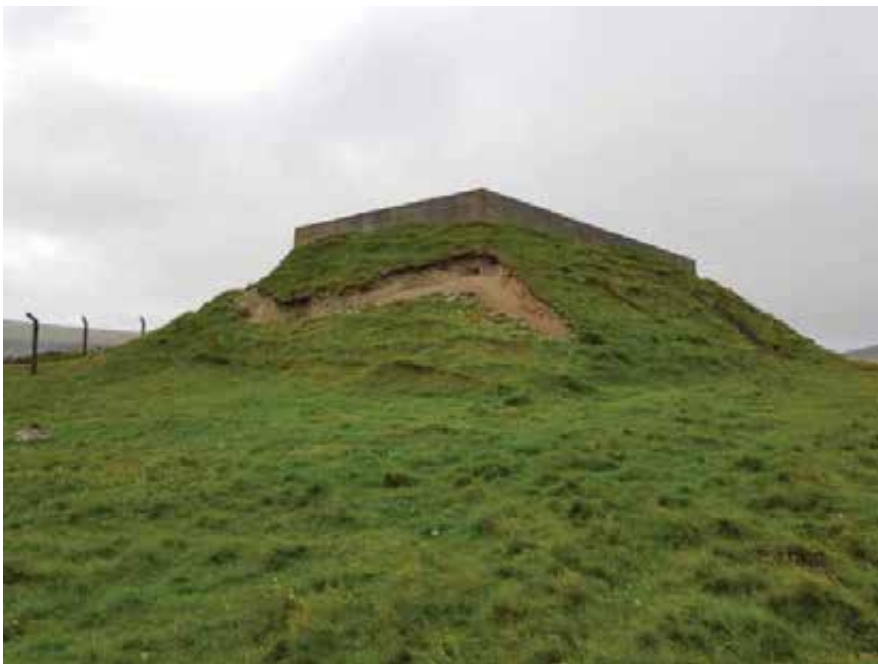
**2.**

**Loss of earth from the embankment owing to burrowing and grazing activities.**

<p>9. Replacement of missing earth from the embankment. Not costed.</p>	Desirable

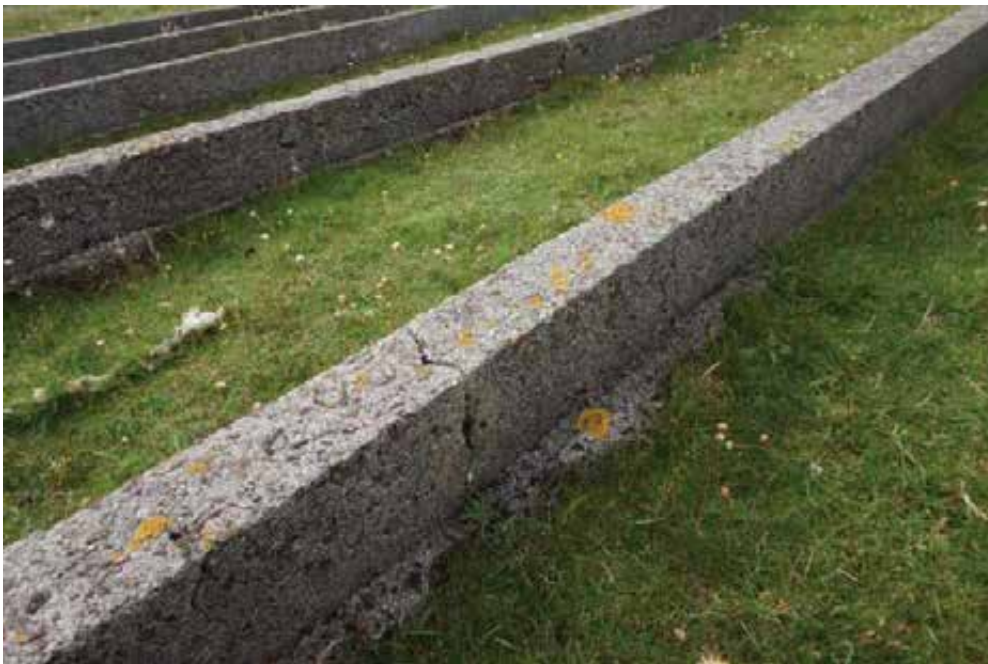
5

**Despite widespread cracking, the walls remain stable.**

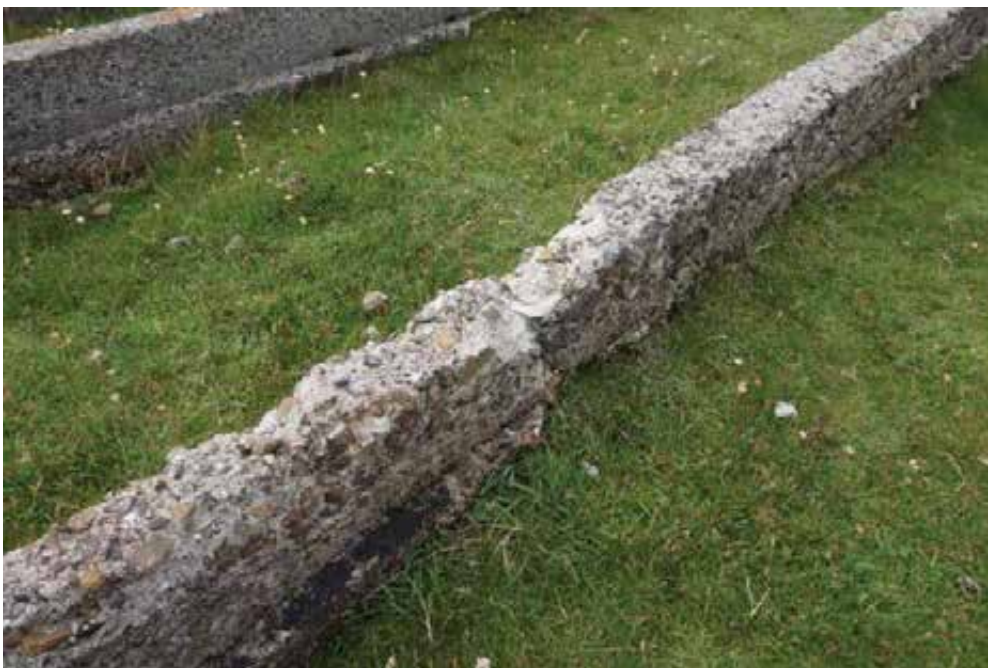
6

**Localised spalling and disaggregation at the eastern end of one of the centre sleeper walls.**

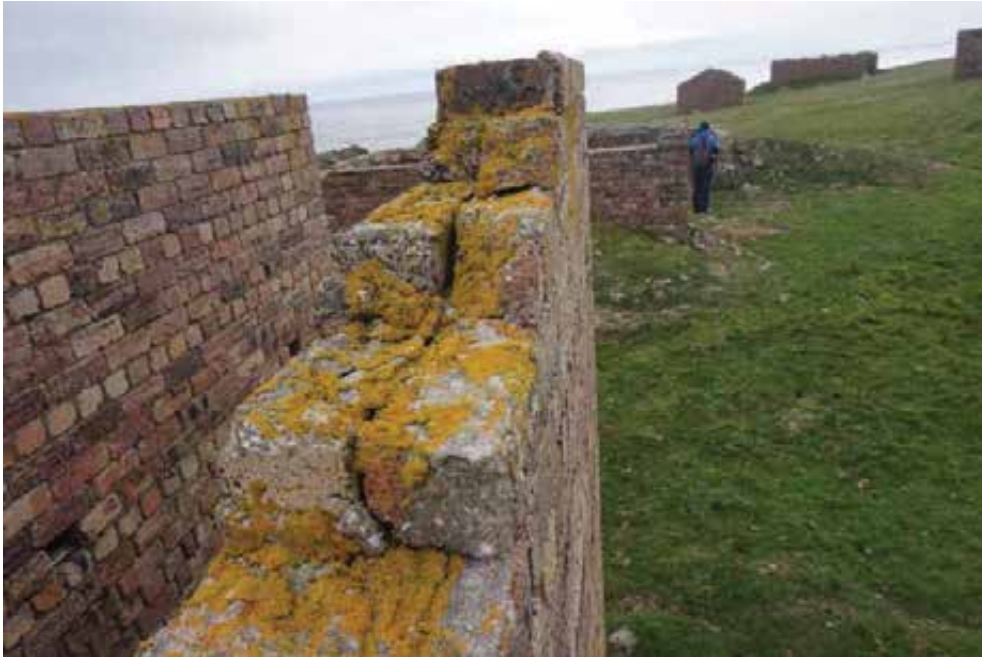
**1**

**Failing skyward facing joints should be repointed.**

1.	Repoint failing skyward facing wallhead joints and elsewhere on wall faces, including minor cracking to allow future monitoring. <b>£2000.00</b>	Necessary

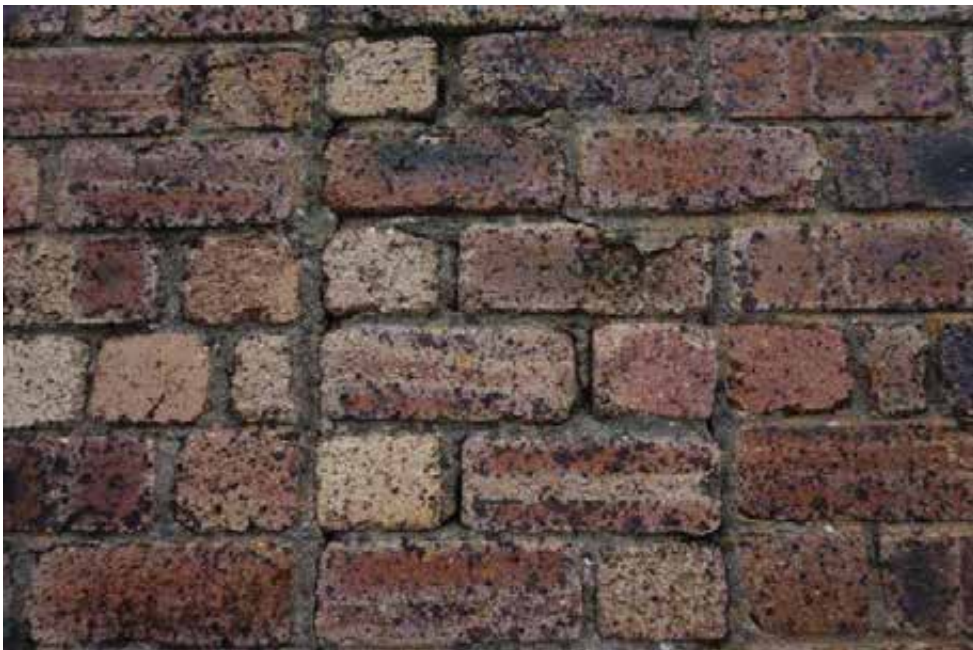
**2**

**Localised failing wall face joints and minor cracking should be repointed. Note poor continuity between pier (middle of photo) and adjacent panels – see also photos 5 and 6.**

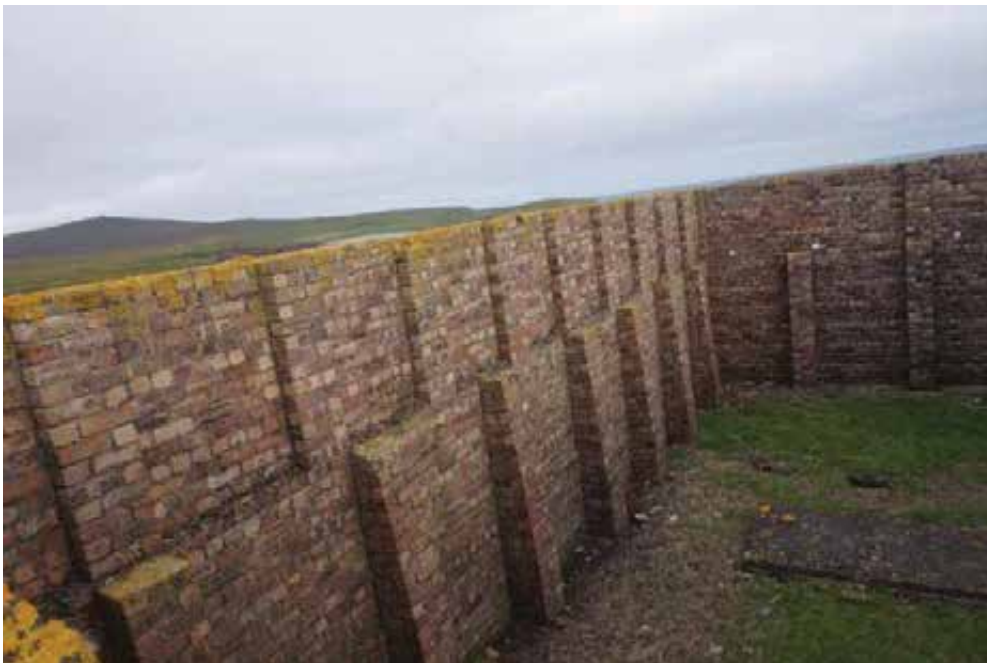
**Cracks at higher levels are aligned with the upper piers which are poorly tied to the adjacent thinner single brick thick infilled brickwork. See also Photo 2**

3.	Allow stitching/tying of cracks on wall faces, including at higher levels where thinner brickwork is poorly tied to adjacent piers, for example, raking out joints and inserting stainless steel ties (e.g. Helibar by Helifix) to bridge cracks. Repoint joints and monitor thereafter. <b>£2500.00</b>	Necessary

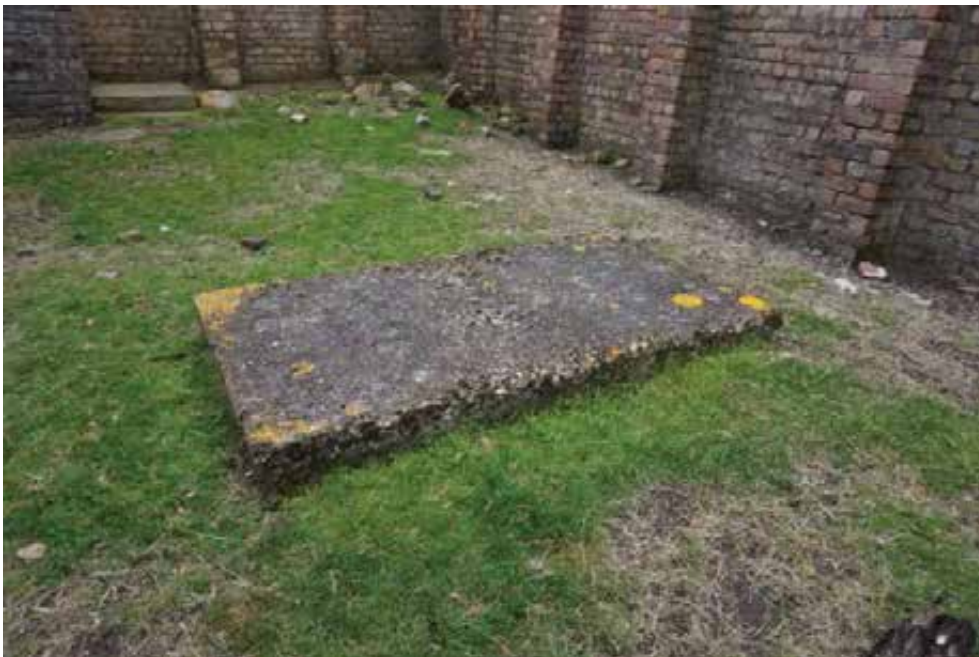
7

**The concrete base internally is in good condition.**

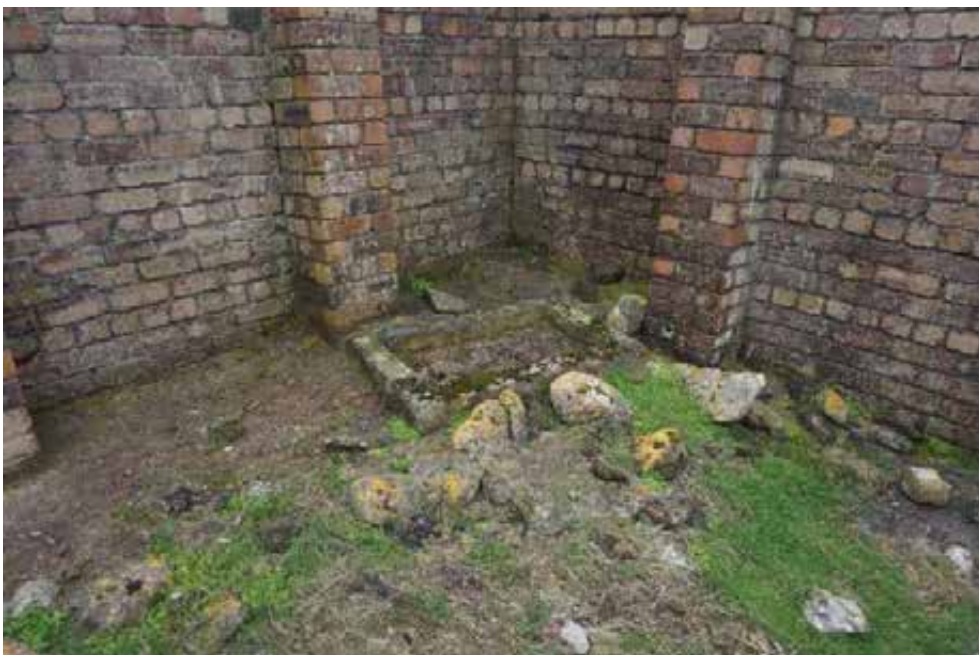
8

**The small rectangle brick structure internally is in good condition. There are loose stones and bricks throughout the grass covered floor internally.**

4.	Remove fallen brickwork and loose stones internally to reduce health and safety risk if increased footfall anticipated.	Necessary (assuming no increased footfall)

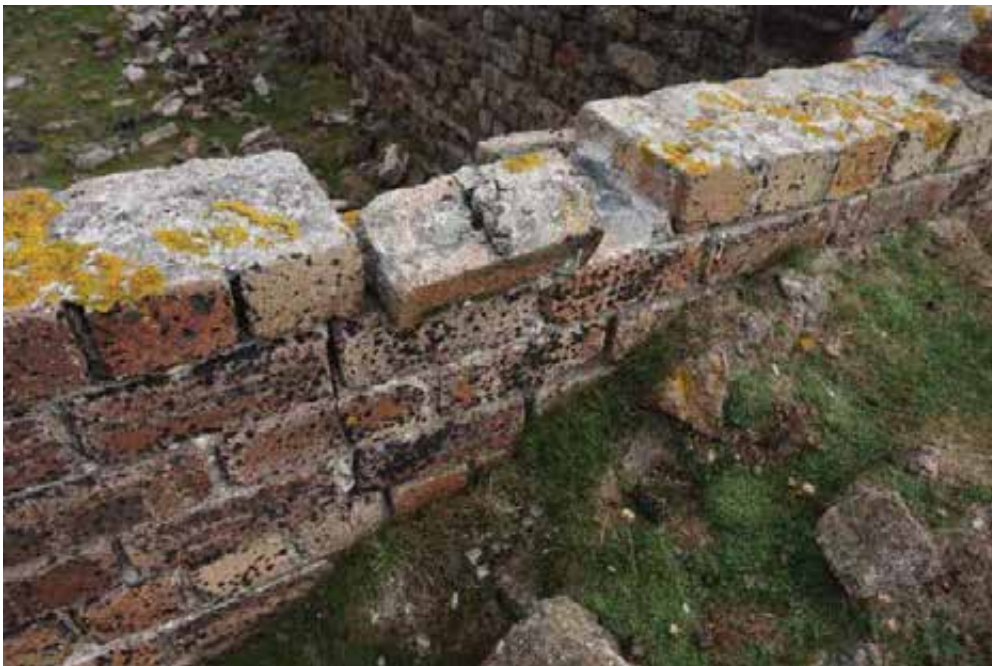
3

Defective skyward facing joints should be repointed, with allowance for resetting loose brickwork.

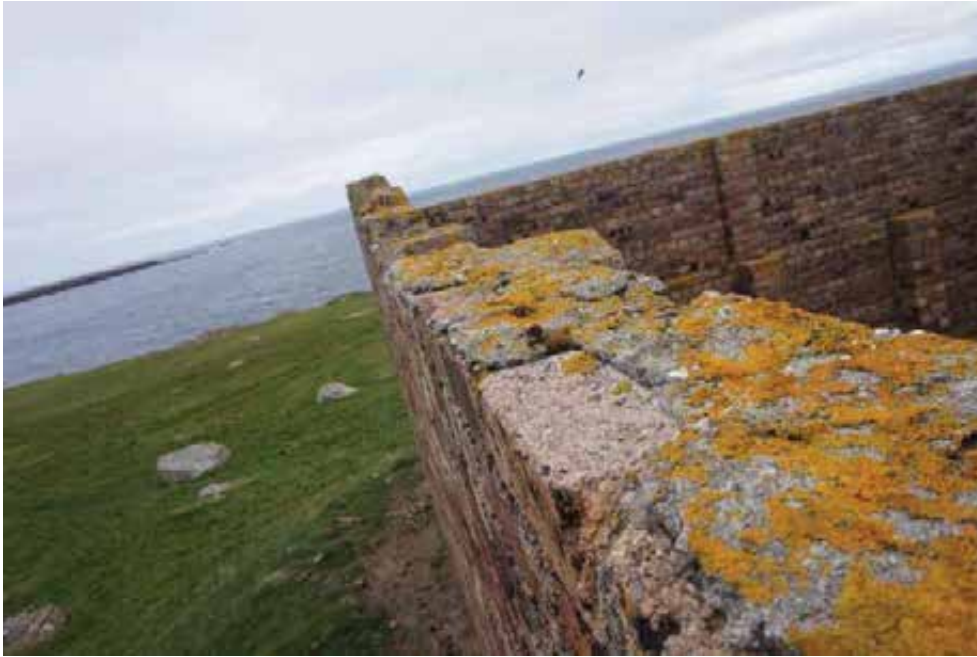
**1**

**Failing skyward facing joints should be repointed, with allowance for rebedding loose bricks.**

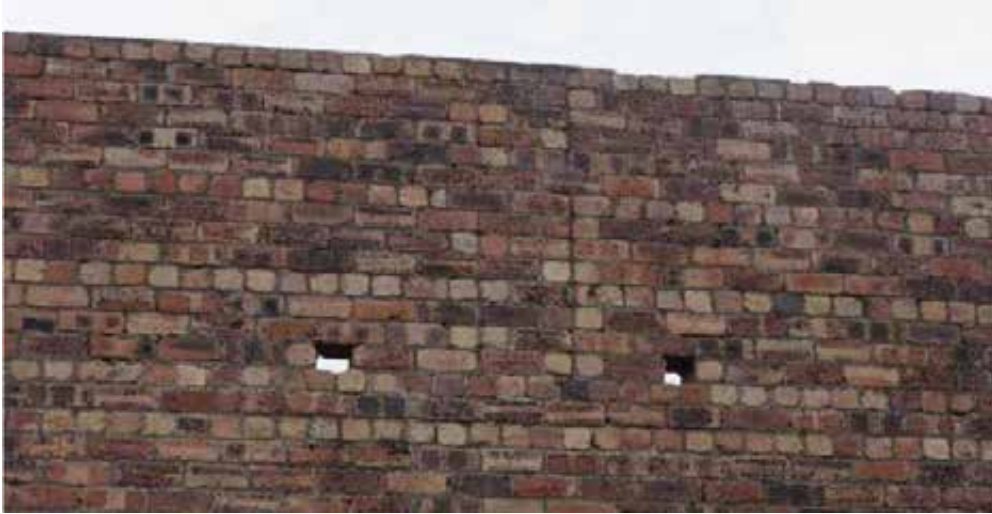
5

Cracks at higher levels are aligned with the upper piers which are poorly tied to the adjacent thinner single brick thick infilled brickwork.

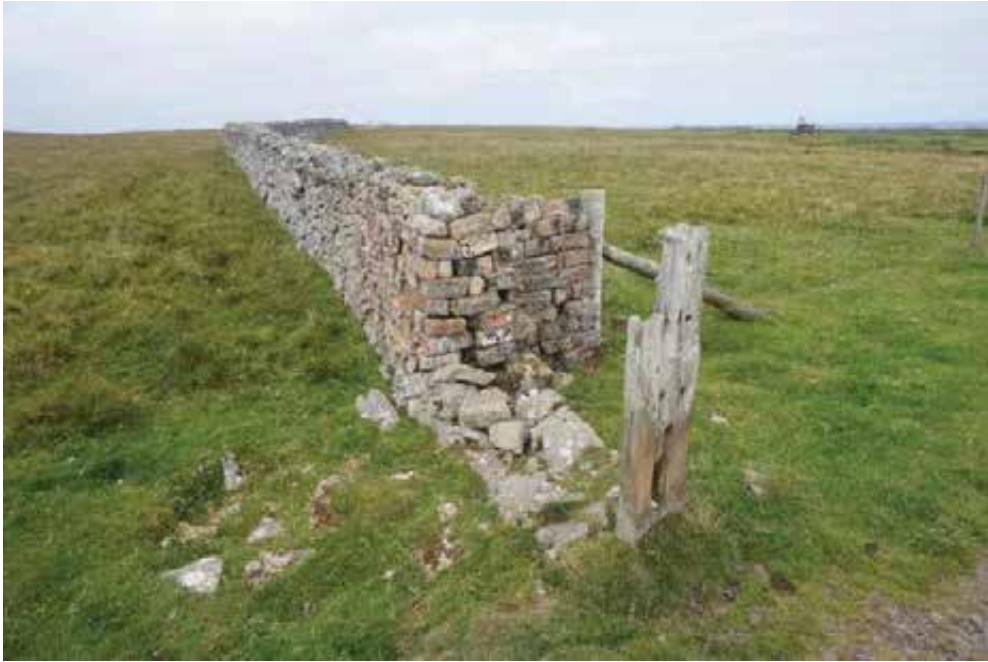
**1**

**General view north: Brick repairs immediately north of the access road. The repairs remain functional. Rotten timber gate post.**

3.	Although the brick repairs are functional, if replacement with stonework to match surrounding walls is deemed a requirement, allow c. <b>£3500.00</b> , including reinstating full length to timber gate post.	Desirable

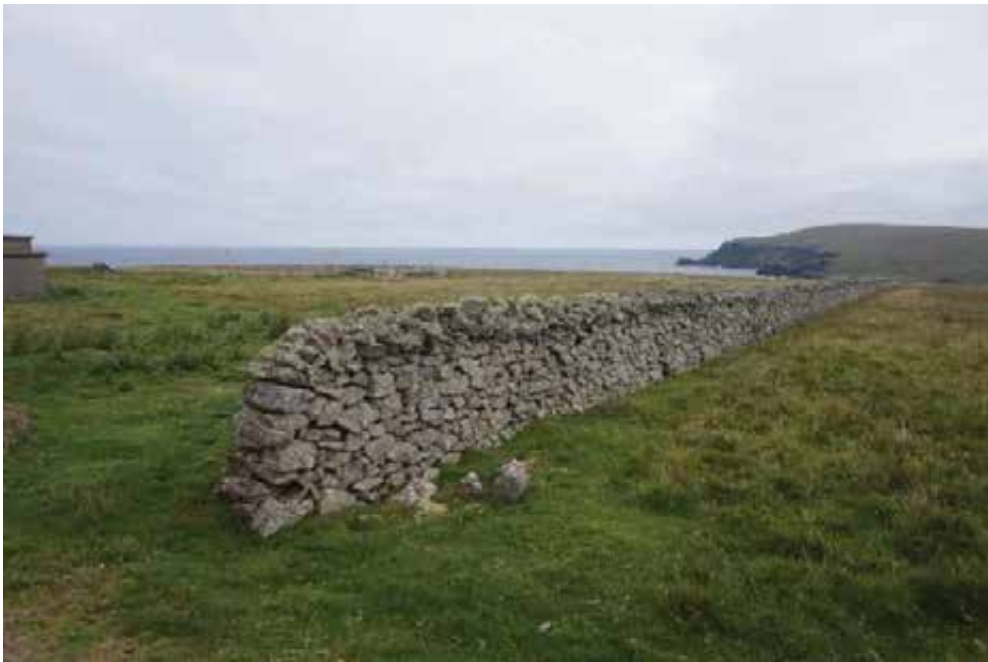
**2**

**General view south: Copes should be regularly check and loose/displaced stones reset.**

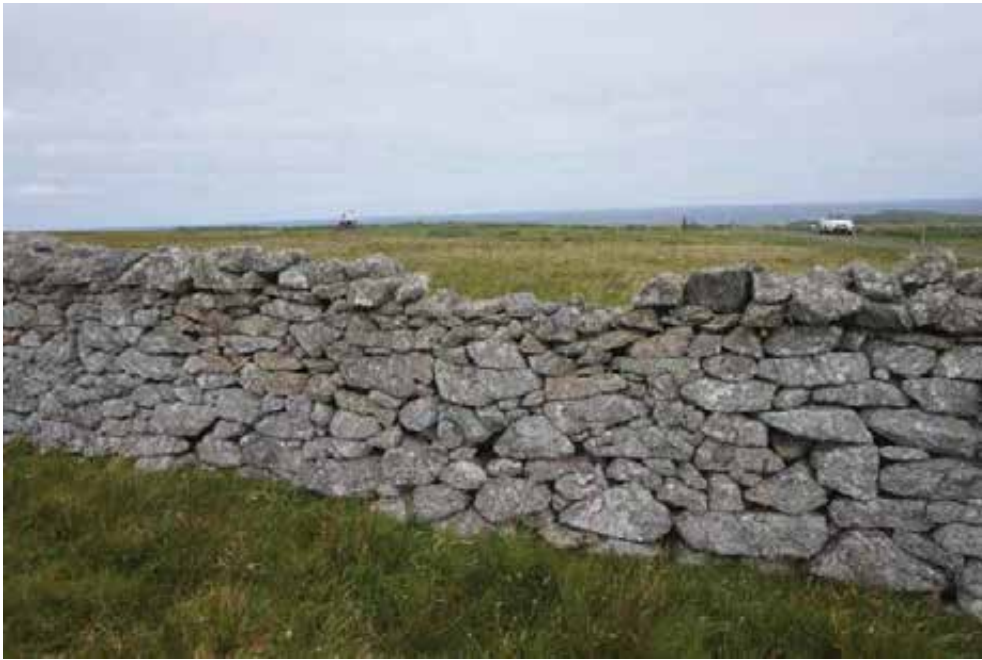
3

**Displaced cope stones should be reinstated.**

1.	Replace missing copes with matching stonework. <b>£500.00 (assuming availability of matching stone nearby)</b>	Necessary	
2.	Monitor condition of bulging section and allow c. <b>£2000.00</b> for repairs if condition worsens (not carried to collection).	Desirable

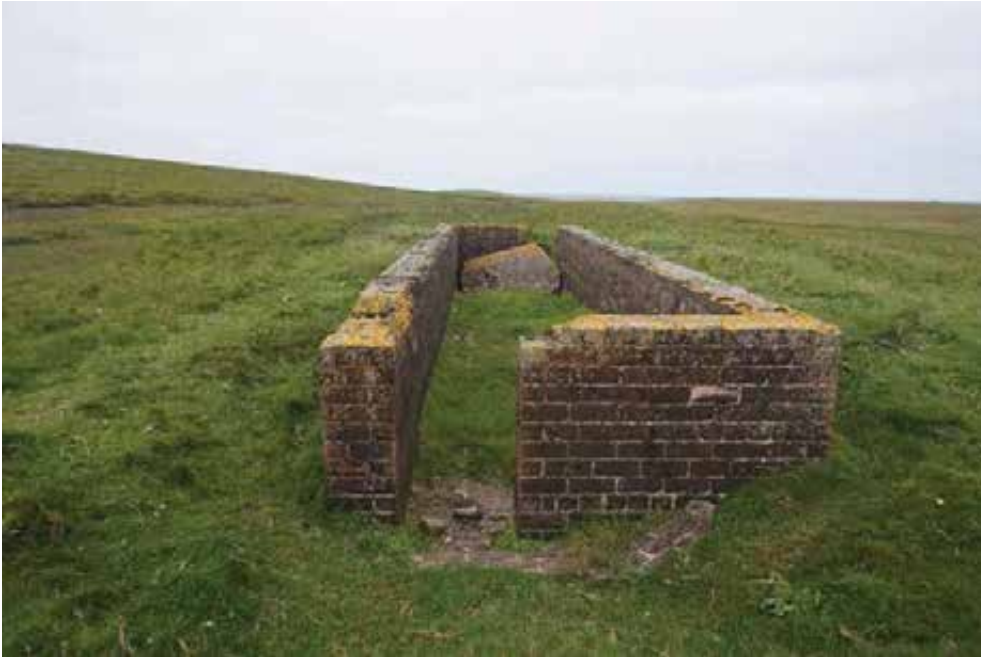
**1**

**View from south showing missing wallhead brickwork, and displaced bricks and concrete roof slab.**

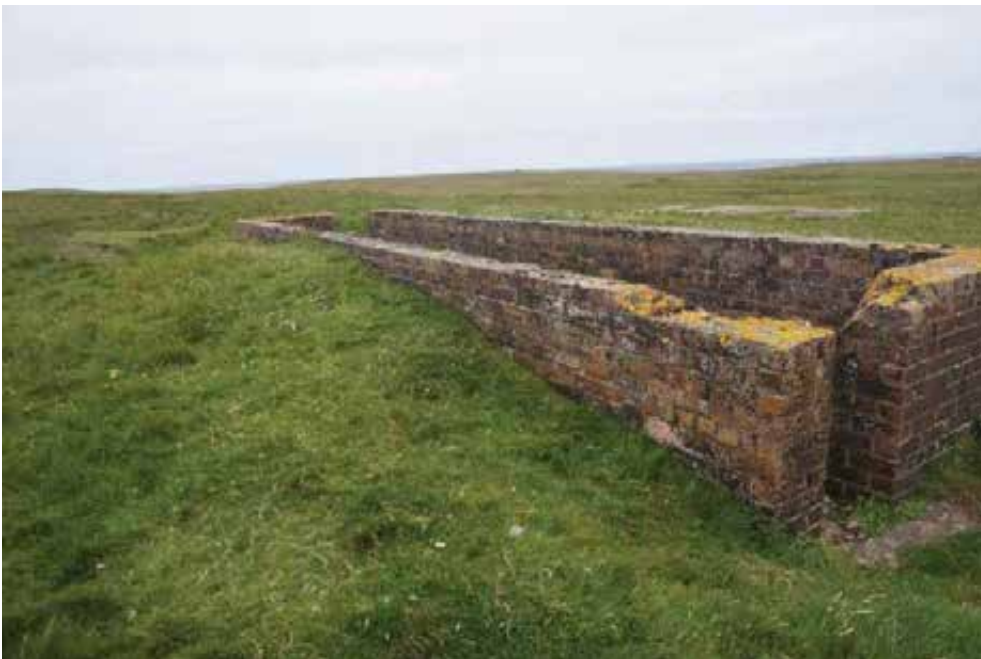
**2**

**Despite localised failing mortar joints, and damaged and missing brickwork, the structure is in a stable condition.**

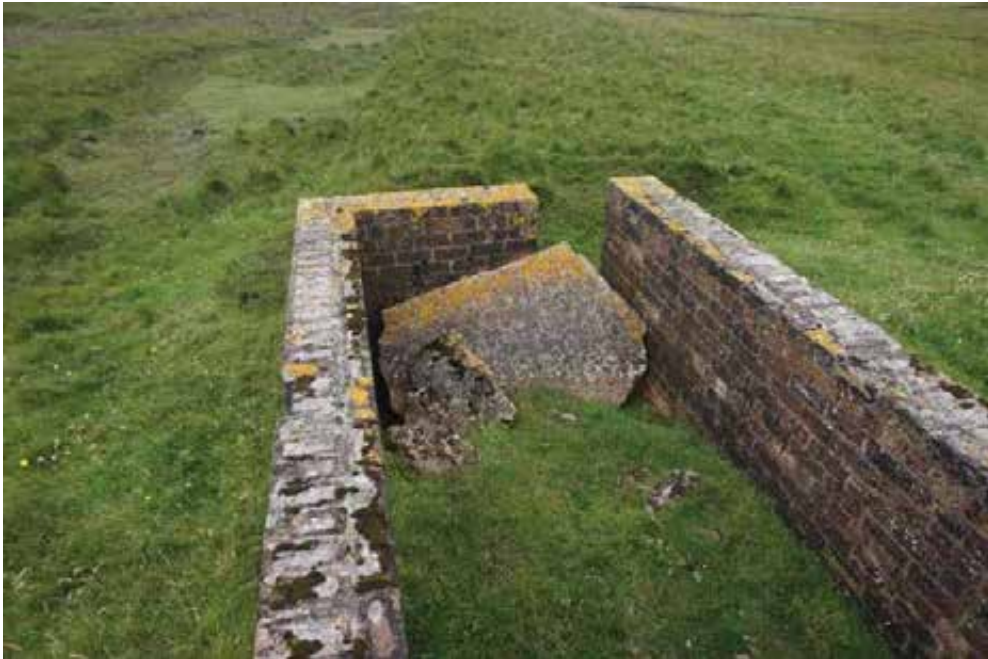
4

Internal ground levels have increased due to accumulations of soil, and fallen brickwork and concrete.

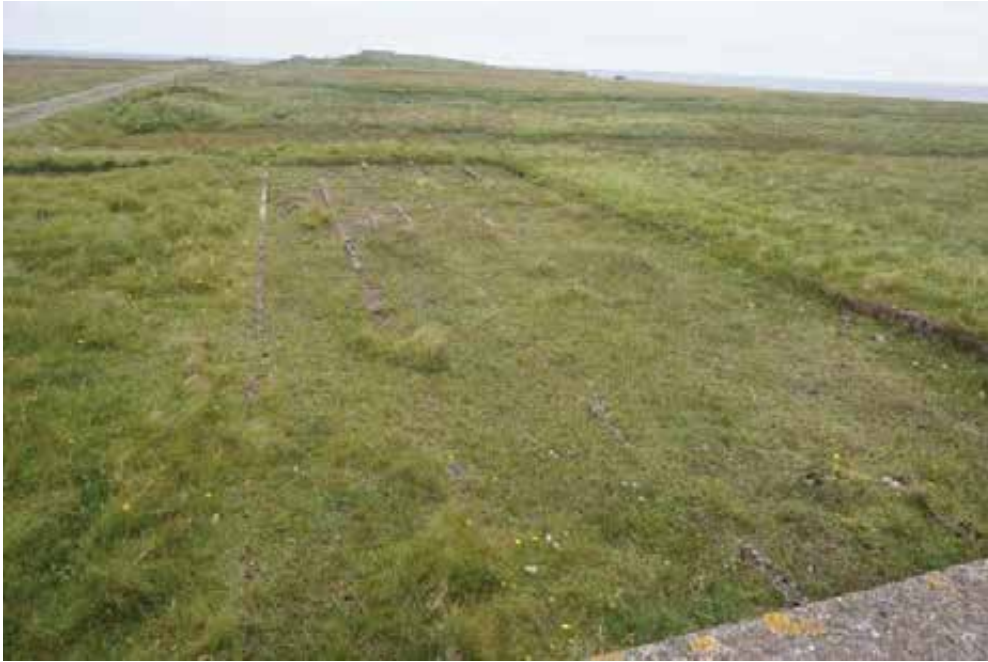
**1**

<b>Condition:</b>			
Poor: Loose and displaced brickwork throughout east portion, with failing mortar joints throughout. Cracked and disaggregated concrete floor slab supporting vegetation growth, and localised missing/damaged wallhead brickwork and failing joints to the west portion.			
<b>Recommendations:</b>			<b>Priority:</b>

**General view from west of east portion comprising part buried brick footings.**

1.	Record as existing and consider burying to protect footings and concrete from further damage from exposure and increased footfall. <b>£5000.00 – Provisional cost</b>		Necessary
