# Appendix 14.9 Data Interpretation Strategy

# Appendix 14.9 Draft Heritage Interpretation Strategy

## **4.2 Condition Survey**

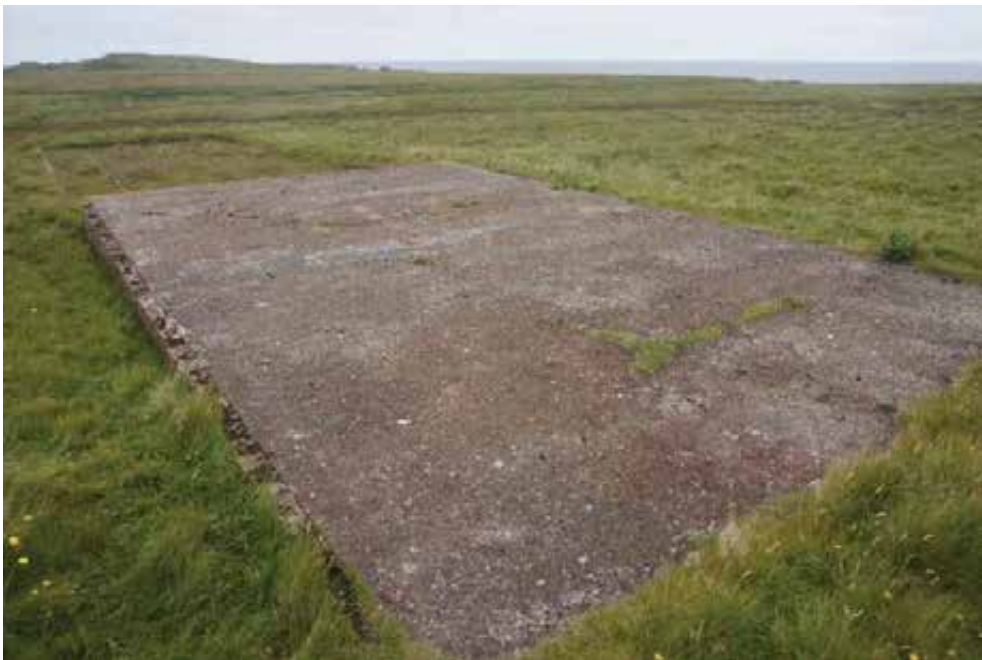
5

**General view from northwest of west portion comprising concrete floor slab surrounded by part buried brick footings.**

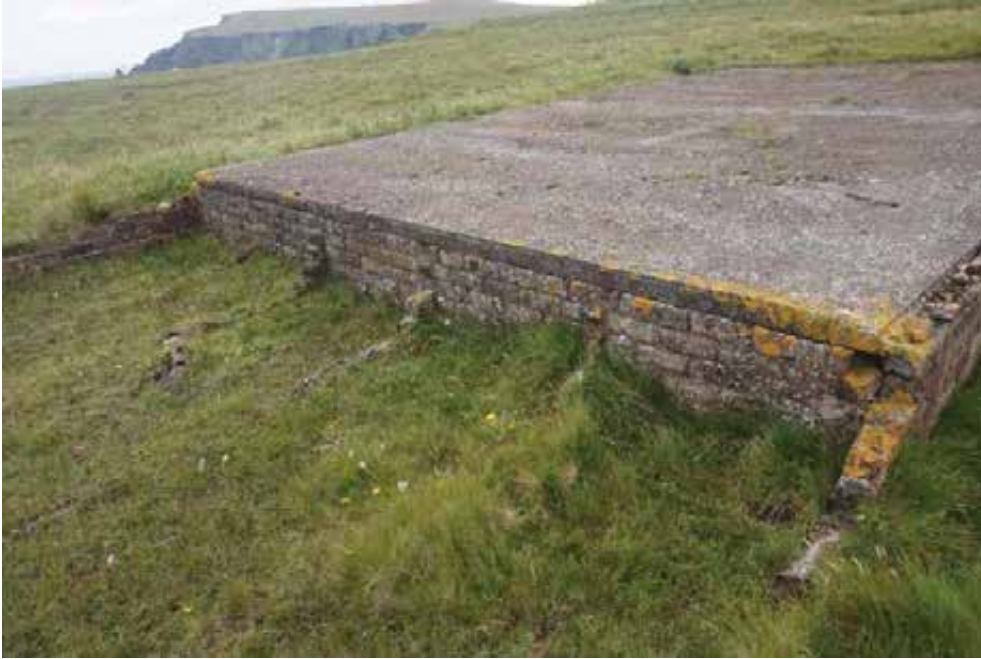
7

**East face of west portion with failing joints and damaged brickwork.**

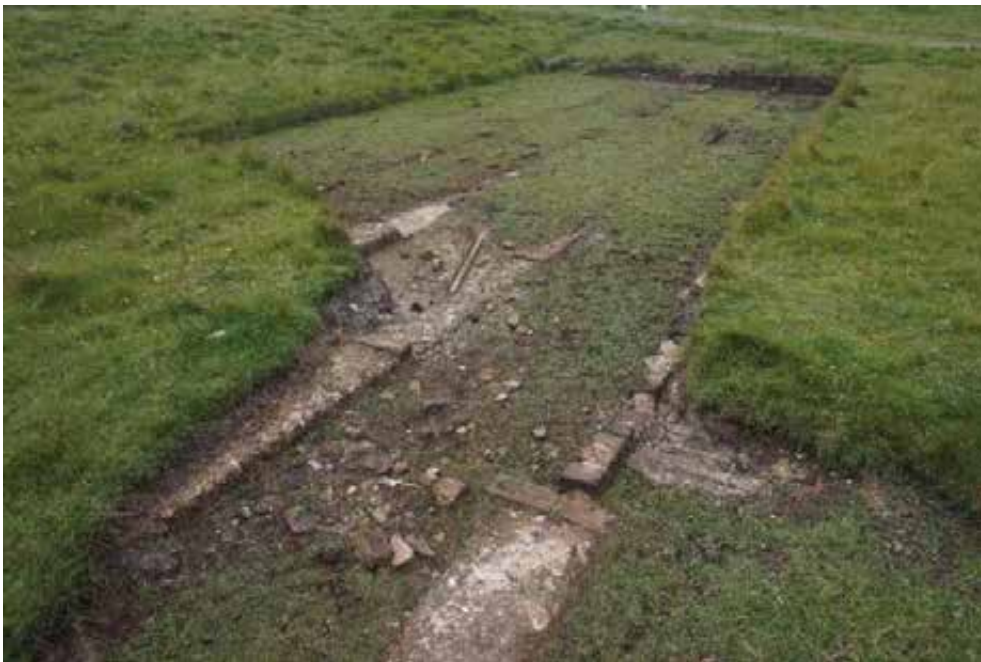
**Loose brick footings, disaggregated concrete strip foundations and displaced bricks, timber and metal work at southern portion of the structure.**

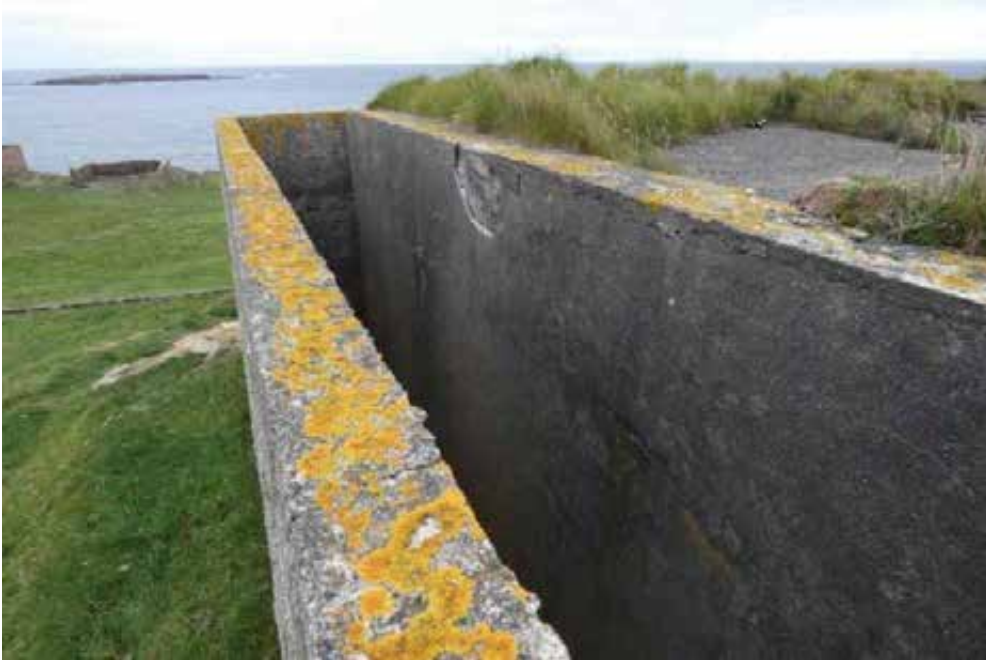
3.

As before. Note the loss of render from the wall of the building.

5.	Check all wall renders and ceiling plaster and remove all loose and boss material. Stabilise perimeters of areas of missing material to limit further loss of fabric. Cost <b>£300.00</b>	Necessary.

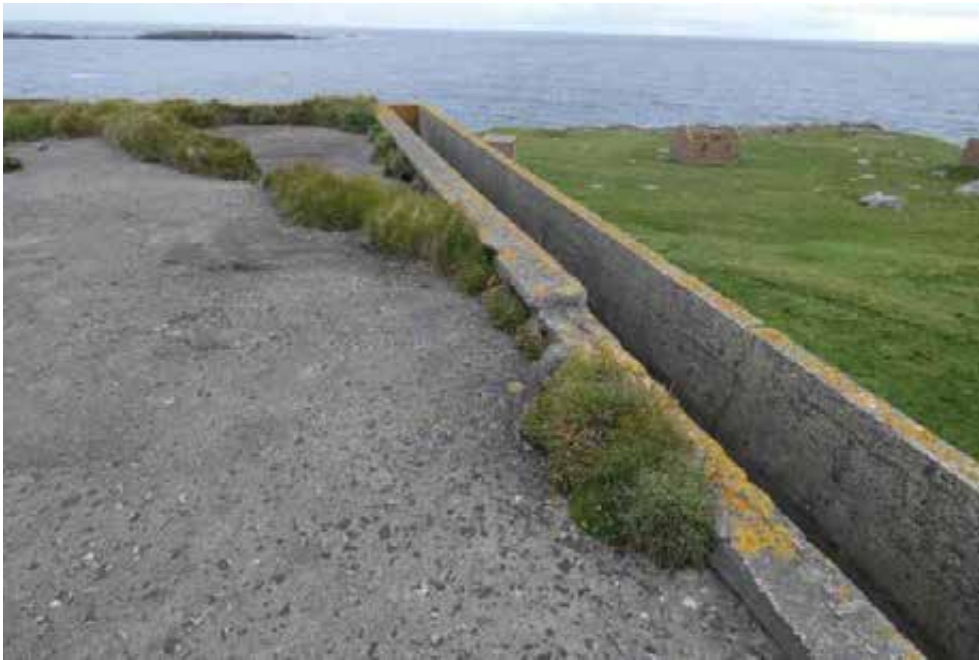
6.

The roofscape. Note missing copes from parapet.

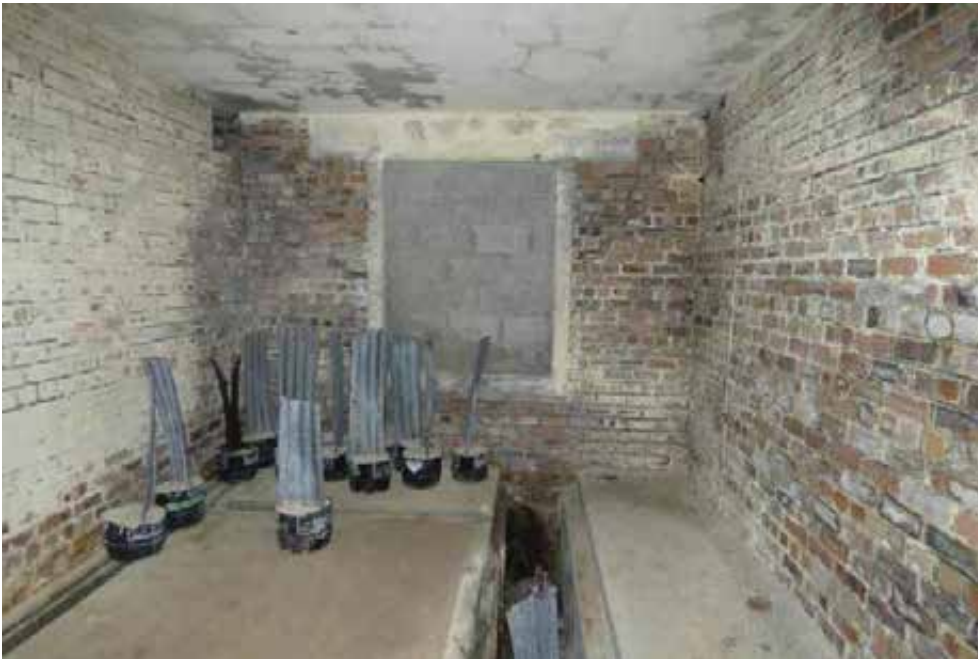
11.

As 10. Note cracked ceiling plaster and indications of general dampness in the brick masonry.

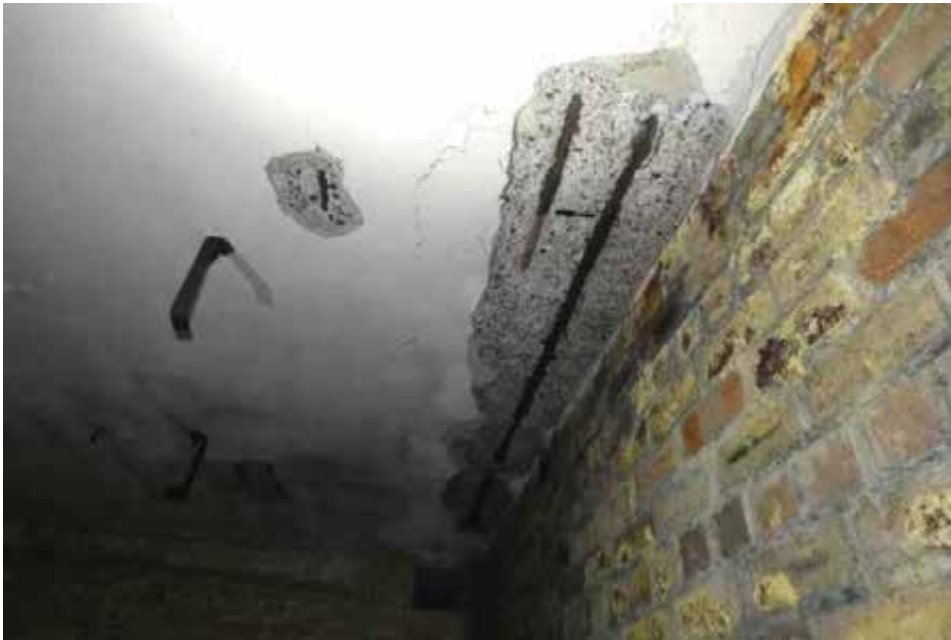
14

In places, expansive corrosion of reinforcement is causing spalling of concrete from roof soffit.

6.	Implement a regular programme of inspection and monitoring to determine rate of deterioration of building fabric generally. In time, repair of damaged concrete will be necessary. The timing, extent and significance of the repair will depend on any preventative measures taken.	Necessary.

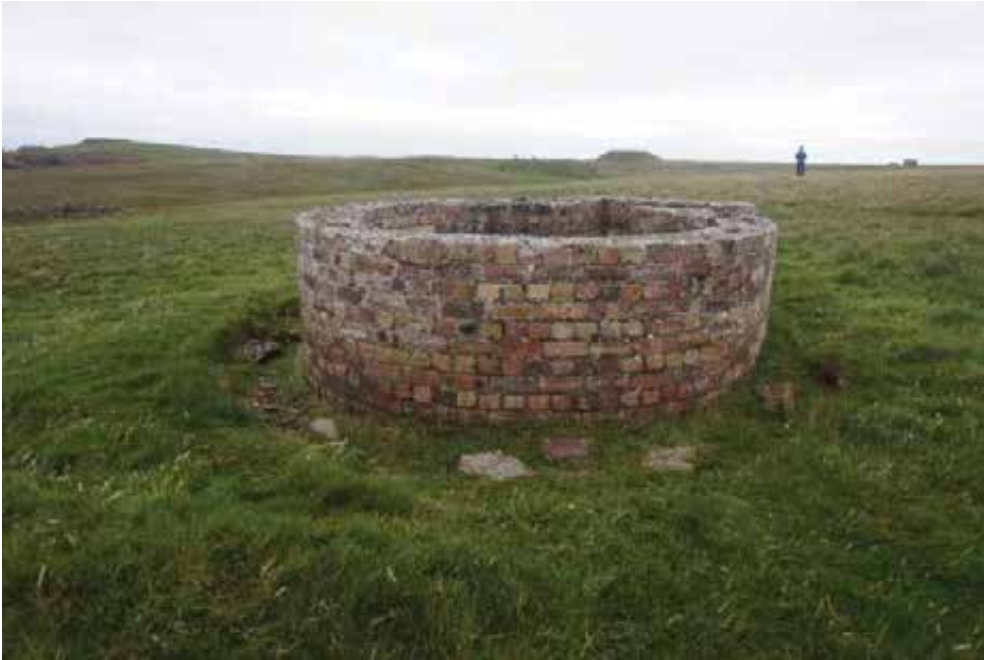
**1**

**General view from south showing damaged wallhead brickwork and localised failing joints to wall face. Displaced bricks around base of wall.**

<b>Condition:</b>			
Fair: Localised open, cracked and failing mortar joints, including to exposed wallhead which is supporting vegetation growth. Minor damaged brickwork to wallhead.			
<b>Recommendations:</b>			<b>Priority:</b>
1.	Record and monitor future condition, with provision for localised repointing of open and defective joints, especially skyward facing joints. <b>£100.00</b>		Necessary

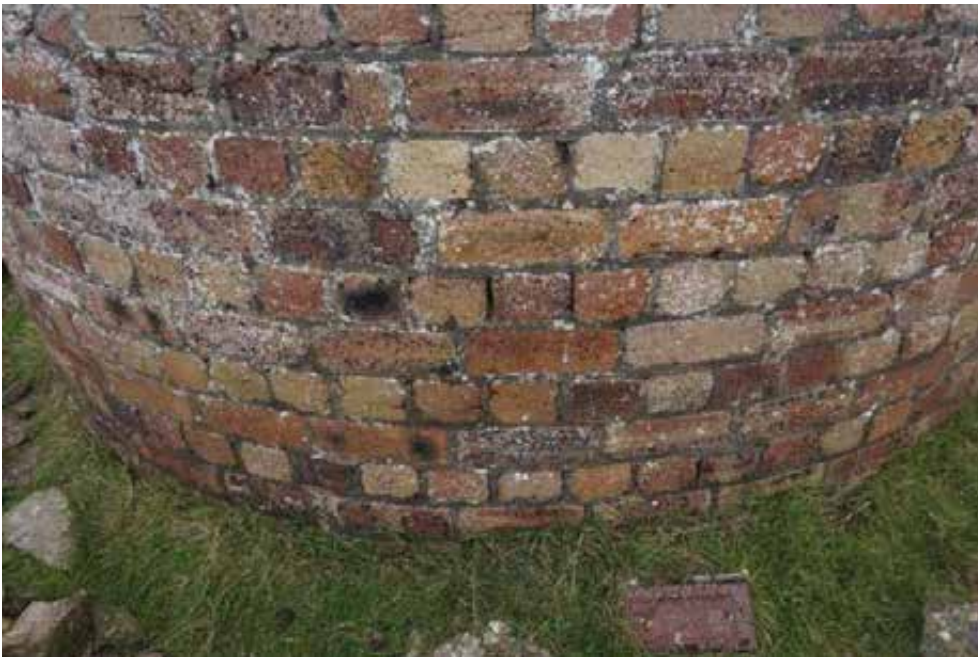
**Localised failing joints to wall face.**

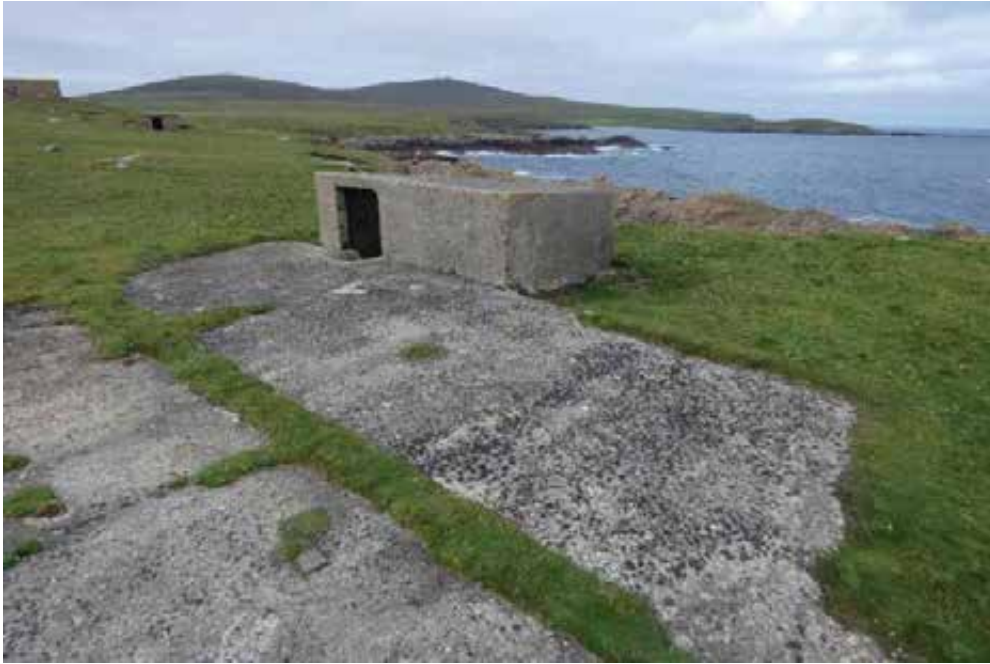
**1**

**General view showing cracked hardstanding which is supporting vegetation growth.**

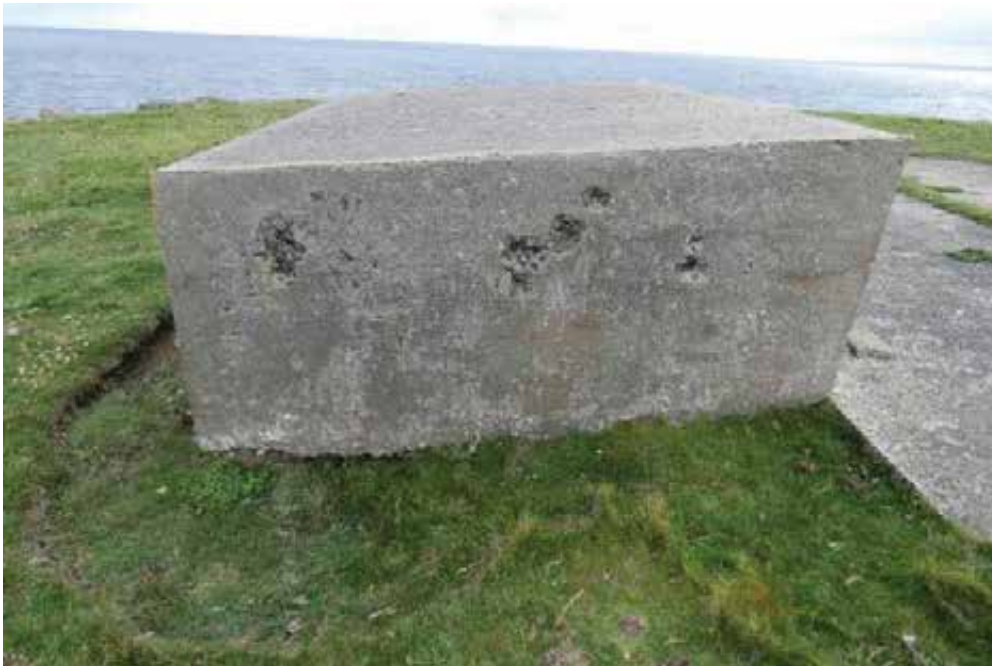
3

**Localised spalling and damage to external walls.**

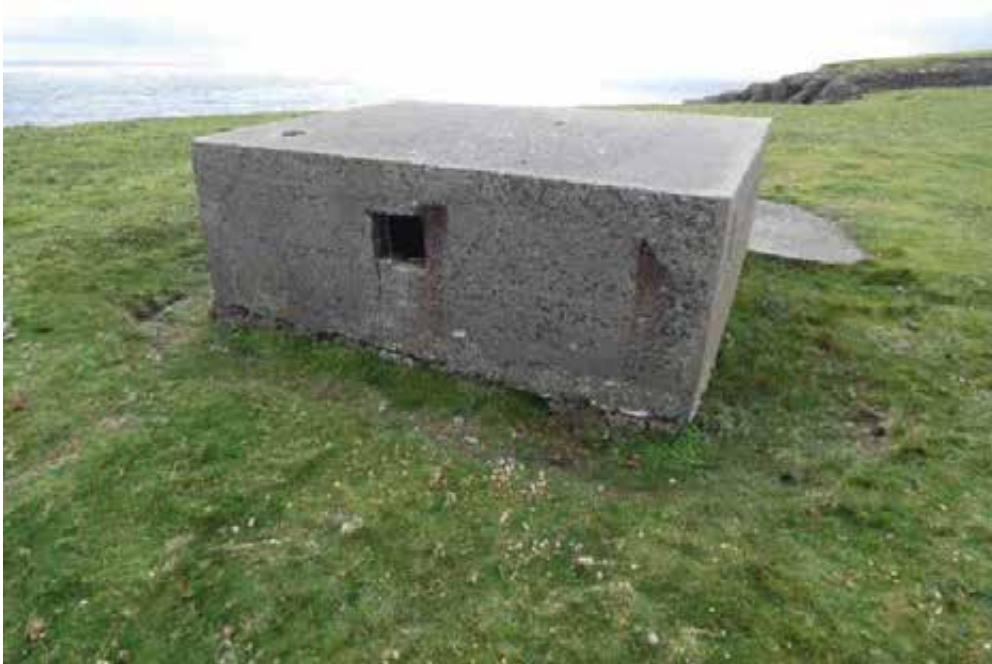
4

**Localised cracking and rust staining.**

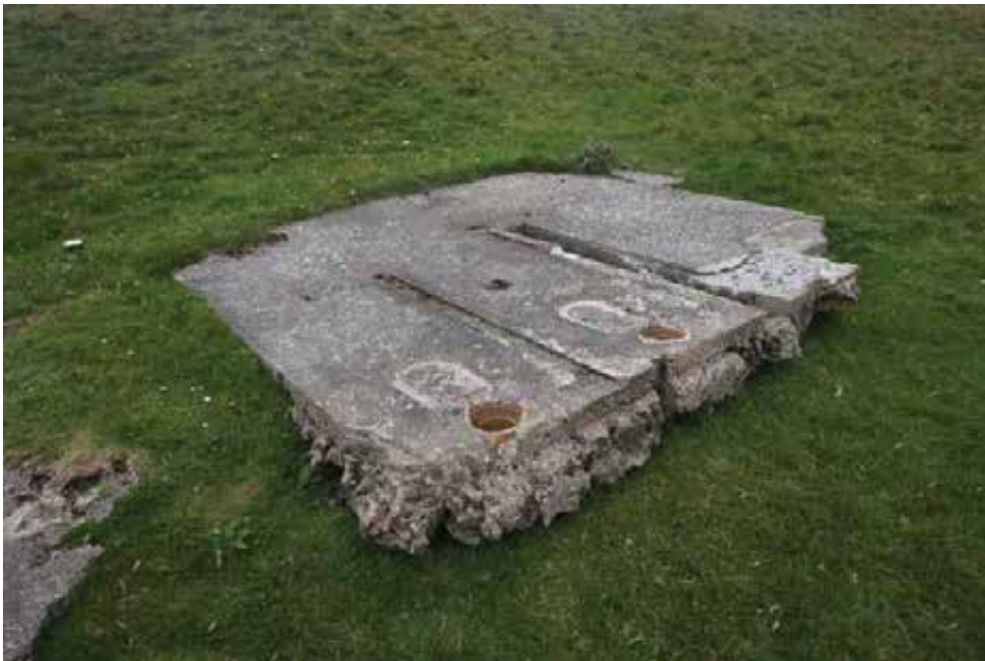
**2**

**East concrete base with spalling upper face.**

1.	<p>As the structure is stable, monitor its condition as part of a regular inspection regime. If its condition significantly worsens, consider interventions such as packing under exposed concrete edges, localised crack filling and repointing brickwork consolidation. <b>£600.00</b></p>		Necessary

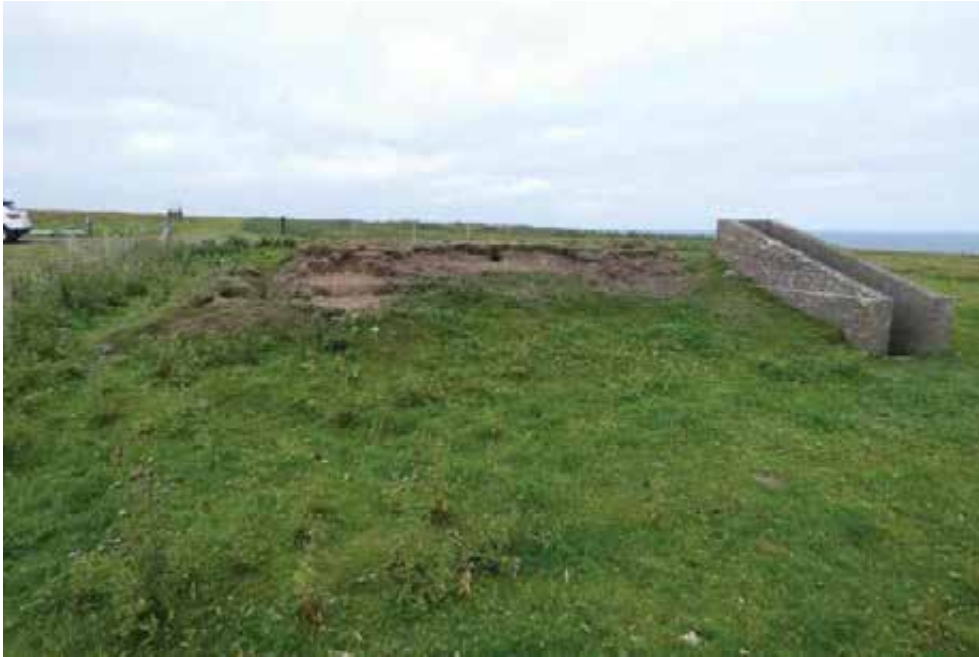
**1**

**General view from southwest. Note damage caused by grazing and burrowing animals.**

1.	Record and use as basis for regular inspection to assess future changes in condition.		Necessary
2.	Reinstate earth and turf to further protect buried parts of the structure. <b>£1000.00 – provisional</b>		Desirable

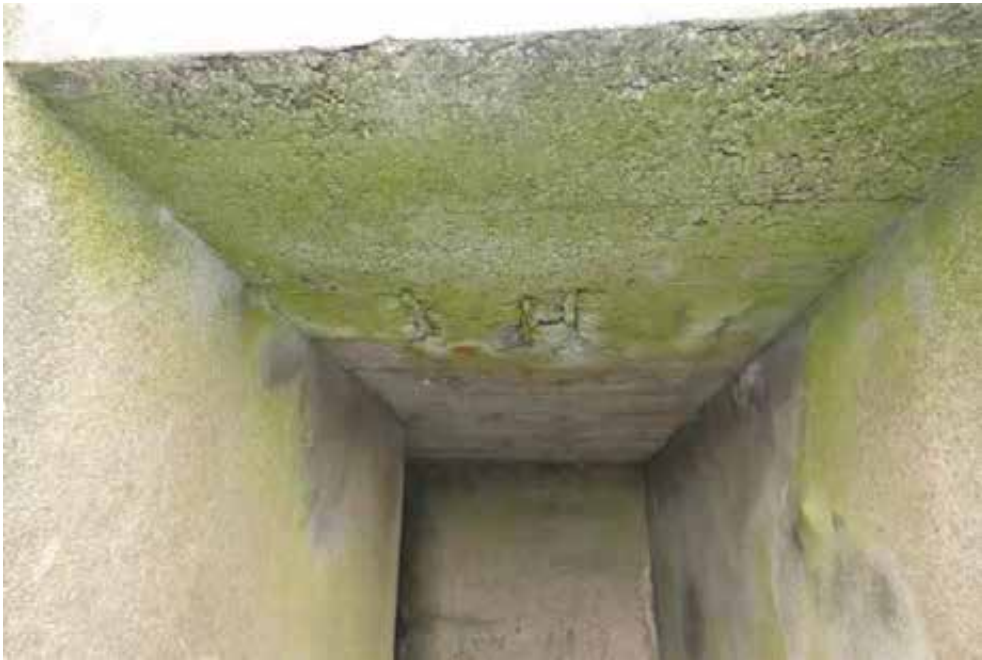
3

**Localised spalling to the soffit of the roof slab exposing reinforcement.**

3.	Remove all loose and friable material from interior surfaces of the building (walls and roof). <b>£200 - provisional</b>		Necessary

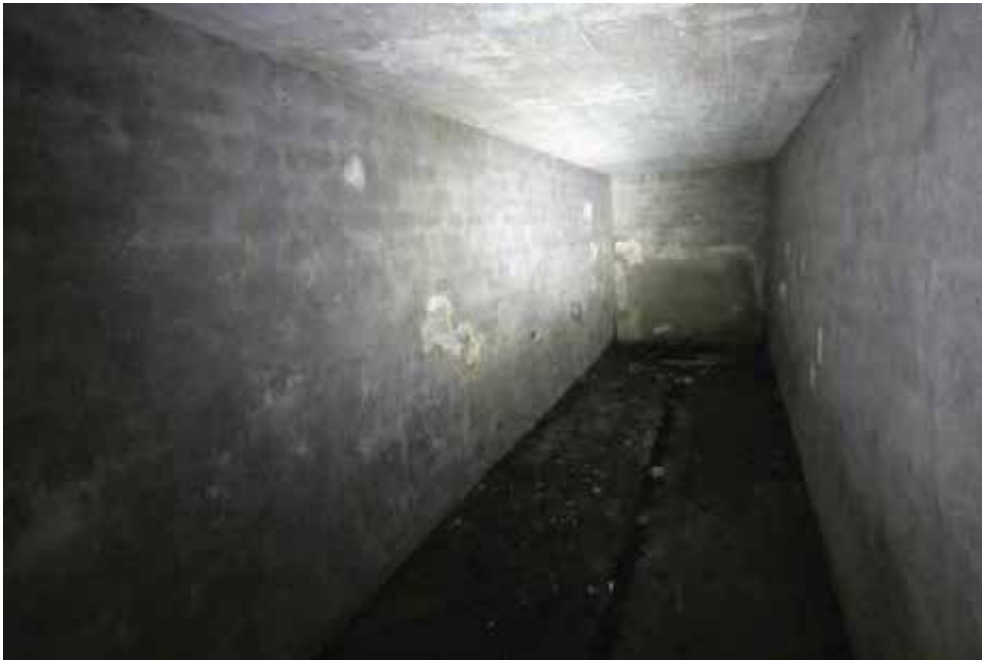
4

**Localised failing render internally.**

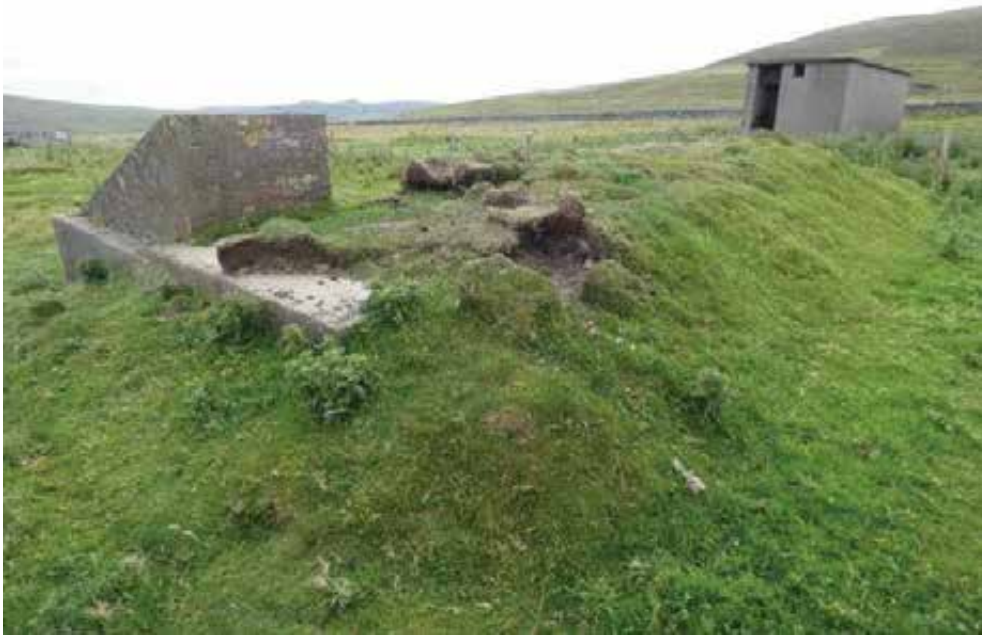
**Replacing the missing and damaged earth and turf banking will protect the structure below.**

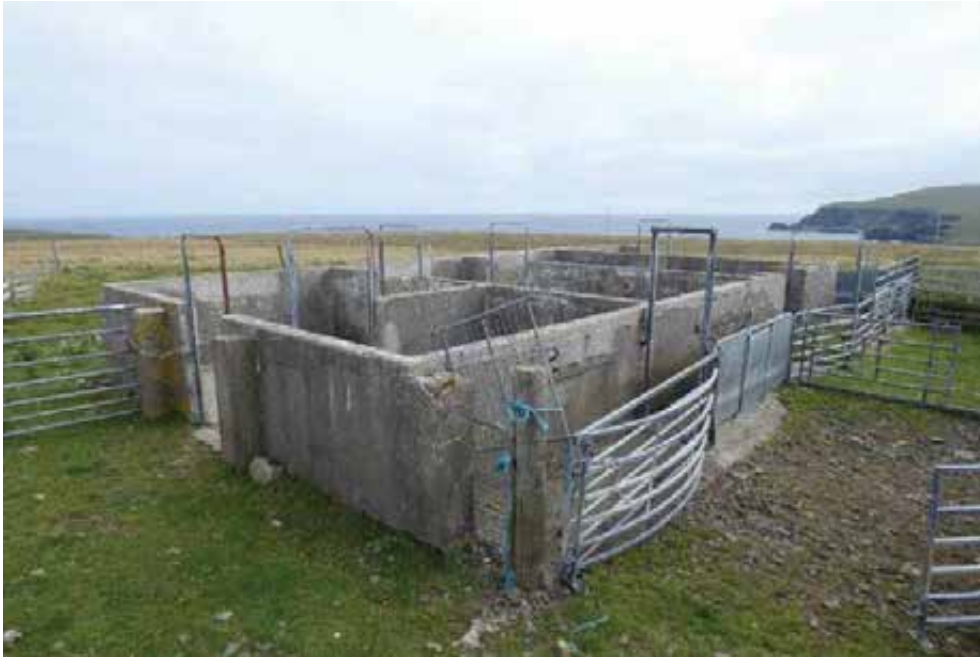
**1**

**View from northwest. Walls have been lowered, with rendering patch repaired and gates inserted to accommodate agricultural use.**

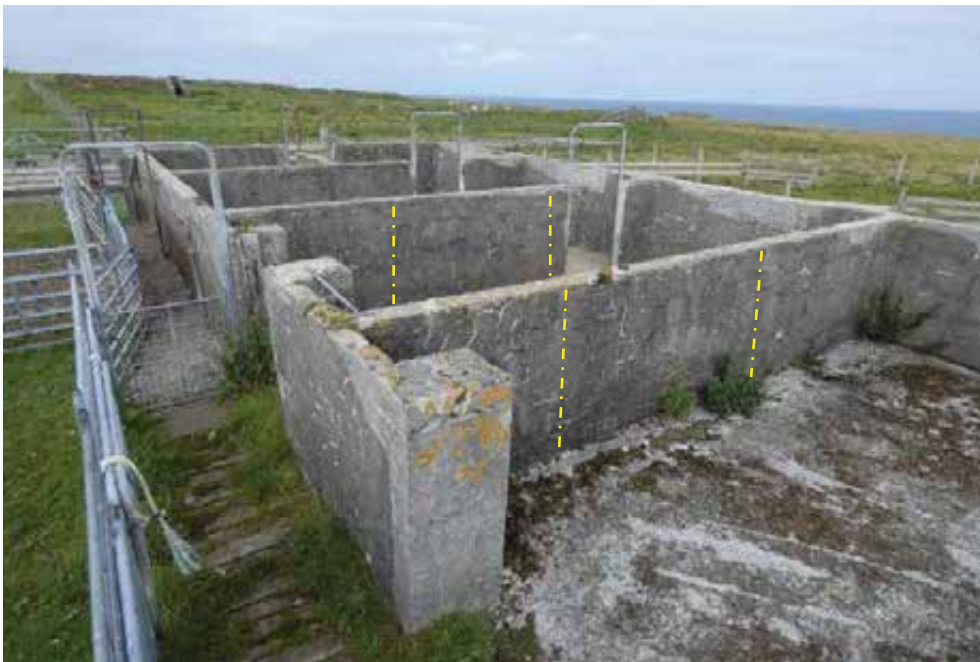
**2**

**The cement render is extensively cracked and in some areas is supporting vegetation growth. The concrete floor has minor disaggregation and is supporting vegetation growth. The relatively long and slender internal partition walls depend on the integrity of the mortar in their bed joints for their stability. The robustness of these walls can be increased with the introduction of new buttresses at key points (indicated)**

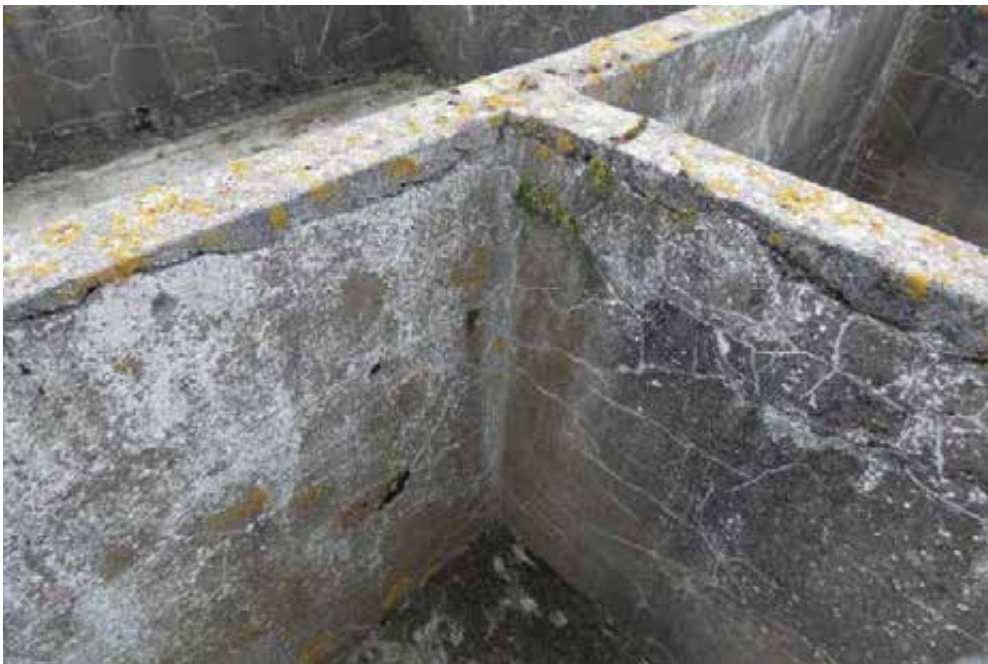
3

The render was patch repaired when the walls were lowered. All render (original and later) has cracked.

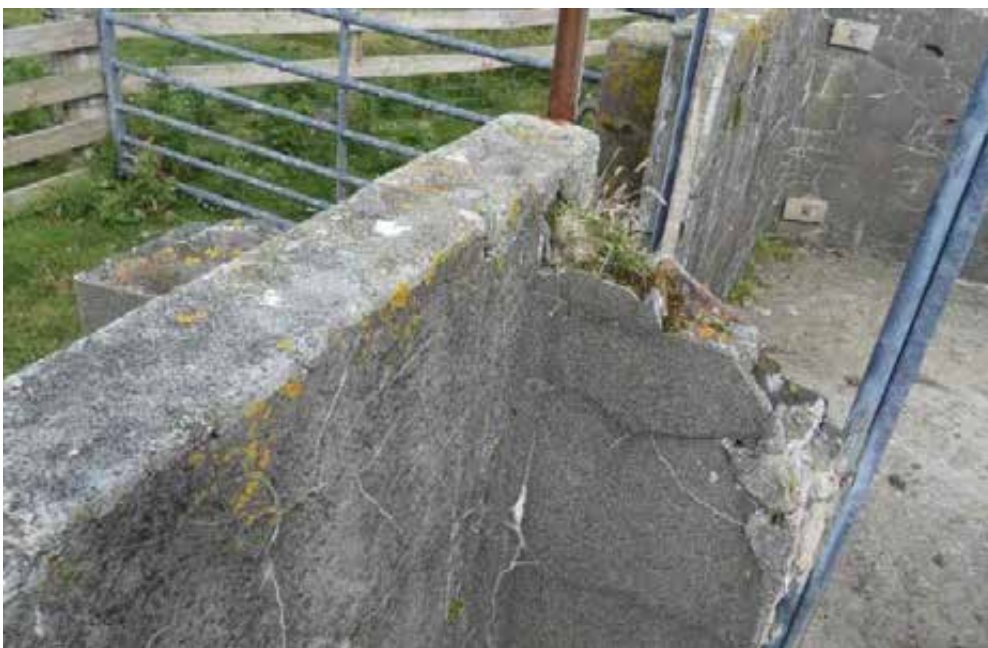
4

Localised damaged wallhead brickwork.

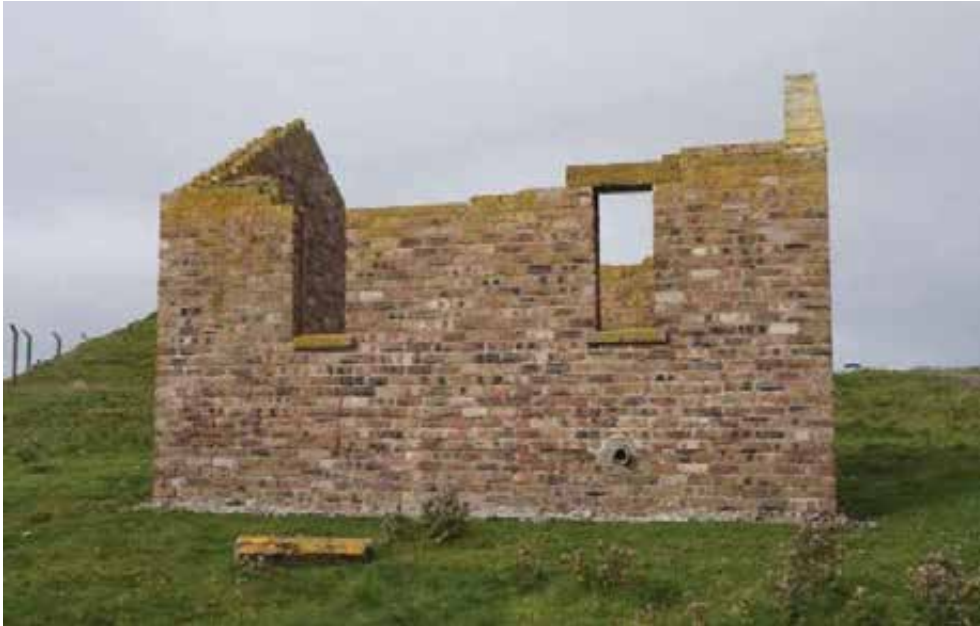
**1**

**East elevation with dislodged lintol and fallen wallhead brickwork. To prevent ingress into the cavity, consider resetting the lintol and brickwork to allow the wallhead to be capped in concrete.**

3.	To minimise future water ingress into cavity, replace missing and damaged concrete cappings to gables, and consider resetting lintol and fallen brickwork to elevations and thereafter capping wallheads in concrete. <b>£3000.00</b>		Necessary.

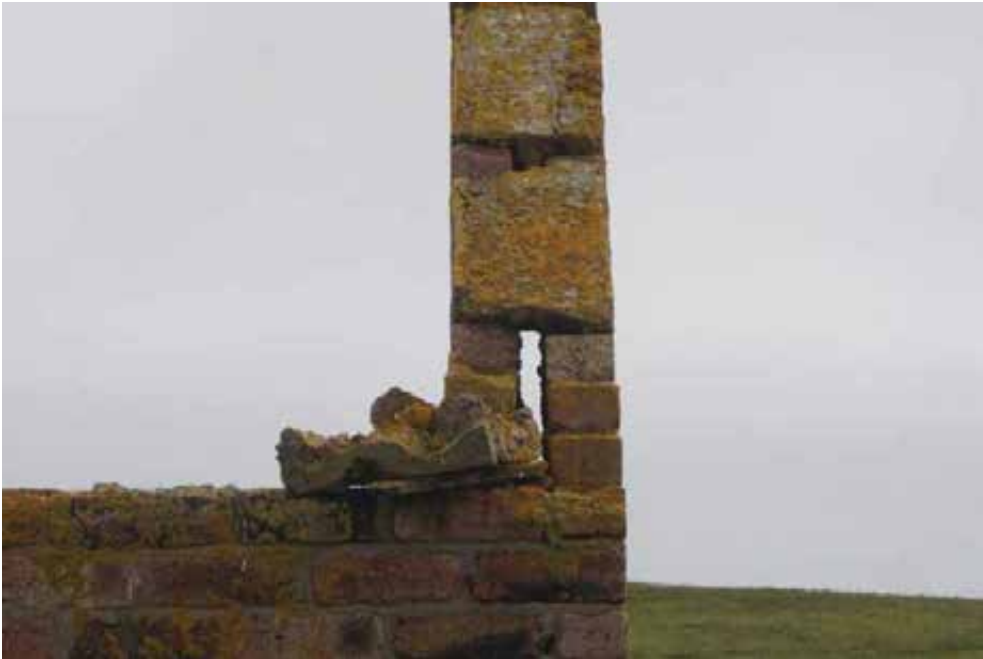
4

**Damaged and dislodged concrete capping to south gable should be removed to reduce health and safety risk. Note that no wall ties are visible within the cavity. Reinstating the wallhead capping will prevent water ingress into the cavity.**

<b>Recommendations:</b>			<b>Priority:</b>
1.	Record and monitor future condition to inform and finalise extent of future repairs. Remove dislodged and loose concrete capping to minimise health and safety risk. (not costed)		Urgent

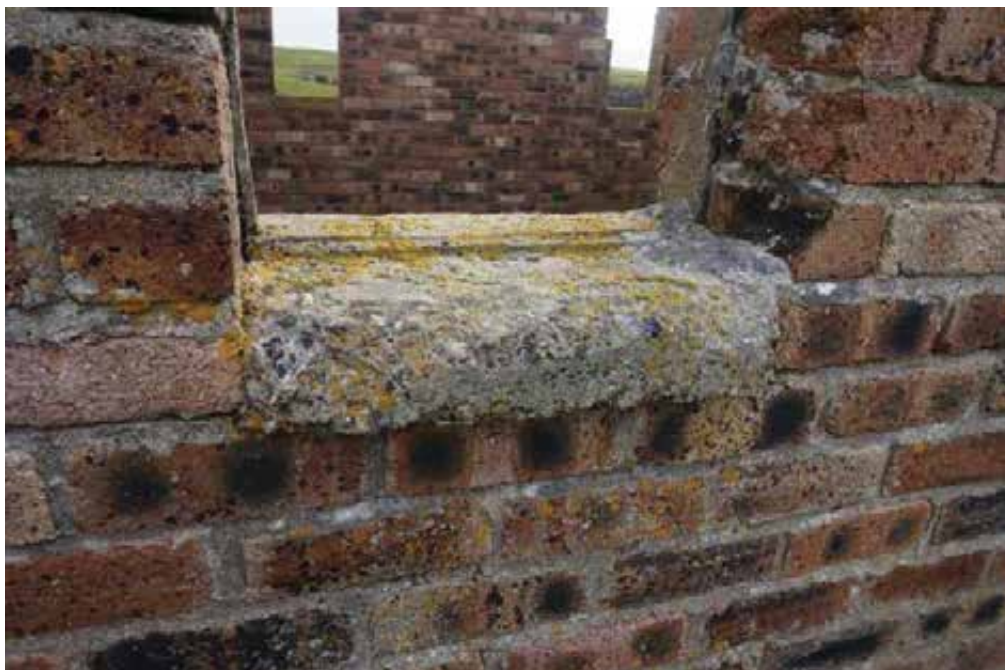
7

**Disaggregating concrete cill.**

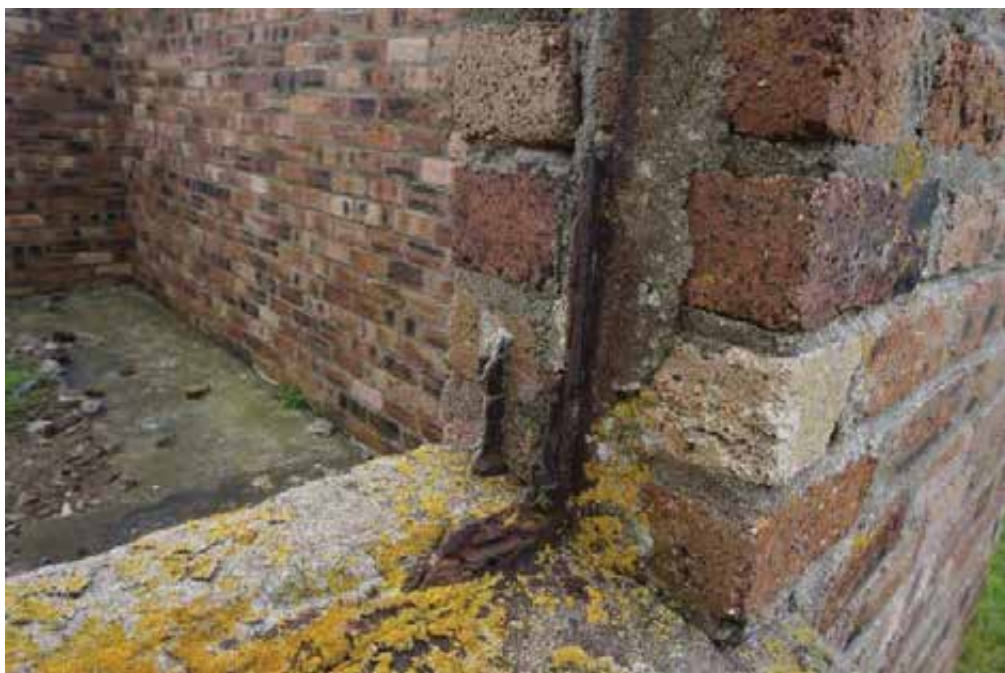
8

**Evidence for metal window frames survives within window checks.**

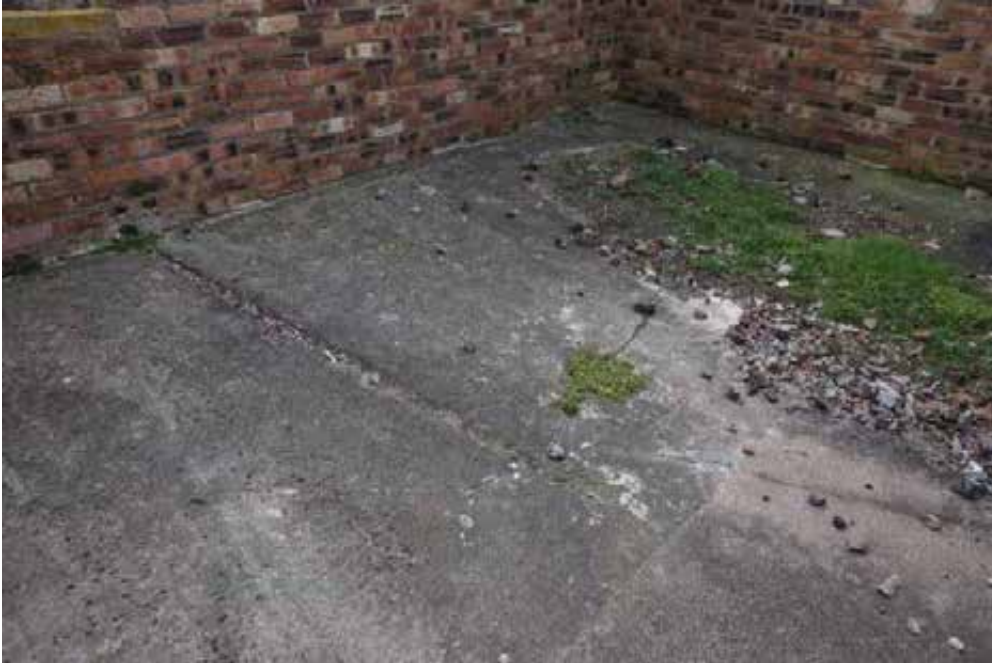
9

**Cracked concrete floor slab supporting vegetation growth.**

5.	Remove vegetation internally and point up wider cracks (>3mm) in concrete floor. <b>£300.00</b>	Desirable
----	--	-----------

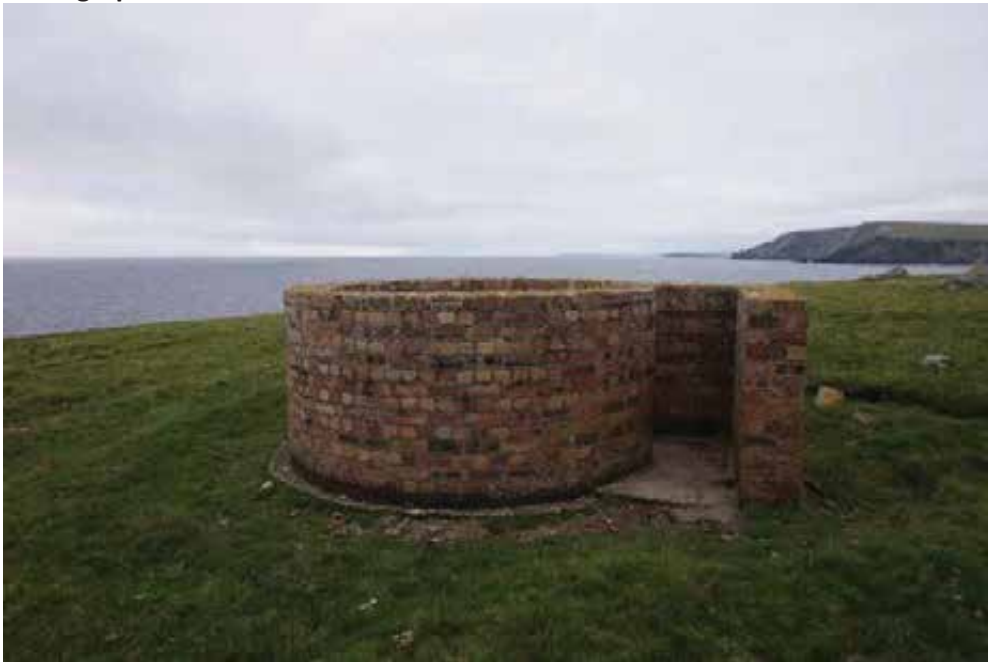
**1**

**View from east showing concrete strip foundation and concrete floor.**

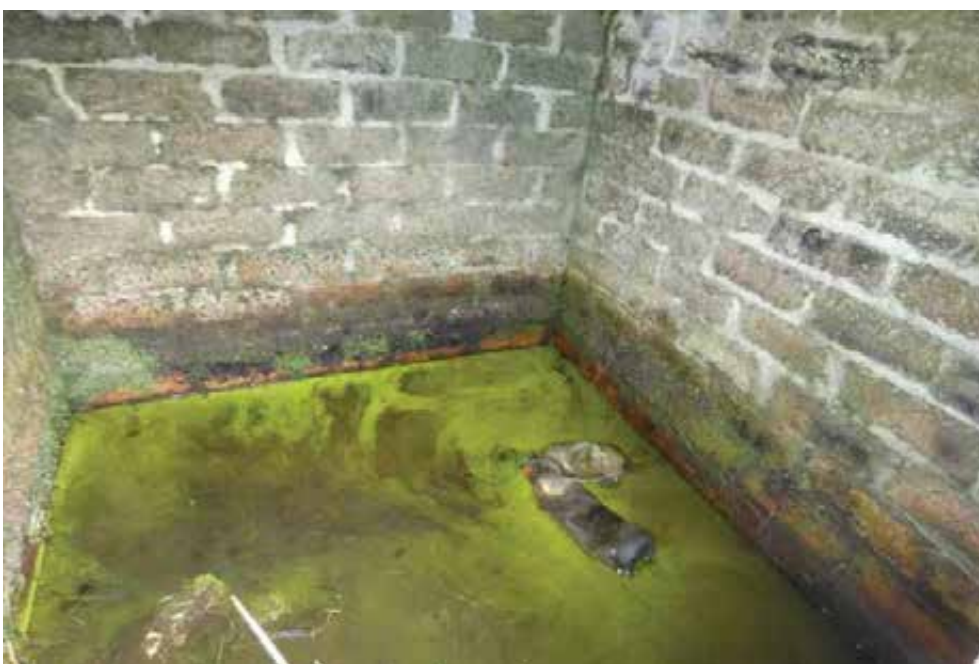
4

Flooded covered area saturating brickwork above.

1.	Record and monitor condition of concrete roof. Repoint failing brick joints. <b>£100.00</b>		Desirable
2.	Clean out all flood water and clean internal surfaces of the structure. Establish management policy for regular removal of water from inside the structure. Not costed.		Necessary

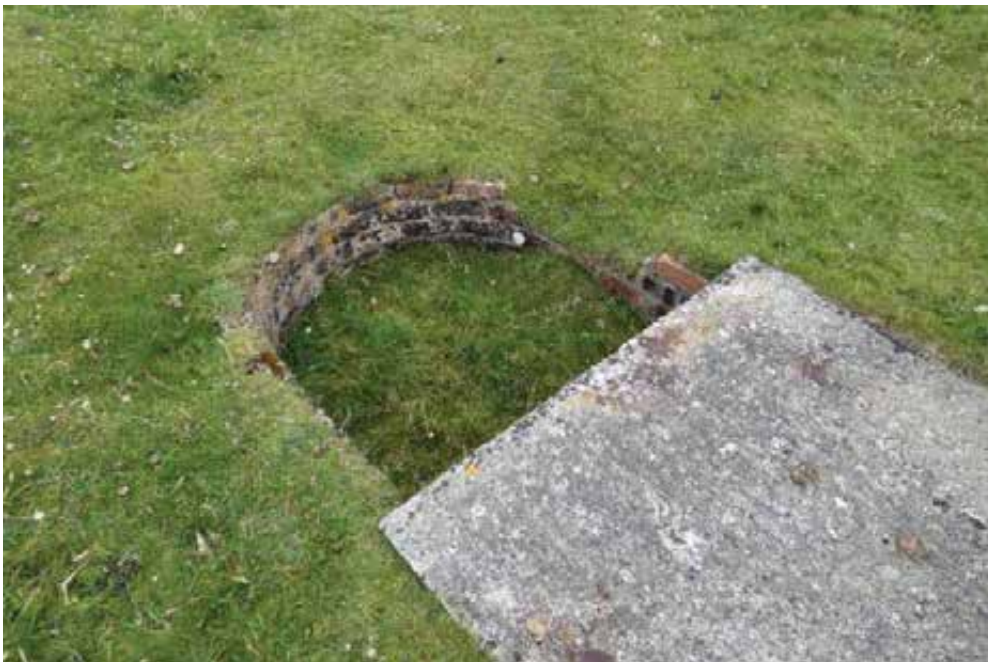
**2**

**Missing wallhead brick work and defective mortar joints. Localised rust staining to concrete roof slab.**

1.	Record and monitor condition of concrete roof. Repoint failing joints around wallhead of curved end. <b>£100.00</b>		Desirable
2.	Clean out all flood water and debris and clean internal surfaces of the structure. Establish management policy for regular removal of water from inside the structure. Not costed.		Necessary

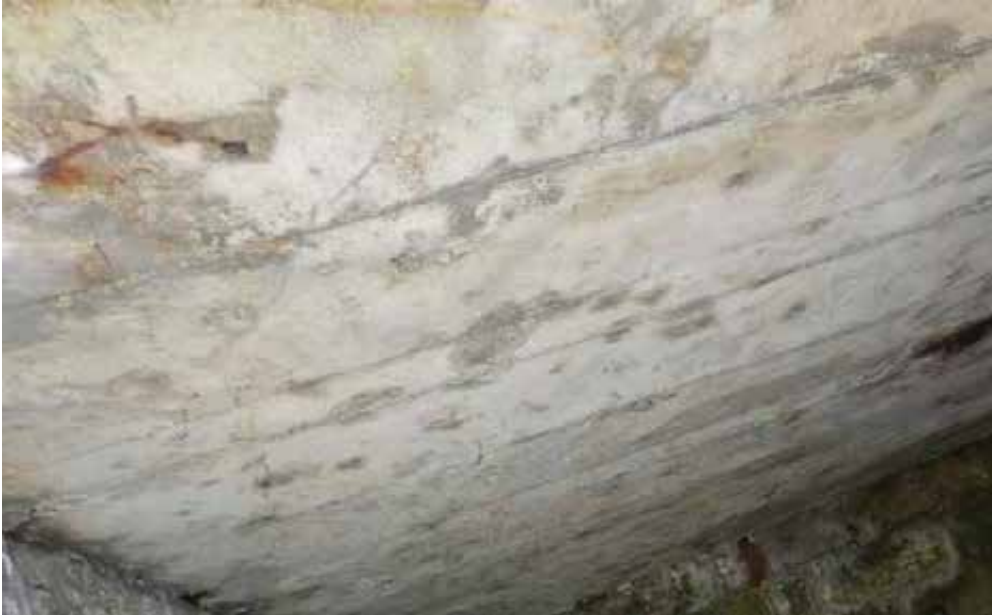
3

**Minor spalling and exposed reinforcement.**

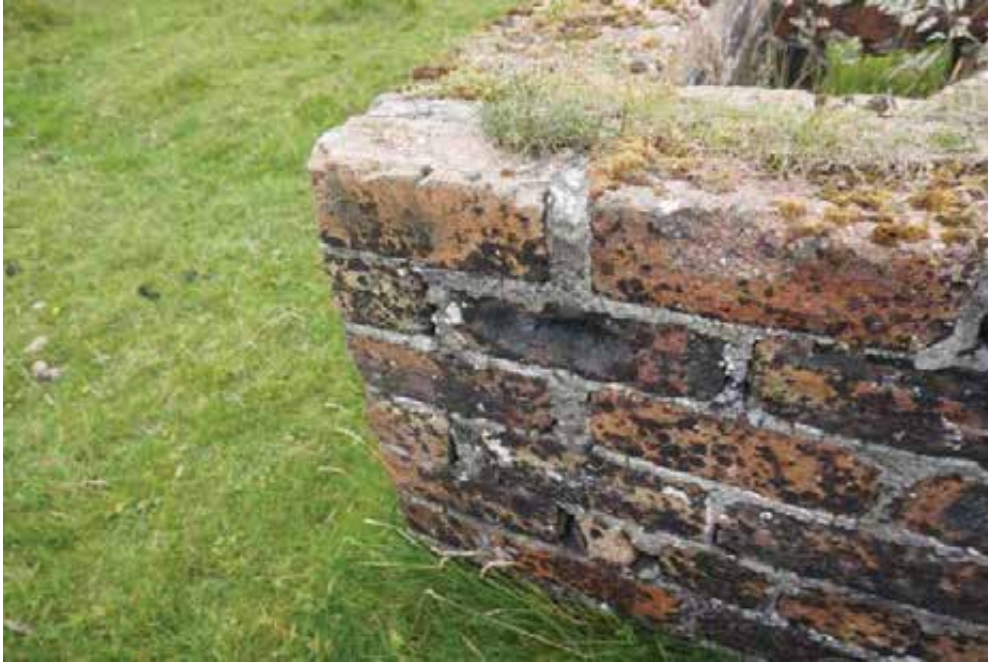
3

**Failing joints to wallhead supporting vegetation growth. Localised damaged bricks and open joints to wall face.**

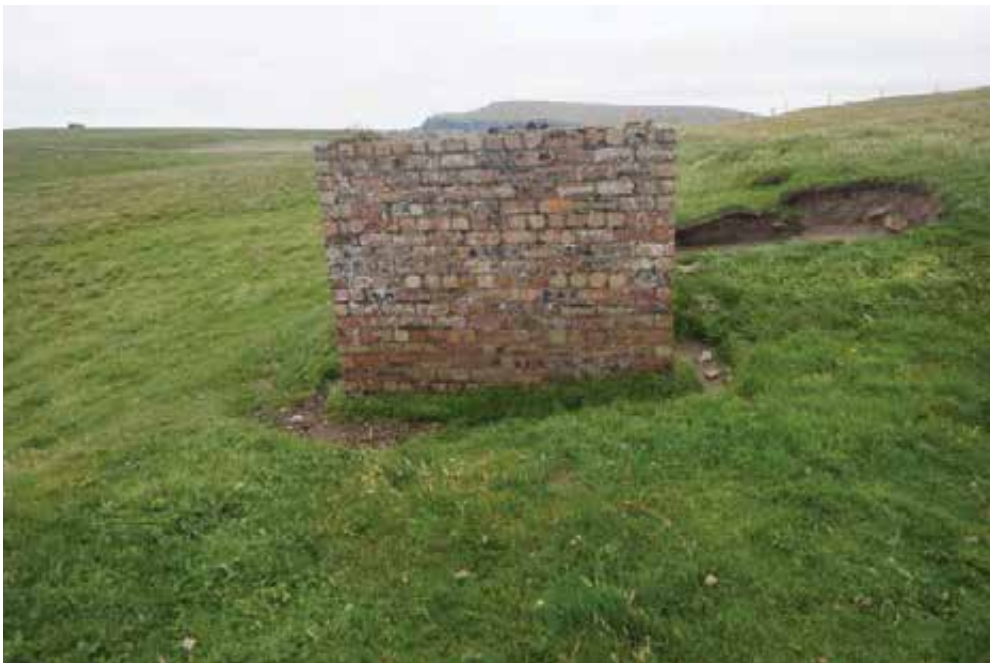
**2**

**No structural cracking was observed despite the walls not being plumb or level.**

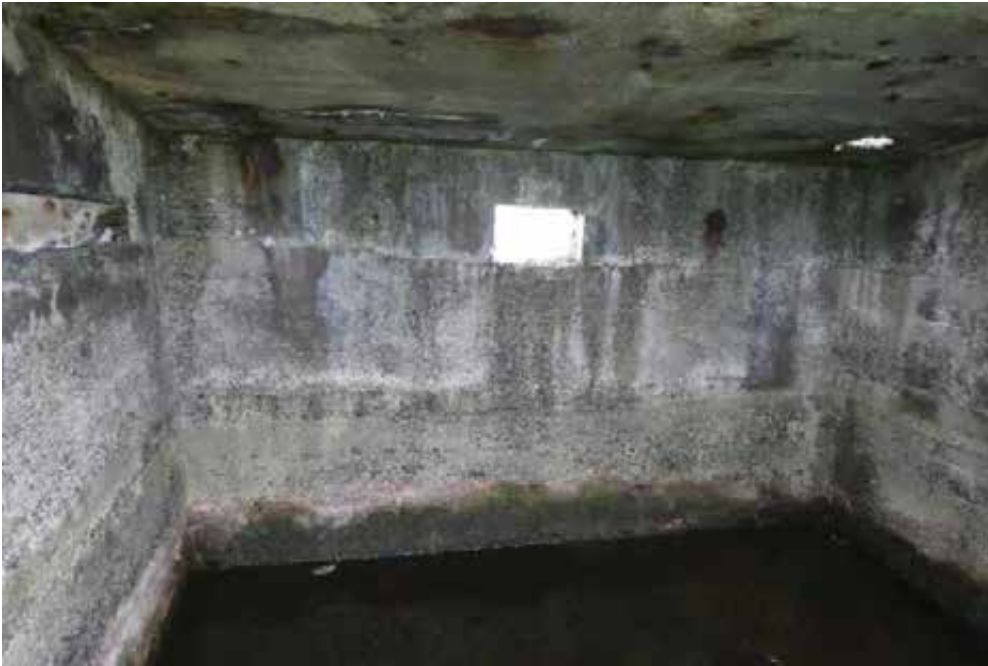
**Hairline cracking, rust staining, leaching and discolouration to the walls exacerbated by flooding internally.**
