# Appendix 14.9 Data Interpretation Strategy

# Appendix 14.9 Draft Heritage Interpretation Strategy

## **4.2 Condition Survey**

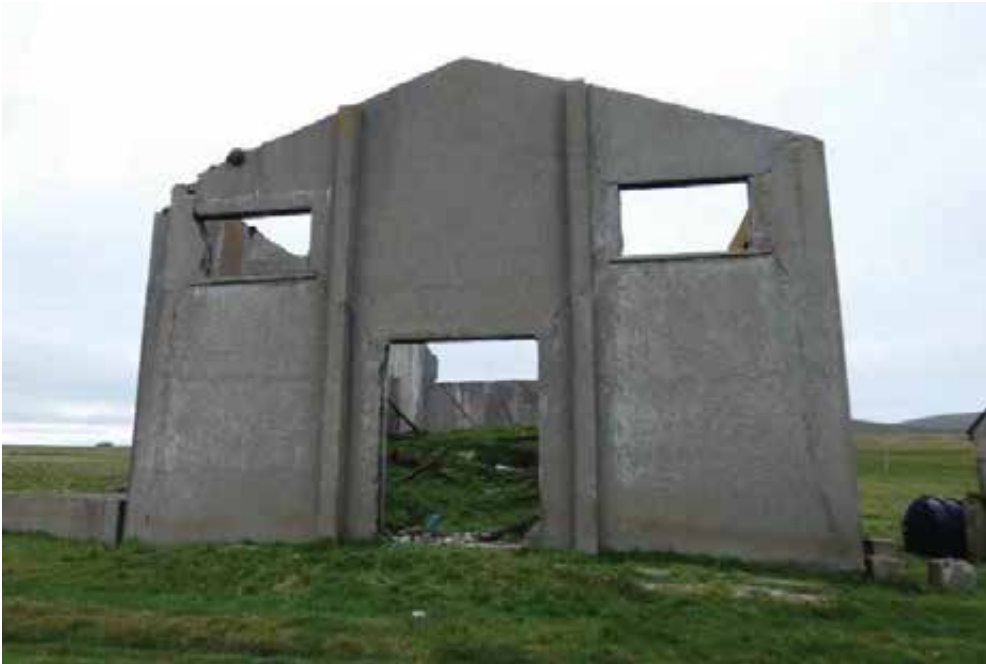
4

East elevation. Note the vertical cracking at each corner. Note the diagonal cracking between the entrance opening and both window openings and how this cracking continues up to wallhead: this elevation is a stack of independent, thin, tall, wall panels sitting atop each other.

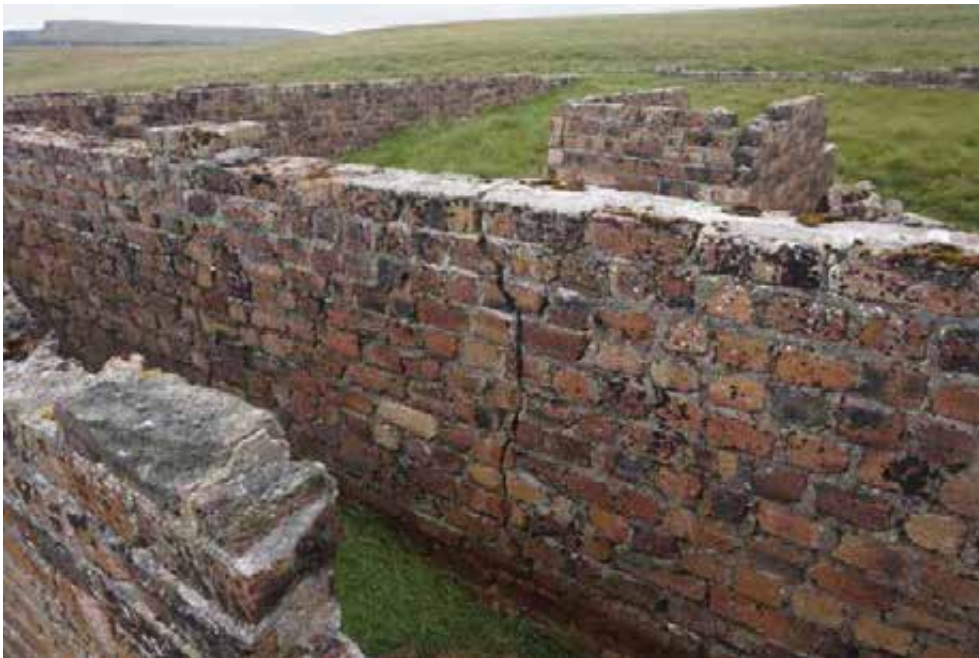
6

**Cracked brickwork to the single brick thick east facing inner skin. Cracks should be repointed to allow future monitoring.**

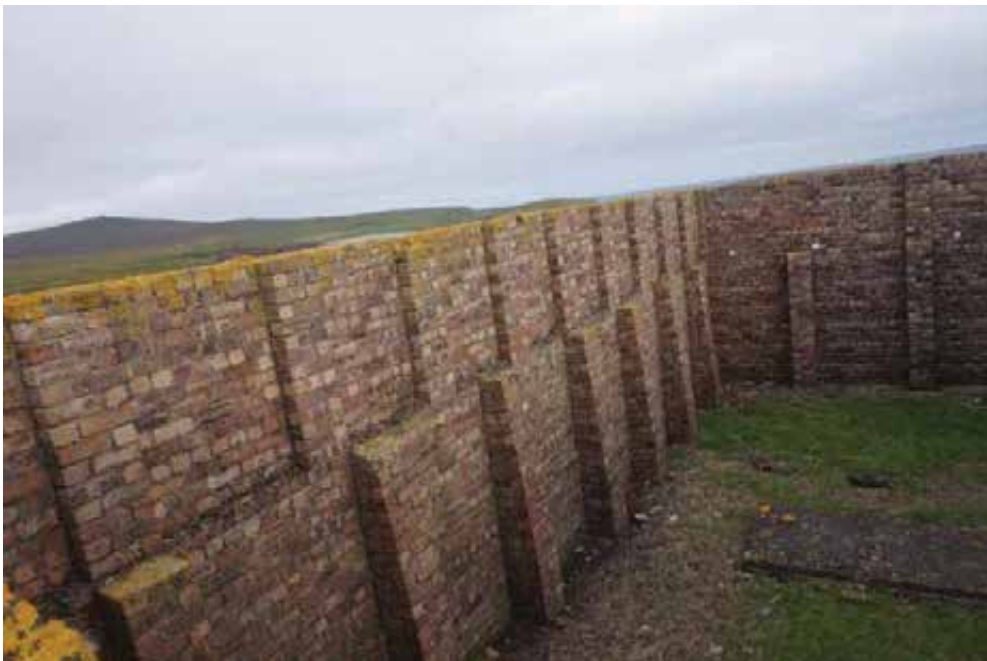
6

**Cracks at higher levels are aligned with the upper piers which are poorly tied to the adjacent thinner single brick thick infilled brickwork. See also Photo 2**

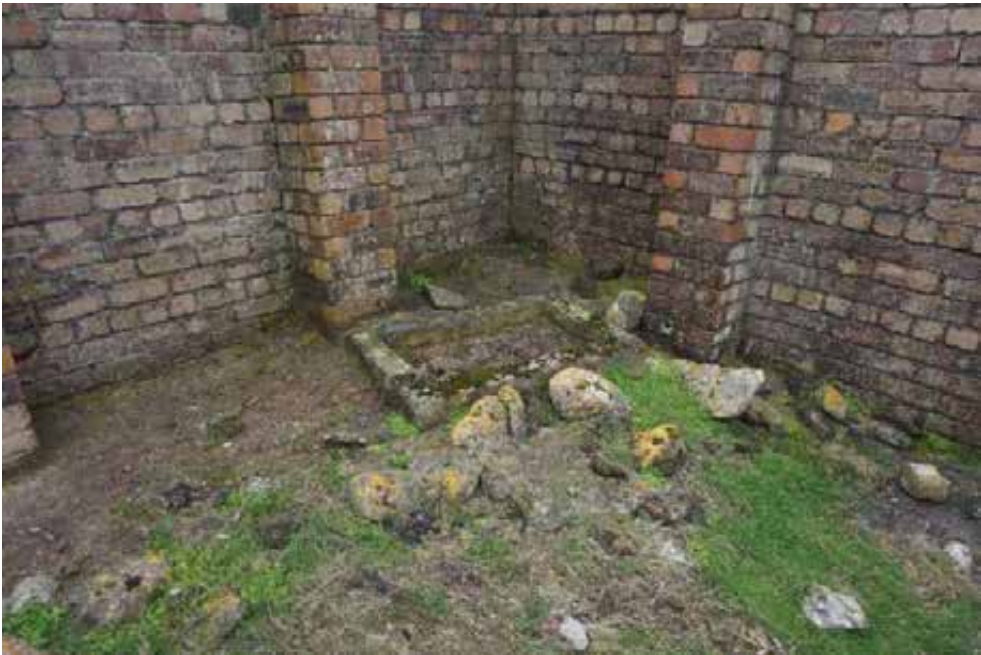
8

**The small rectangle brick structure internally is in good condition. There are loose stones and bricks throughout the grass covered floor internally.**

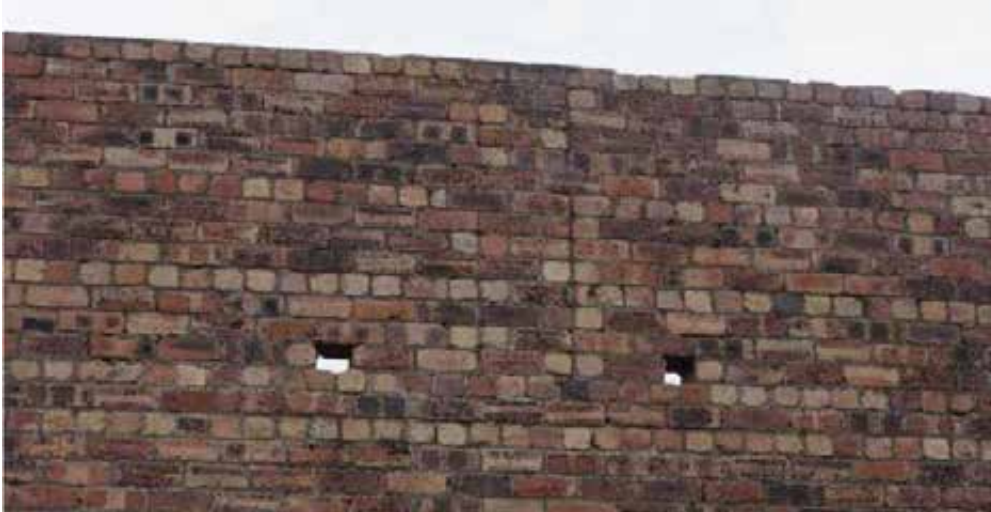
5

Cracks at higher levels are aligned with the upper piers which are poorly tied to the adjacent thinner single brick thick infilled brickwork.

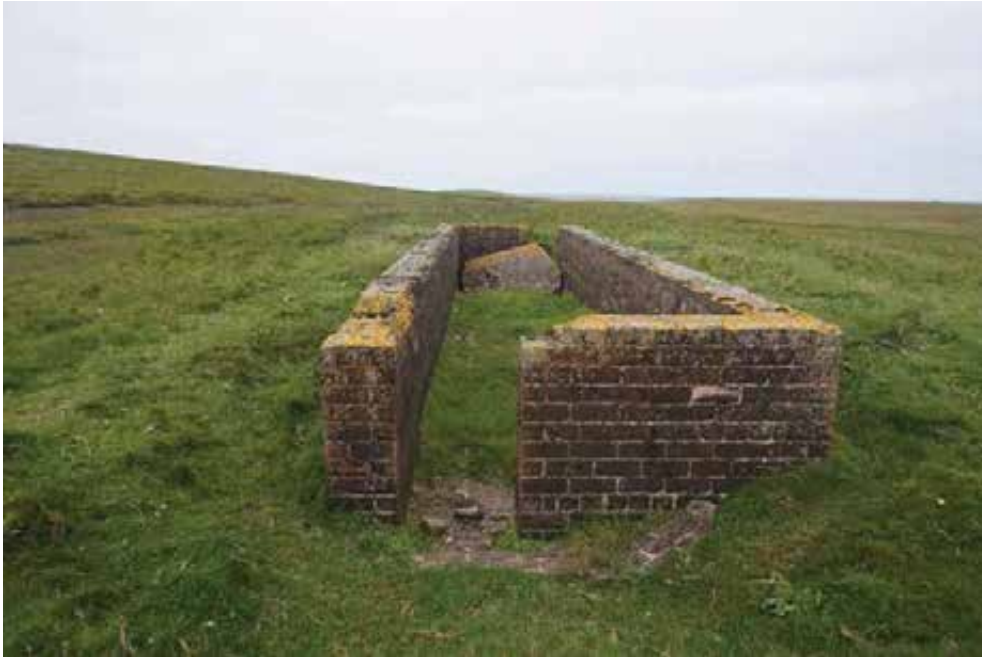
**1**

**View from south showing missing wallhead brickwork, and displaced bricks and concrete roof slab.**

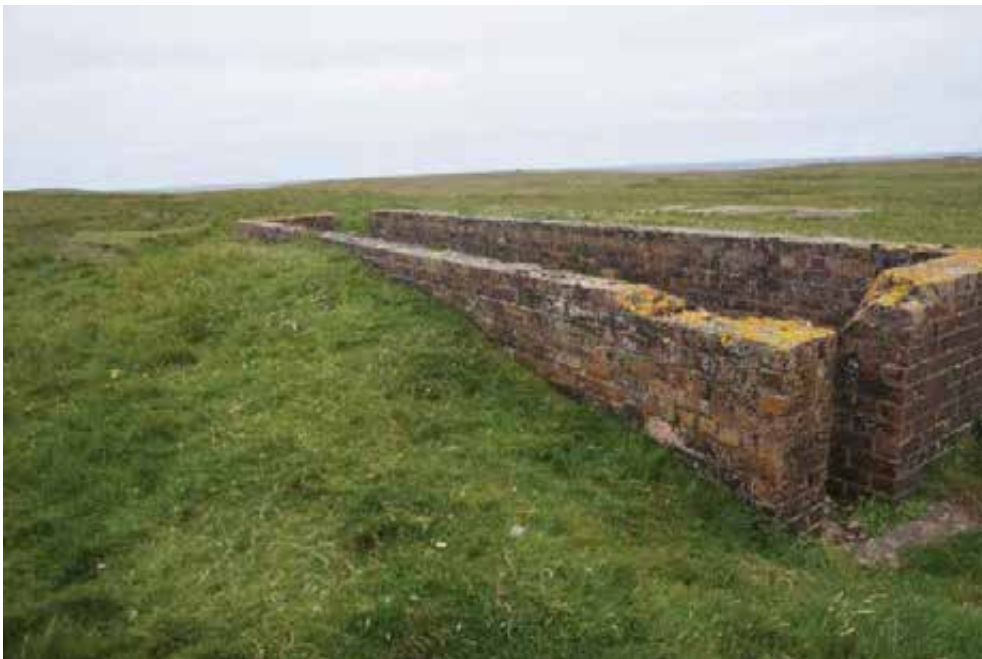
**2**

**Despite localised failing mortar joints, and damaged and missing brickwork, the structure is in a stable condition.**

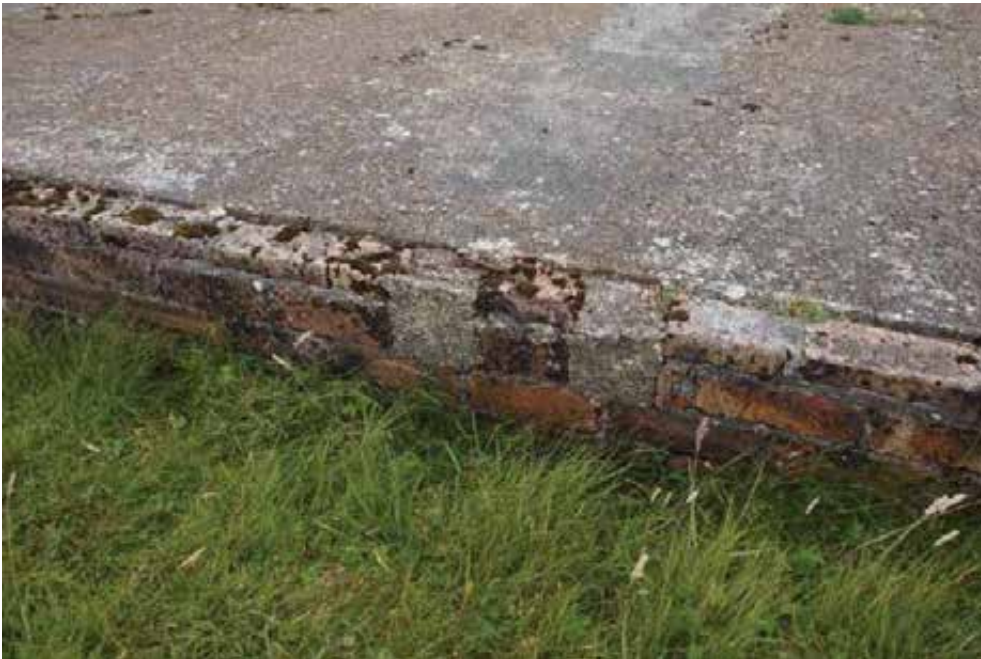
6

**Stumps of reinforced concrete superstructure visible on the footings of the north and south elevations. Note cracked and failing mortar joints.**

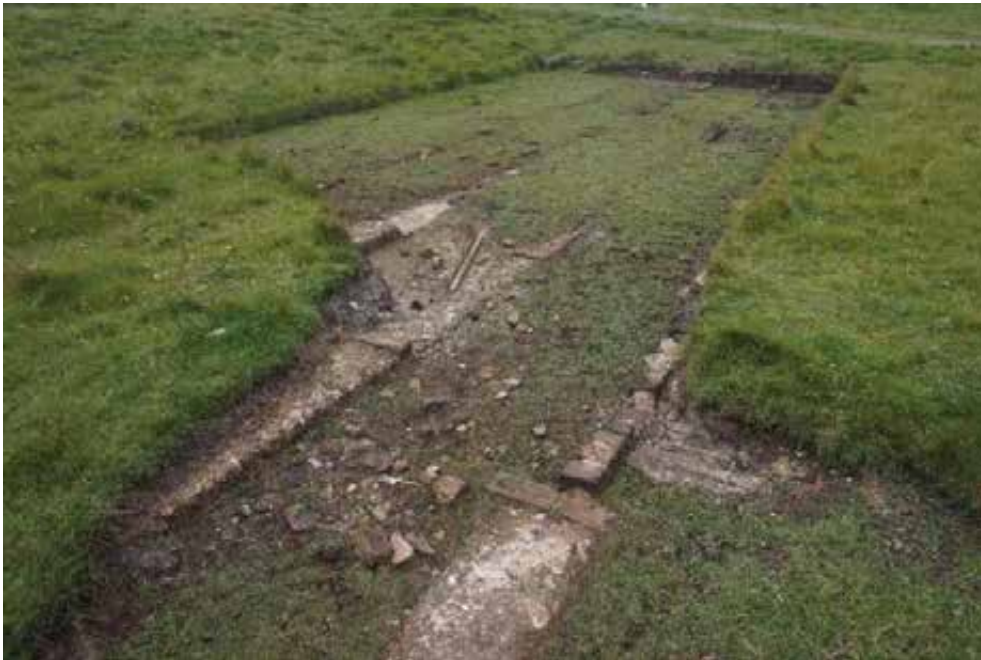
**Loose brick footings, disaggregated concrete strip foundations and displaced bricks, timber and metal work at southern portion of the structure.**

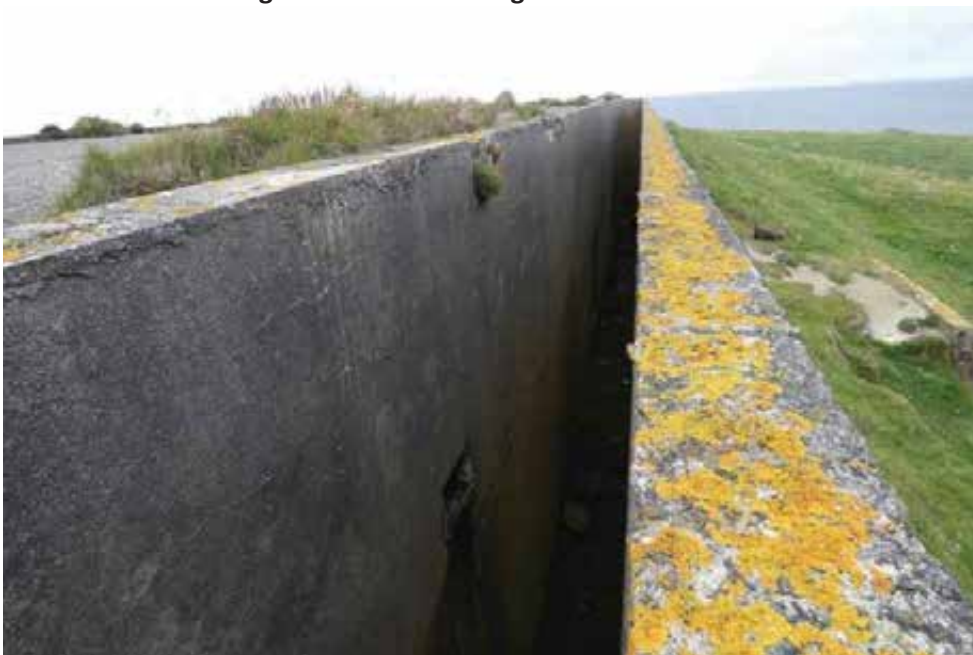
2.

From the top of the embankment looking down into the gap between blast wall and building. The discharge point from the rainwater roof outlet can be seen partway down the wall of the building. Vegetation growing from this outlet is blocking it.

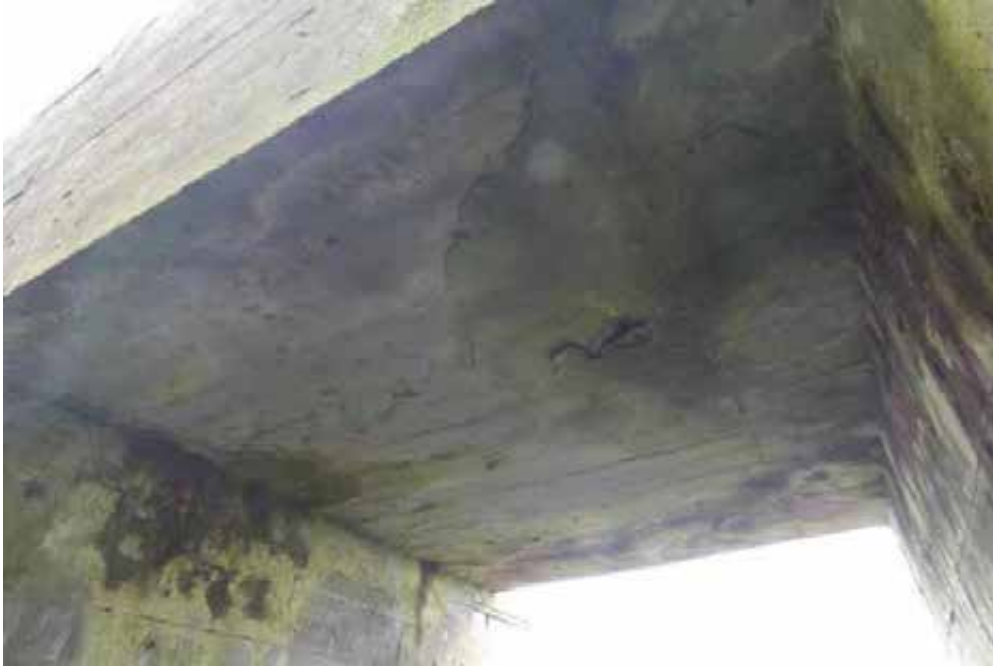
8.

Spalling concrete and render finishes from the soffit of an access tunnel roof.

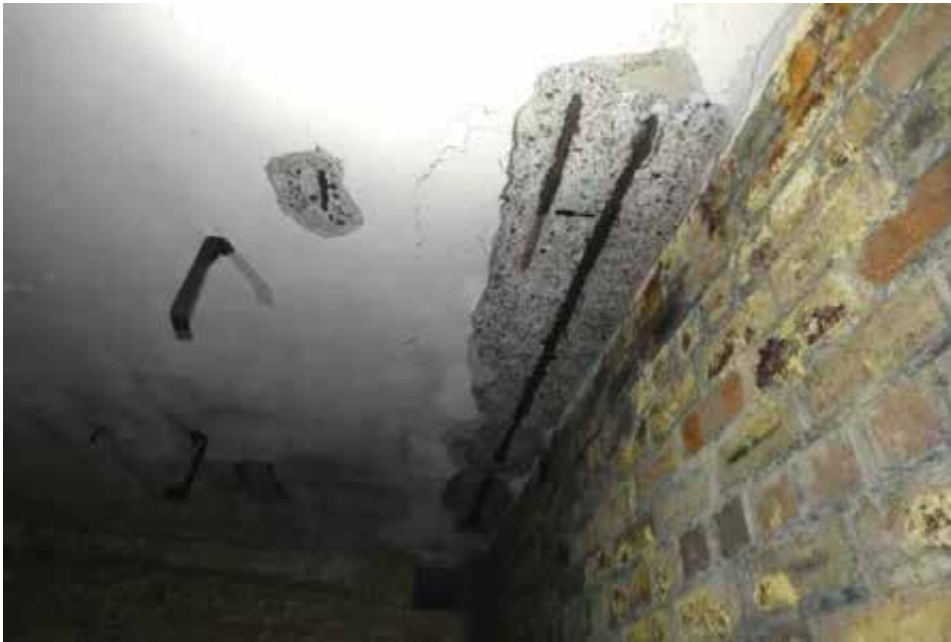
14

In places, expansive corrosion of reinforcement is causing spalling of concrete from roof soffit.

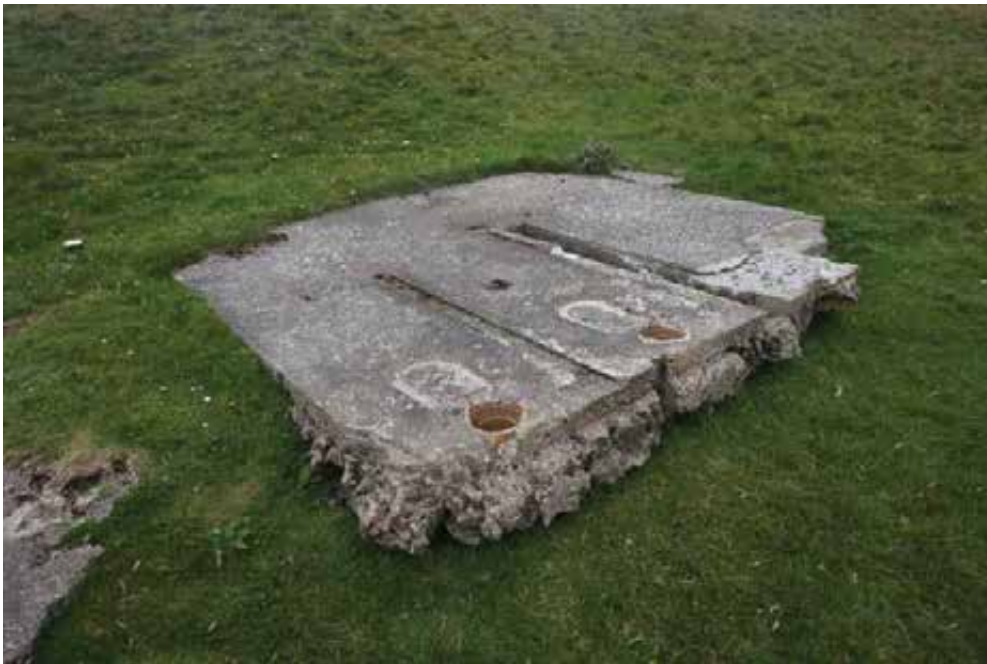
**2**

**East concrete base with spalling upper face.**

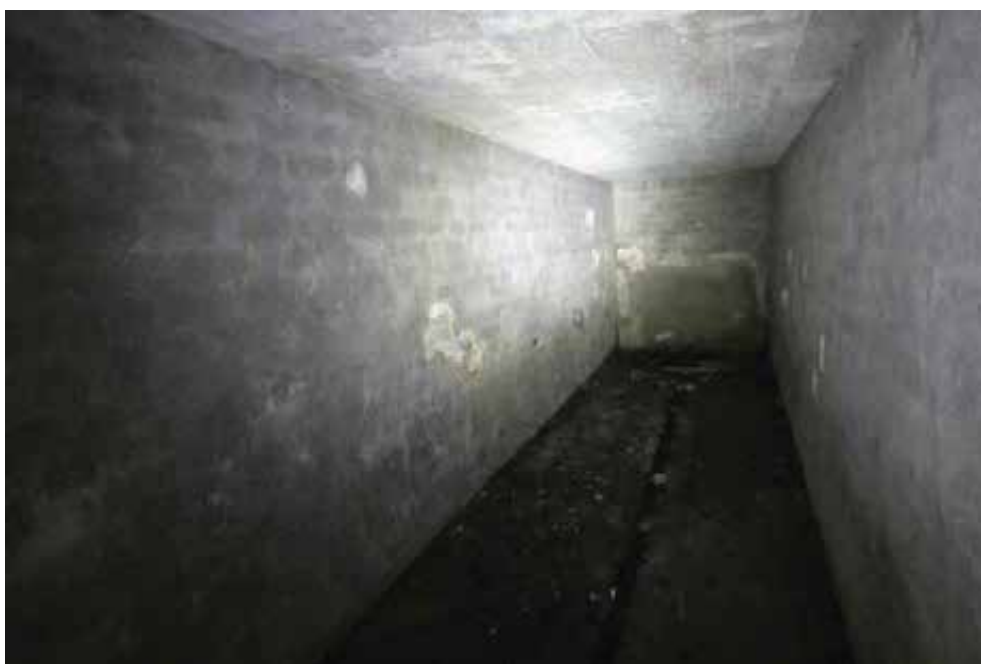
4

**Localised failing render internally.**

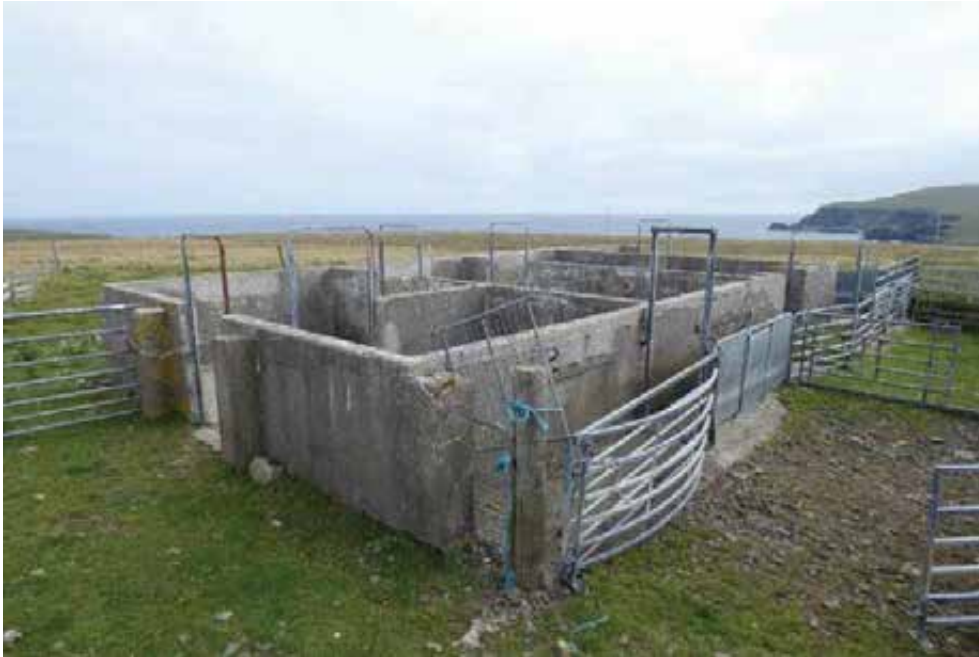
**1**

**View from northwest. Walls have been lowered, with rendering patch repaired and gates inserted to accommodate agricultural use.**

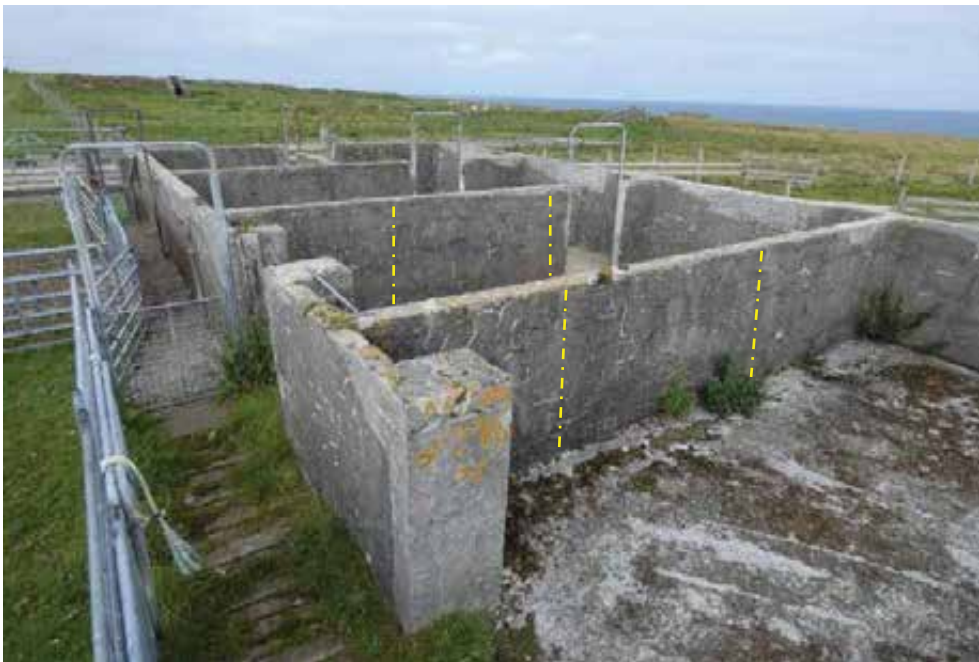
**2**

**The cement render is extensively cracked and in some areas is supporting vegetation growth. The concrete floor has minor disaggregation and is supporting vegetation growth. The relatively long and slender internal partition walls depend on the integrity of the mortar in their bed joints for their stability. The robustness of these walls can be increased with the introduction of new buttresses at key points (indicated)**

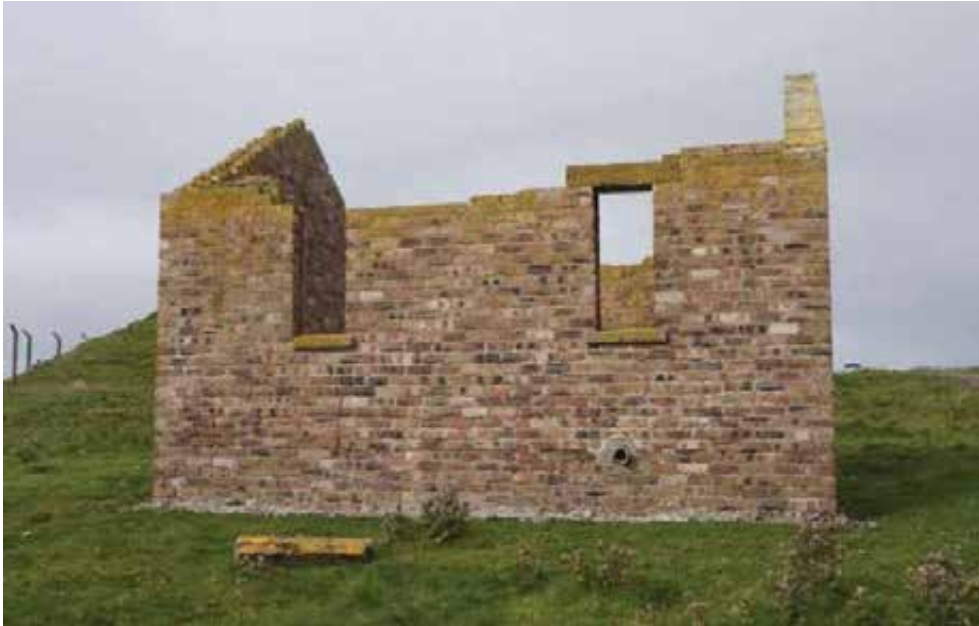
**1**

**East elevation with dislodged lintol and fallen wallhead brickwork. To prevent ingress into the cavity, consider resetting the lintol and brickwork to allow the wallhead to be capped in concrete.**

3.	To minimise future water ingress into cavity, replace missing and damaged concrete cappings to gables, and consider resetting lintol and fallen brickwork to elevations and thereafter capping wallheads in concrete. <b>£3000.00</b>		Necessary.

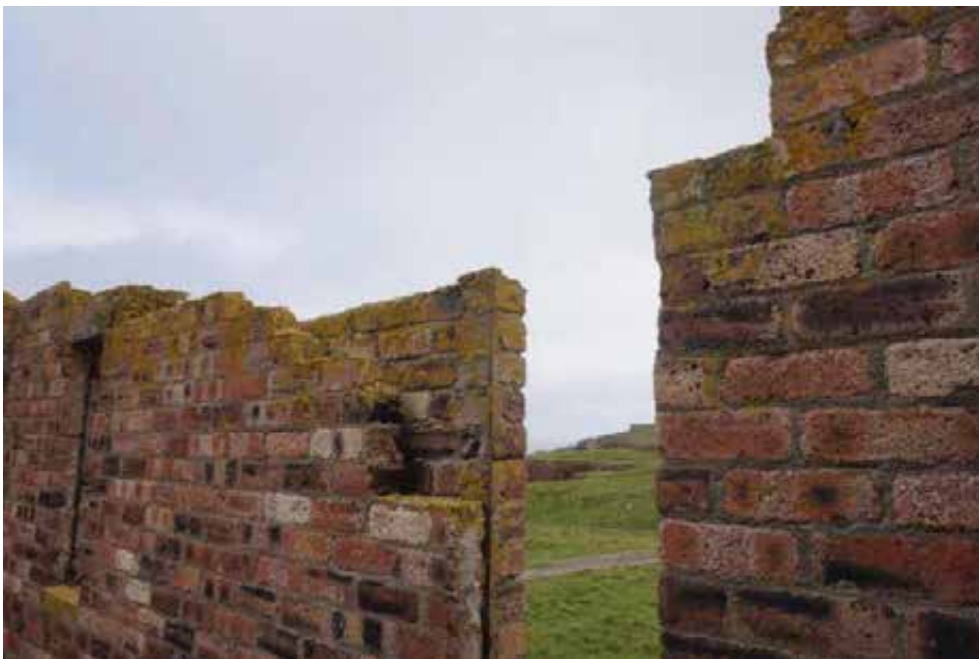
**2**

**East elevation (internal) with dislodged lintol and fallen wallhead brickwork. To prevent ingress into the cavity, consider resetting the lintol and brickwork to allow the wallhead to be capped in concrete.**

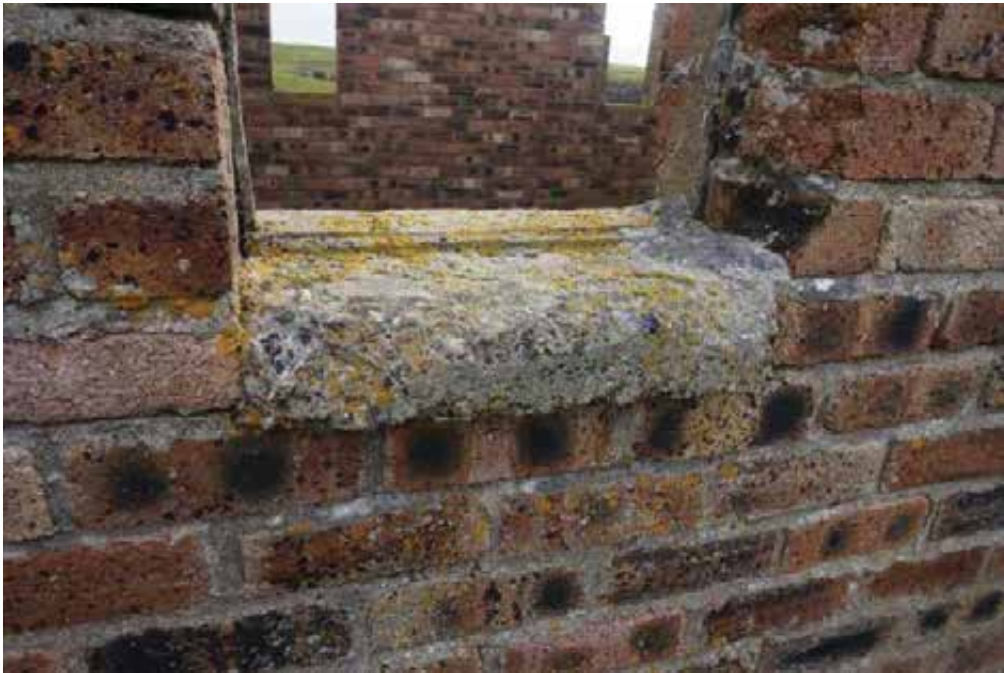
7

**Disaggregating concrete cill.**

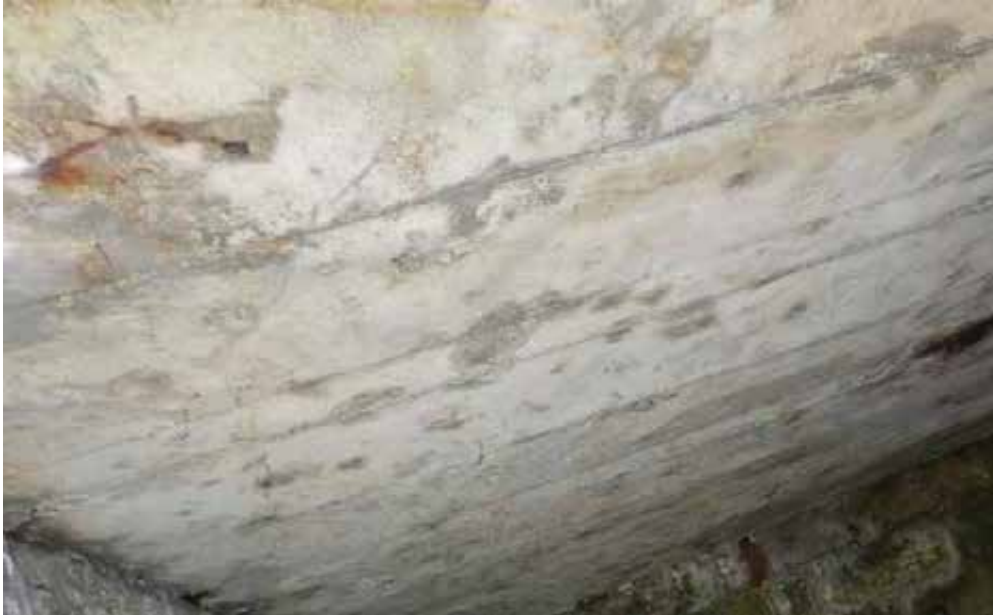
3

**Minor spalling and exposed reinforcement.**

1.	Record and monitor condition of concrete roof. Repoint failing joints around wallhead of curved end. <b>£100.00</b>	Desirable	
2.	Clean out all flood water and debris and clean internal surfaces of the structure. Establish management policy for regular removal of water from inside the structure. Not costed.	Necessary
