# Appendix 14.9 Data Interpretation Strategy

# Appendix 14.9 Draft Heritage Interpretation Strategy

## **4.2 Condition Survey**

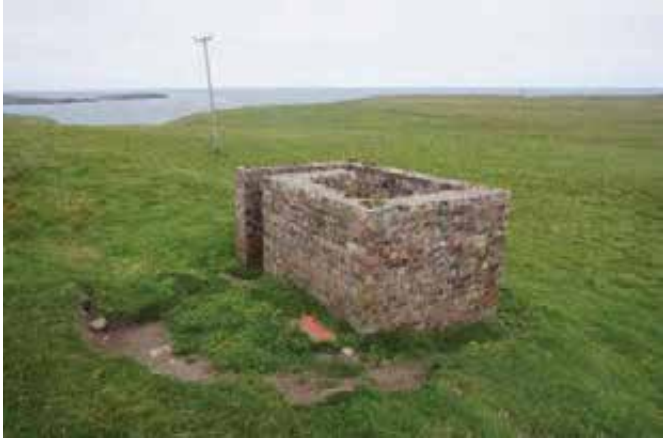
<b>Site No.</b>	71	<b>Site Name:</b>	Possible air raid shelter
<b>Description:</b>		<b>General Photograph:</b>	
<p>1.5 brick thick, part earth retaining brickwork, bedded in cement based mortar. Exposed brickwork up to c.1.2m high. Visible 'frog' marks on upper mortar bed indicate the structure was previously higher. Assumed built from concrete strip foundation. Internal 'floor' covered with soil, animal faeces, grass and displaced bricks.</p>

<b>Condition:</b>			
<p>Fair: Minor localised open, cracked and failing mortar joints, including to exposed wallhead which is supporting vegetation growth. Minor localised damaged bricks. Structure is not plumb or level indicating subsidence but appears stable as no structural cracking visible.</p>			
<b>Recommendations:</b>			<b>Priority:</b>
<b>1.</b>	Repoint open and defective joints, especially skyward facing joints. <b>£200.00</b>		Desirable

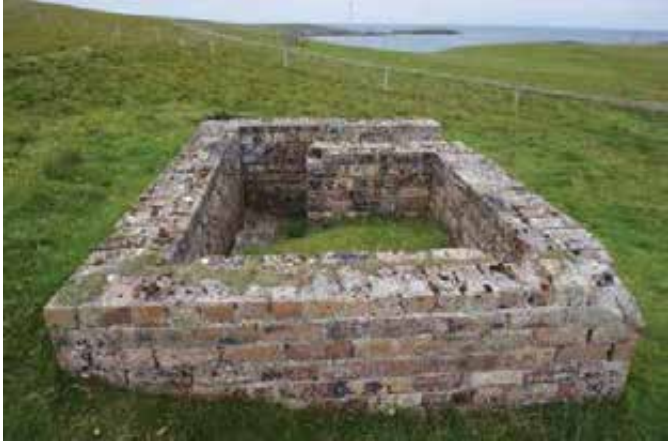
<b>Site No.</b>	72	<b>Site Name:</b>	Possible air raid shelter
<b>Description:</b>		<b>General Photograph:</b>	
1.5 brick thick, part earth retaining brickwork, bedded in cement based mortar. Internal exposed brickwork up to c.1.0m high. Assumed built from concrete strip foundation. Internal 'floor' covered with soil, grass and displaced bricks and concrete.

<b>Condition:</b>			
Fair: Localised open, cracked and failing mortar joints throughout, including to exposed wallhead which is supporting vegetation growth. Damaged and missing brickwork to wallhead.			
<b>Recommendations:</b>			<b>Priority:</b>
1.	Repoint open and defective joints, especially skyward facing joints. Consolidate around damaged brickwork in southeast corner to minimise risk of further loss in this area. <b>£400.00</b>		Desirable

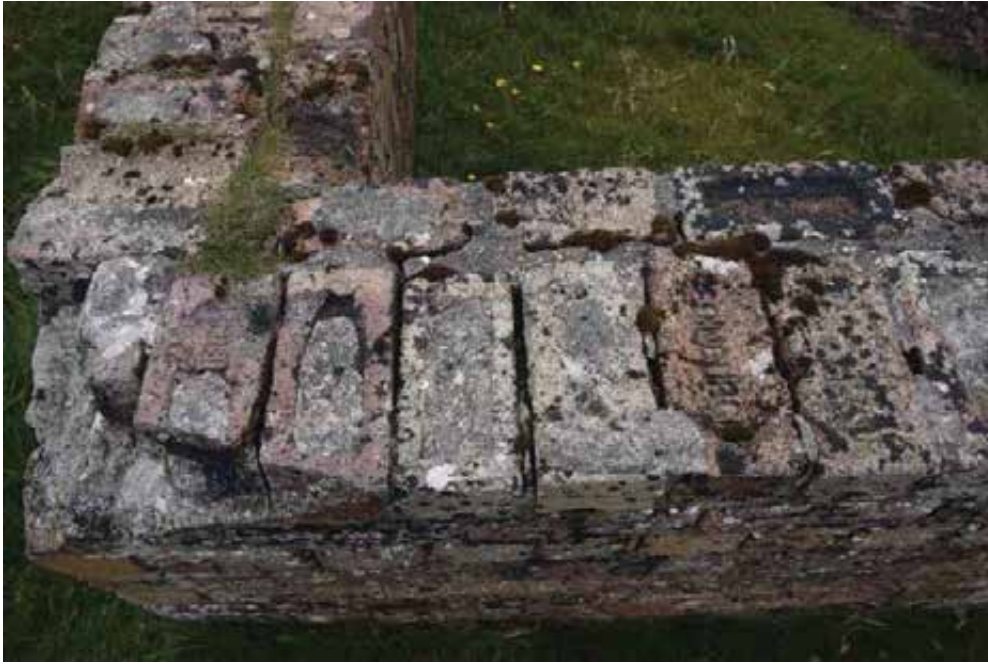
**1**

**Open and defective wallhead joints and damaged brickwork in southeast corner.**

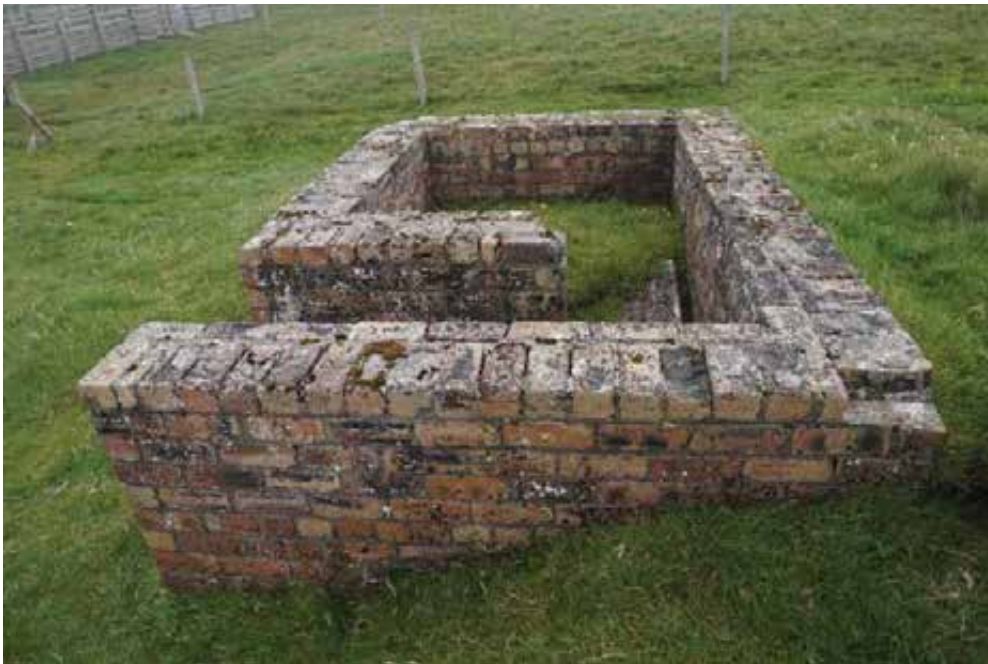
**2**

**North Elevation: Missing and damaged brickwork and defective mortar joints.**

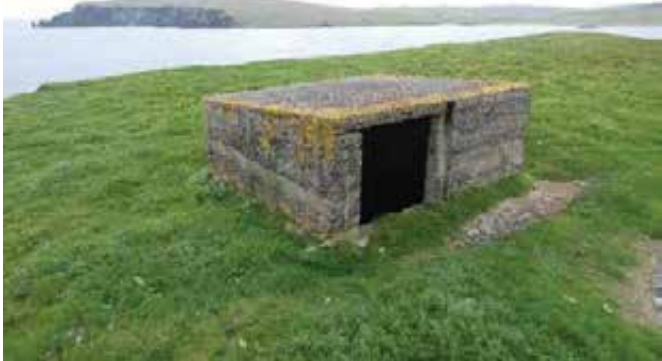
<b>Site No.</b>	74	<b>Site Name:</b>	Gun and Crew Shelter
<b>Description:</b>		<b>General Photograph:</b>	
<p>Reinforced concrete structure, cast insitu walls (part earth retaining) and roof slab. Entrance to north, small opening to south and roof vent. Floor construction obscured by flooding. Embedded timber externally to left of entrance and internally. Concrete hardstanding at entrance partly covered with soil and grass.</p>

<b>Condition:</b>			
<p>Fair: Constructed with poorly mixed and compacted concrete with cracking visible at lift lines approx. mid point of external walls and at roof junction. Structurally stable. Localised disaggregation and surface loss externally. Poor coverage to reinforcement causing localised spalling and rusting staining to roof structure. Leaching saturation and damp staining internally, exacerbated by the flooded floor. Lichen growth externally.</p>

<b>Recommendations:</b>			<b>Priority:</b>
1.	<p>Record and use as basis for regular inspection to assess future changes in condition. Clean out all flood water and clean internal surfaces of the structure. Establish management policy for regular removal of water from inside the structure. (not costed).</p>		Necessary

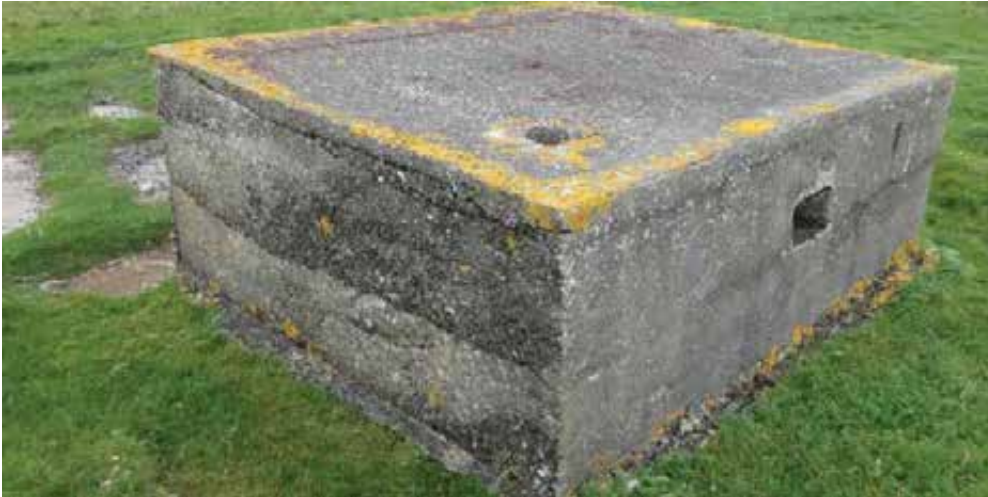
1

**Cracking at lift lines on external walls and at the junction with the roof slab. Poorly mixed and compacted concrete with minor surface disaggregation, cracking and spalling. Lichen growth on all faces.**

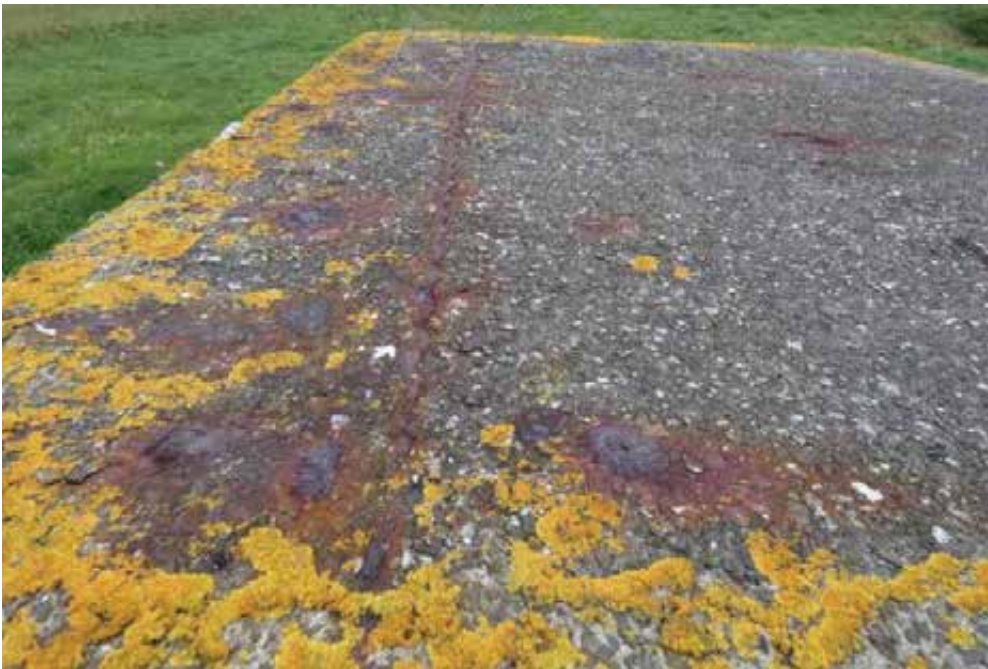
**Poor coverage has exposed reinforcement externally on the roof slab.**

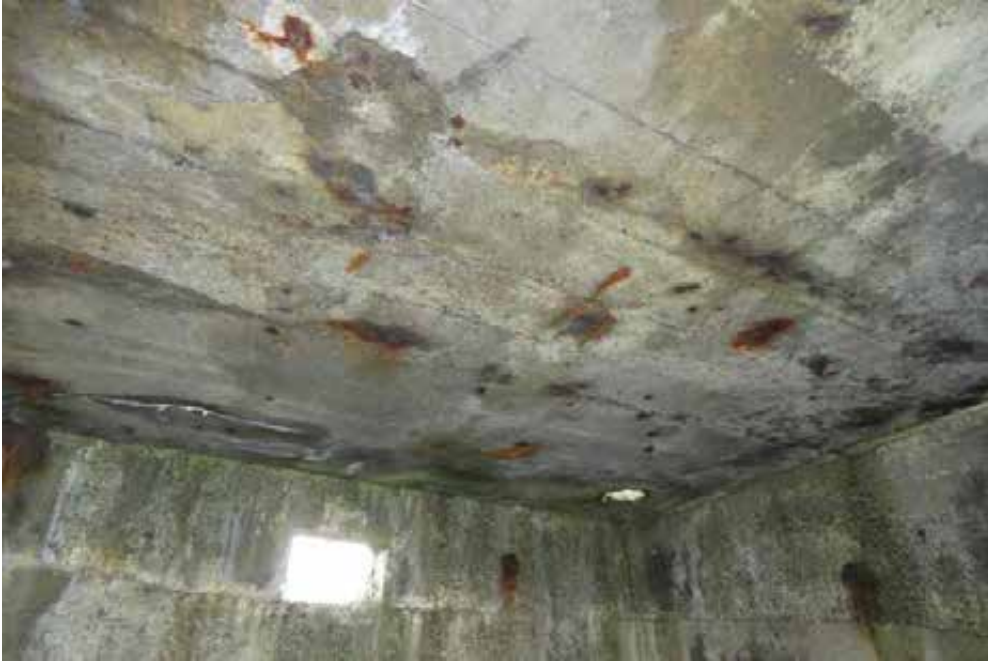
**Hairline cracking, rust staining, leaching and discolouration to the soffit of the roof structure.**

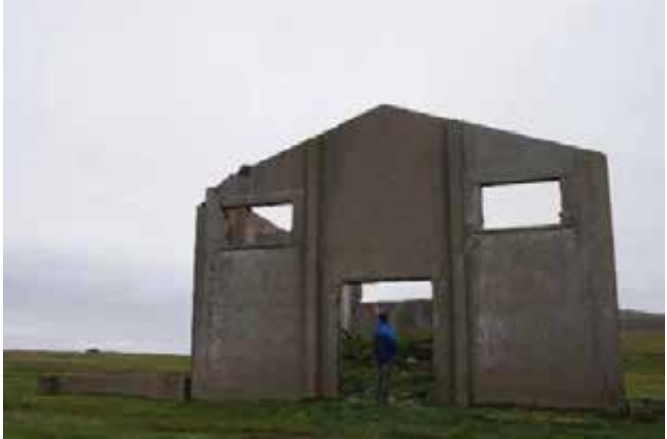
<b>Site No.</b>	77	<b>Site Name:</b>	Power House
<b>Description:</b>		<b>General Photograph:</b>	
<p>Cement rendered one-brick-thick brick-masonry walls with external and internal piers, the latter appear to have been built to support steelwork carrying an unknown intermediate structure, now removed or buried under collapse debris. The roof structure has collapsed but can be seen to have comprised steel Fink-type trusses spanning onto the external walls. Rendered lean-to extension to east elevation and three concrete bases with rendered brick perimeter footing to the south. Precast reinforced concrete window cills and lintels. North facing and lean-to windows have been infilled with concrete blocks. Evidence for steel framed windows in openings. Internal floor obscured by accumulations of soil, animal faeces, grass and the collapsed steel roof structure and asbestos cement roof finish.</p>

<b>Condition:</b>			
<p>Poor: The roof has collapsed. All the walls exhibit significant cracking to such an extent that all the walls are free-standing with no continuity across corners or within individual masonry panels surrounding window and door openings. As such, the walls are not stable in a manner that could be considered robust in any way and it may only be a short time before a collapse occurs. The upper part of the west wall has already collapsed, the survival of its lower part perhaps attributable to the depth of material that has accumulated internally and rests against the wall.</p> <p>The building in its present condition is dangerous. Access into and about the building should be prevented, with a safe perimeter created around the building at a distance from it at least as far as the walls are high.</p> <p>It was not possible to determine the actual condition of the brickwork masonry itself. Given that it is rendered on both faces it may be in a reasonable condition. However, given observations made on other cavity-walled brick-masonry buildings elsewhere about the site it is not possible to be confident of its original build quality.</p> <p>In addition to the structural instability of the building the presence of asbestos within the collapse debris inside the building was obvious.</p> <p>Concrete bases are sound.</p>

<b>Recommendations:</b>			<b>Priority:</b>
1.	<p>Prevent access to minimise health and safety risk.</p> <p>Create a perimeter around the building at a distance from it at least as far as the walls are high.</p> <p>Repair of the building may prove possible as long as a practicable and acceptable sequence of operations can be established that facilitate the safe removal of all asbestos and collapse debris from the interior of the building. This may well require the erection of a full temporary structure outside the building to support the walls whilst clearance is underway and to allow execution of permanent repair and enhancement to the surviving fabric.</p>	<p>Immediate if visitor activity increases.</p>

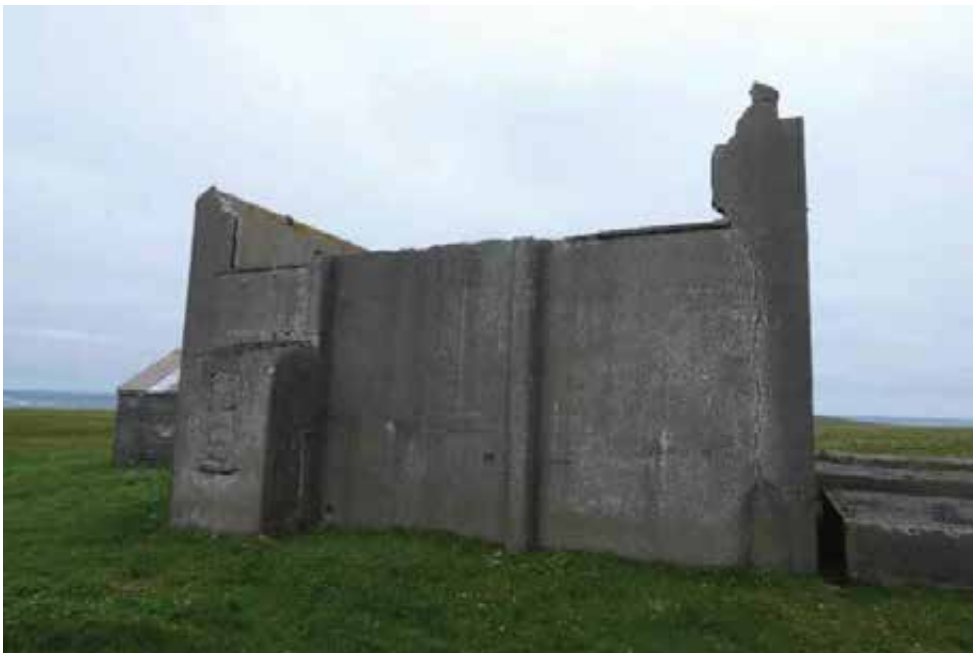
**2**

**West elevation. The triangular gable has collapsed, falling inwards. Note the full-height crack to the south corner: there is no continuity between the west or south walls – they are free-standing elements.**

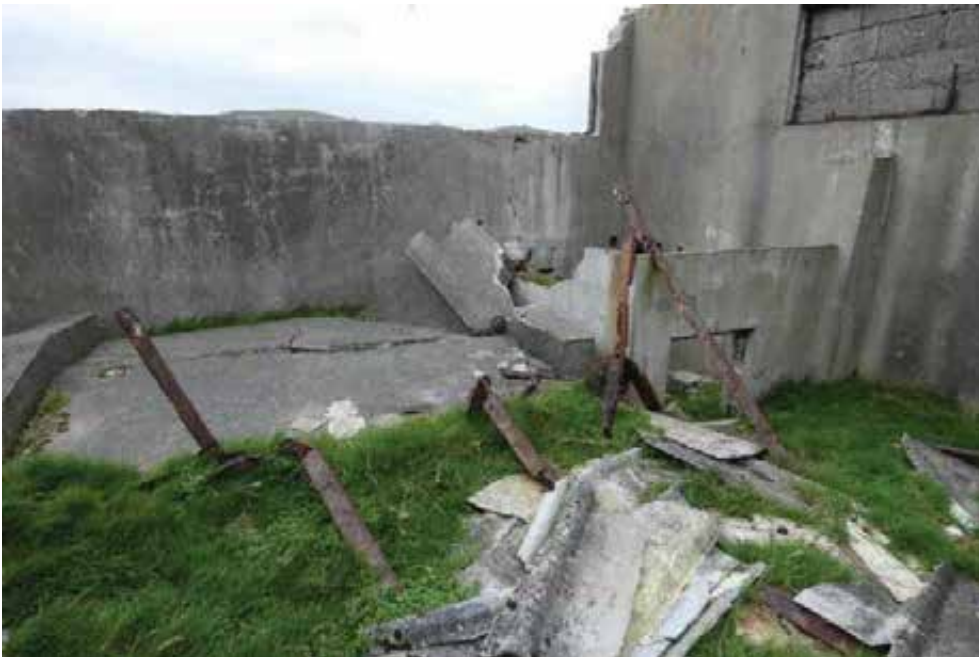
8

**Inside of the west gable. The collapsed upper section can be seen on the floor.**

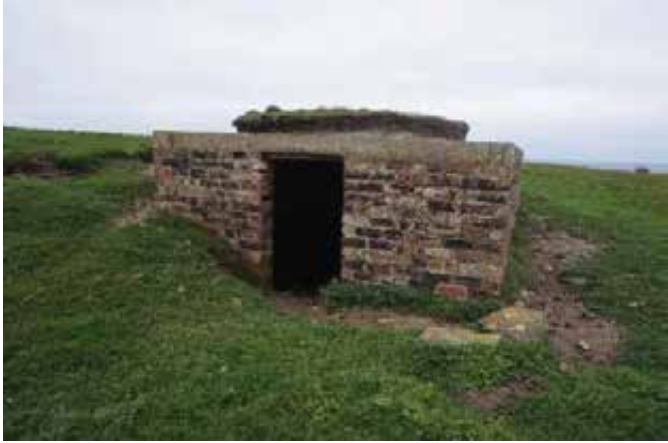
<b>Site No.</b>	78	<b>Site Name:</b>	Air raid shelter
<b>Description:</b>		<b>General Photograph:</b>	
<p>Single brick thick, part earth retaining brickwork, bedded in cement based mortar. Exposed brickwork up to c.1.0m high. Assumed built off concrete strip foundation. Internal 'floor' covered with soil, stones, mud and animal faeces. Reinforced concrete roof slab with central clay pipe vent. Roof partly covered by gravel, soil and turf.</p>

<b>Condition:</b>			
<p>Fair: Localised open, cracked and failing mortar joints throughout, especially immediately below roof slab on external faces where cracked and locally spalling brickwork was also observed. Internal brickwork damp and stained from saturated ground conditions, supporting moss and algal growth. Localised leaching on brickwork internally below roof slab. Rust staining to underside of roof slab, but structurally stable; no spalling concrete. Minor cracking to concrete externally immediately above junction with brickwork. Vent pipe blocked by soft capping</p>

<b>Recommendations:</b>			<b>Priority:</b>
1.	Repoint open, cracked and defective mortar joints, and cracked brickwork. <b>£500</b>		Desirable

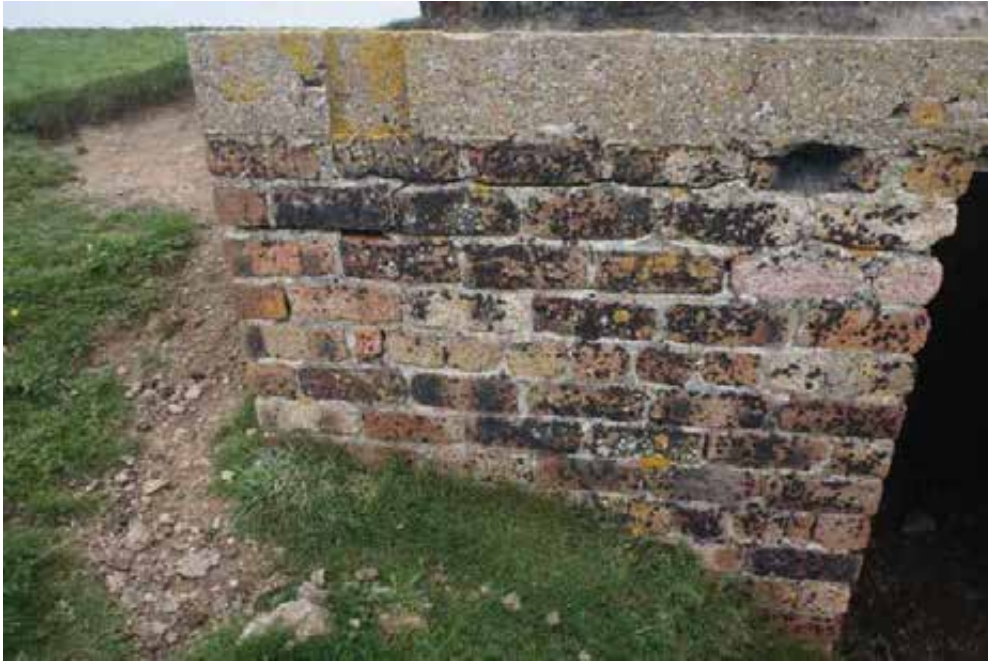
**1**

**Cracked and failing mortar joints, and localised damaged brickwork.**

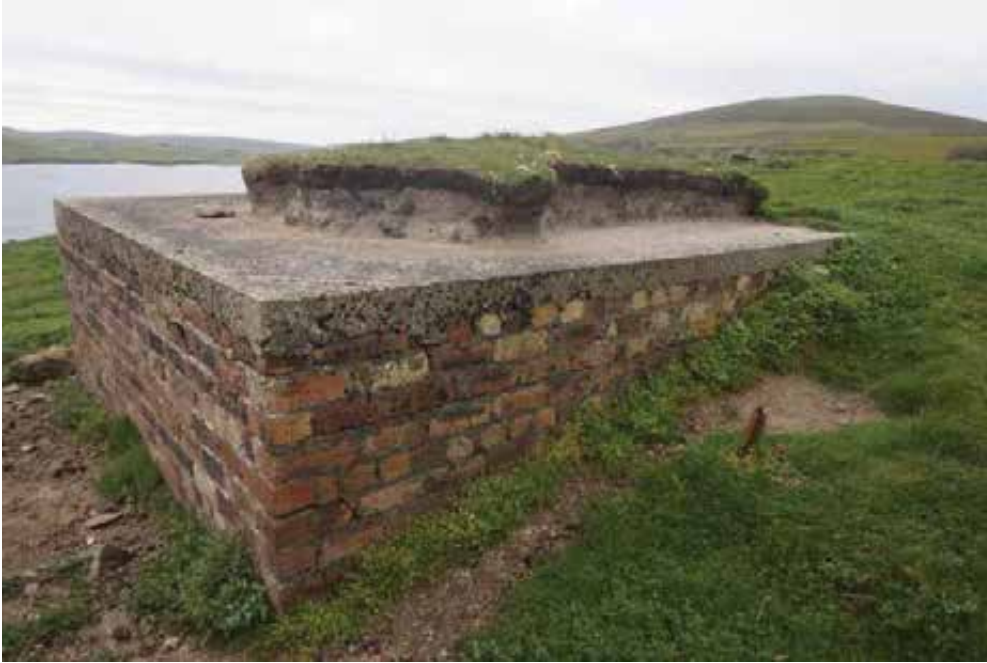
3

The worse affected areas are immediately below roof slab level, although repairs are required locally elsewhere. Cracked / open bed joints to the upper parts of the masonry are indicative of movement induced by drying shrinkage of roof slab.

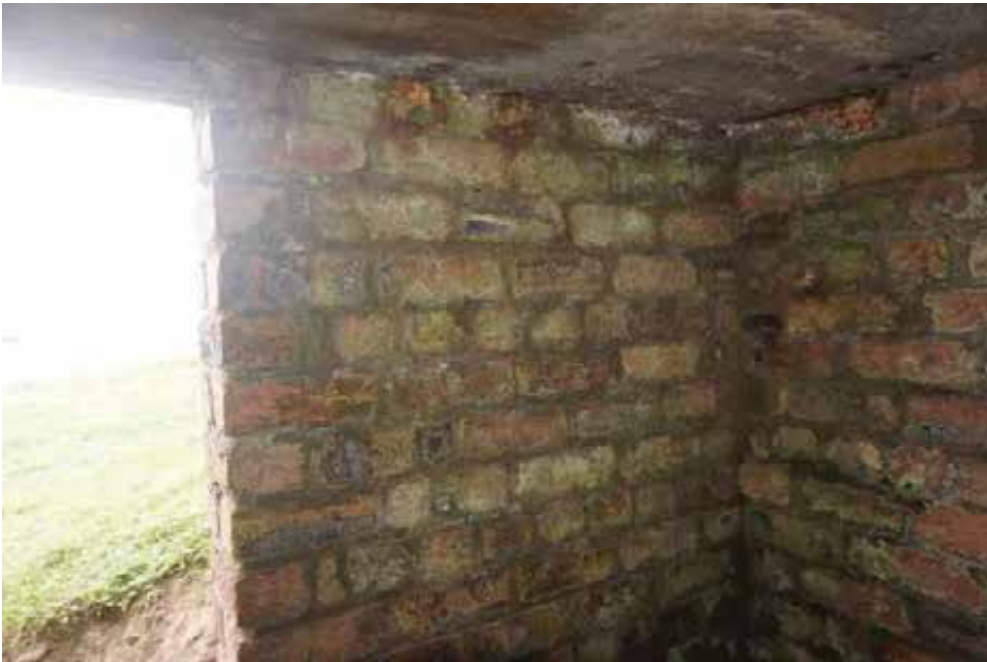
4

Localised leaching internally below the roof slab.

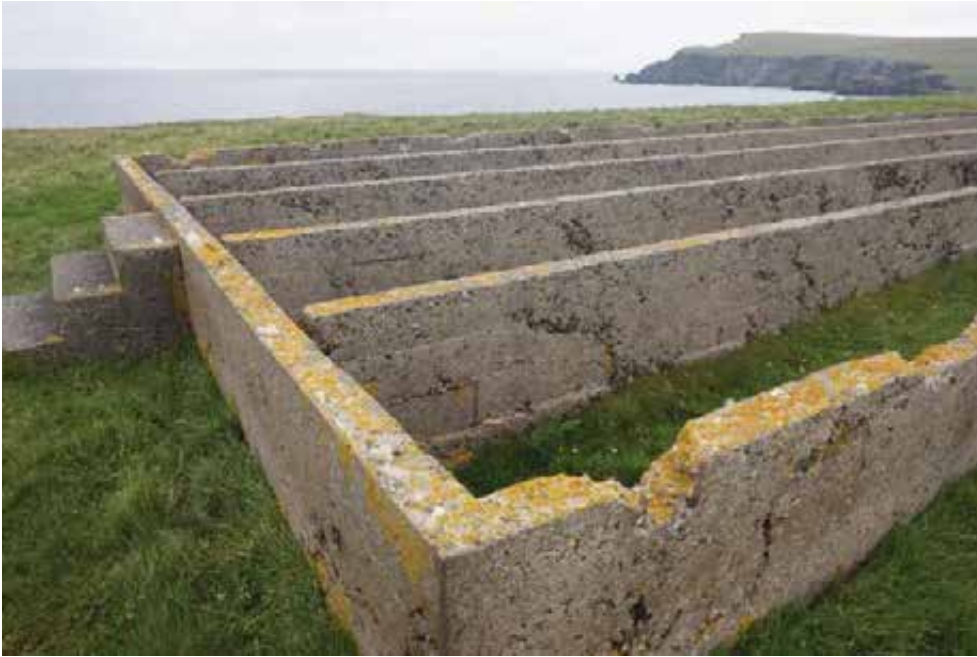
**1**

**Damaged concrete is limited to the perimeter walls, suggesting it was caused during demolition works and removal of the wallplate fixings or when the fixings corroded at a later date causing localised spalling. Note poorly mixed and compacted concrete.**

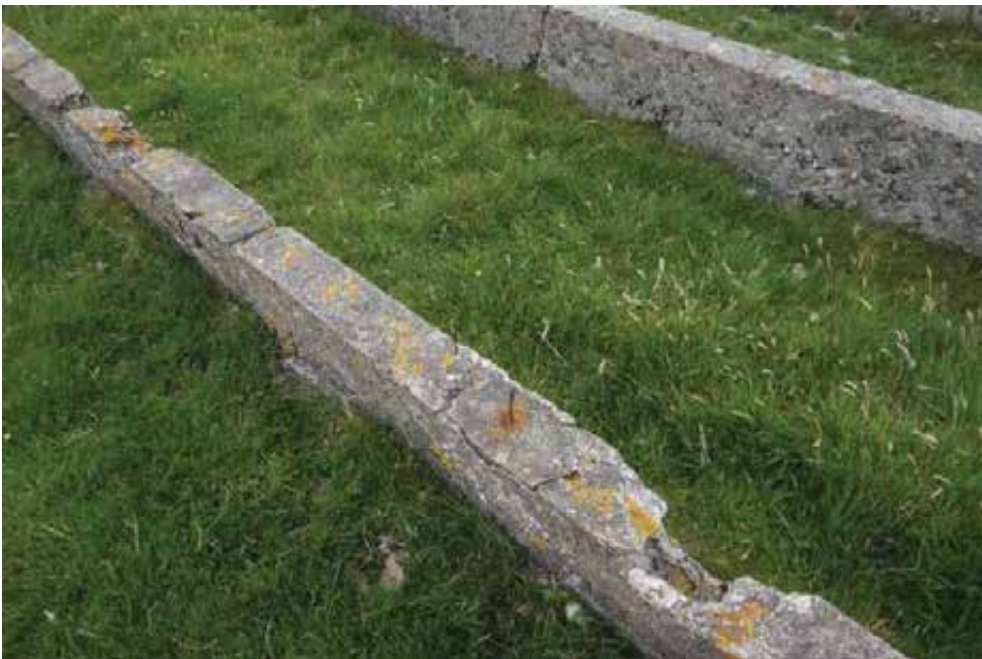
**2**

**Localised spalling where corroded wallplate fixings survive.**

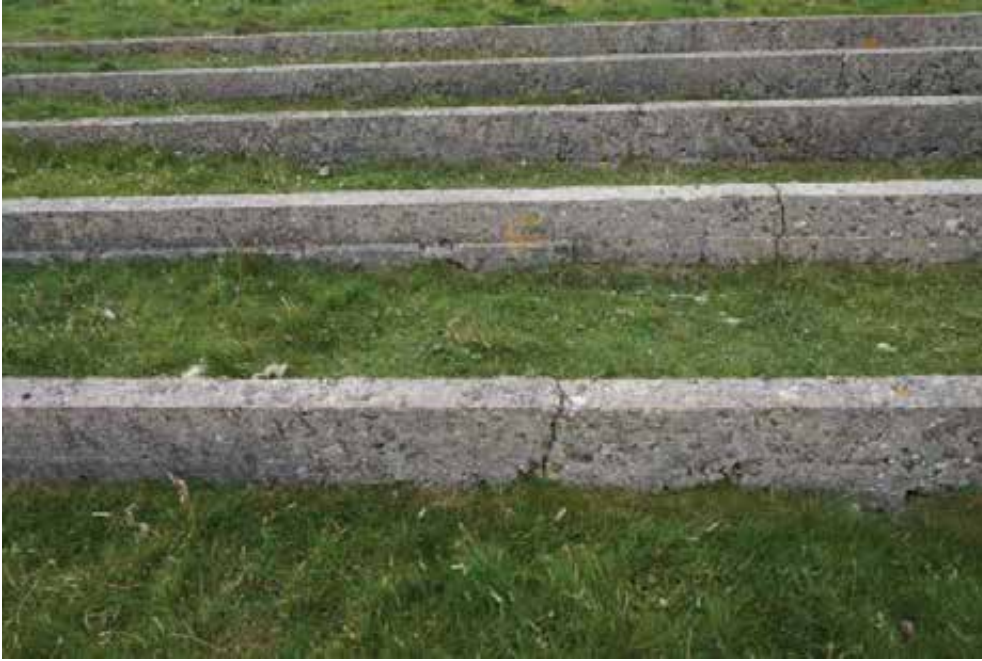
3

Despite the cracking which was observed throughout, the stability of the concrete walls appears unaffected.

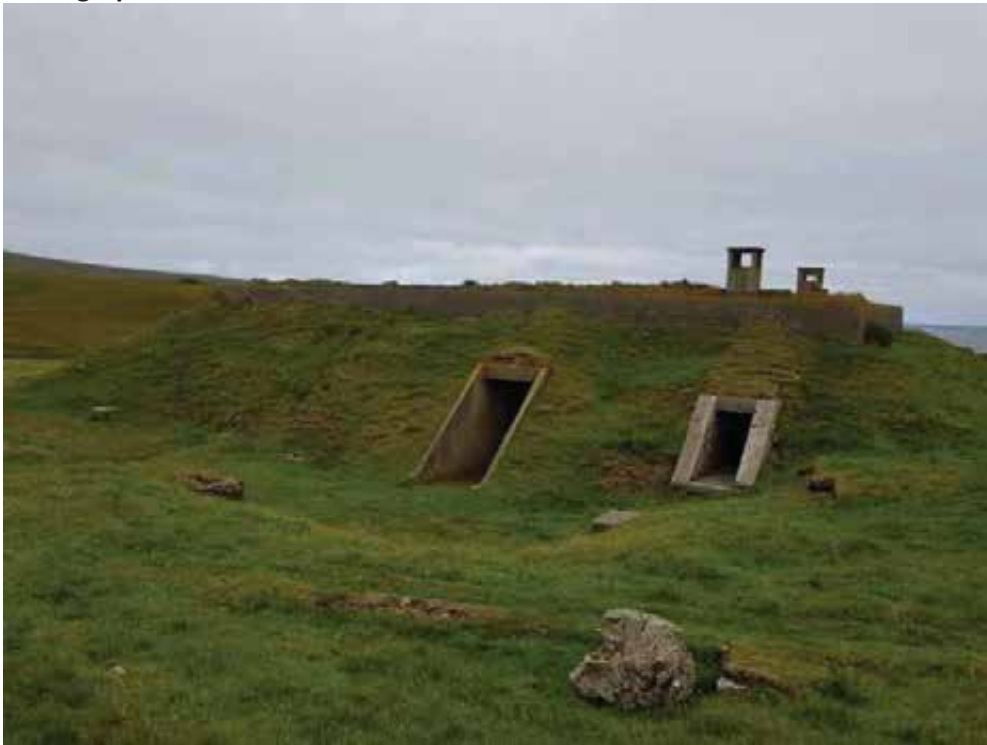
**1.**

**South side of the building. Note duct tunnel adjacent to entrance tunnel.**

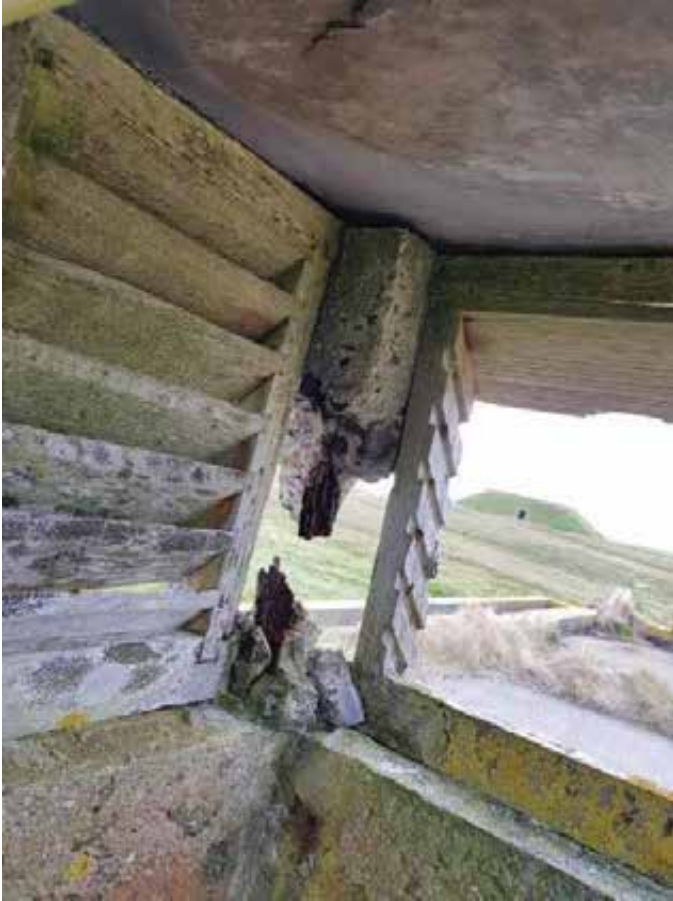
9.

From previous, inside chimney. Chimney is generally of brick construction with an RC base and cap. This leg of the cap is broken as a result of expansive corrosion of its reinforcement. As long as the roof slab is securely fixed to the surviving legs then no further action need be taken at this time.

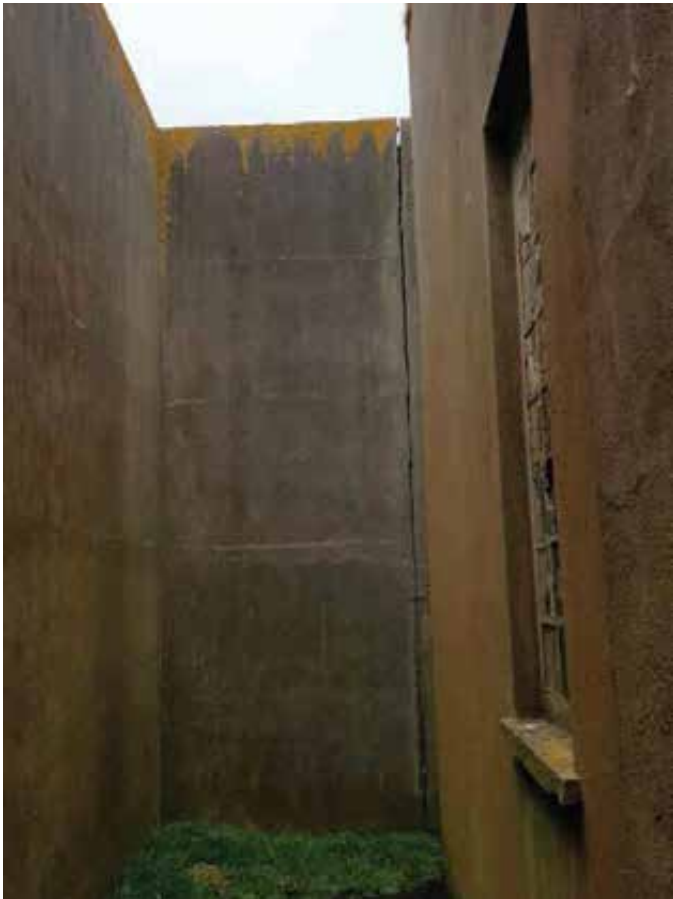
10.

Looking along the external perimeter. The crack in the blast wall seen in the distance may actually be a deliberate joint – possibly true for other similar apparent cracks. Uncracked cement ‘tell tales’ placed across these cracks suggest there has been no recent movement (tell tales are dated 1942)

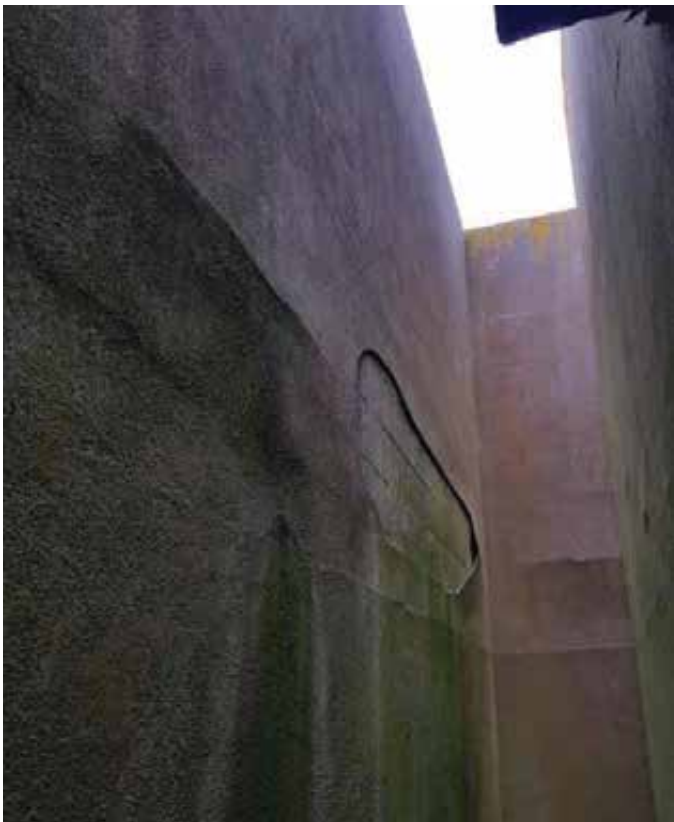
12.

**Note loss of render from face of blast wall.**

5.	Check all wall renders and ceiling plaster and remove all loose and boss material. Stabilise perimeters of areas of missing material to limit further loss of fabric. Cost £300.00	Necessary.

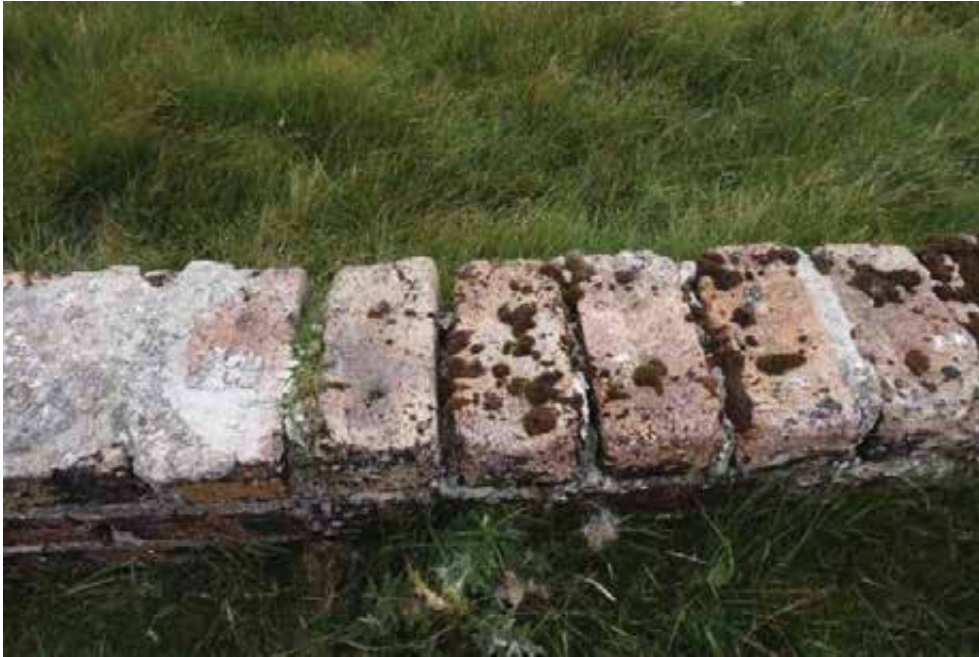
**1**

**Open and defective wallhead joints were observed throughout. Several localised loose bricks were found on all walls.**

6.	General – failing wallhead joints should be repointed and loose bricks rebedded in their current locations. There should be a presumption for retaining damaged bricks, with their longevity increased by ensuring surrounding joints are repointed and consolidated. Any badly damaged bricks should be replaced in suitably matching new or salvaged bricks. Do not disturb buried brickwork at western end of the structure. <b>£3500.00</b>	Necessary

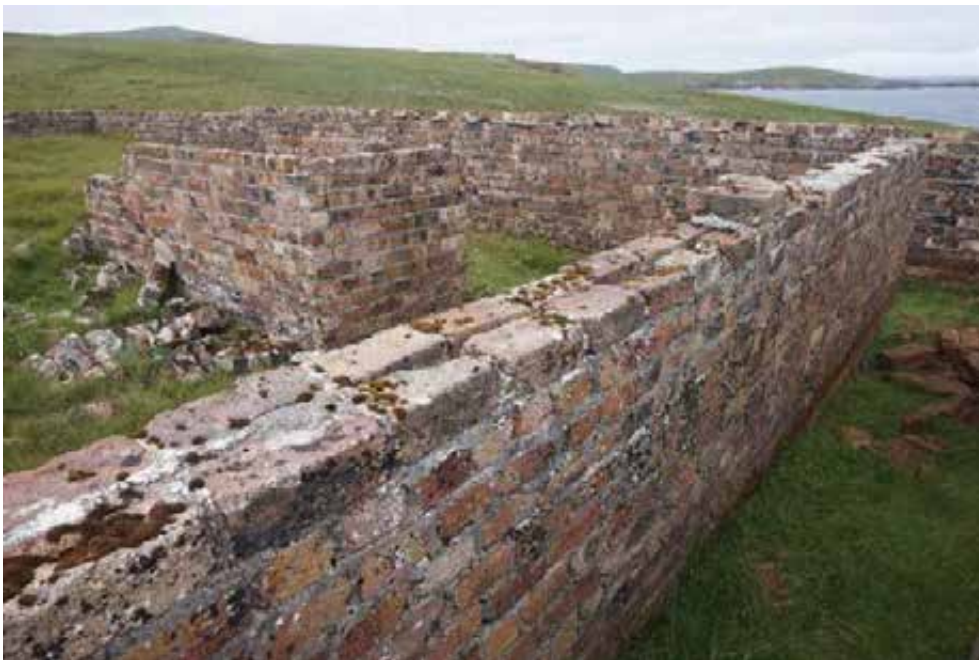
**2**

**Failing wallhead joints should be repointed and loose bricks rebedded.**

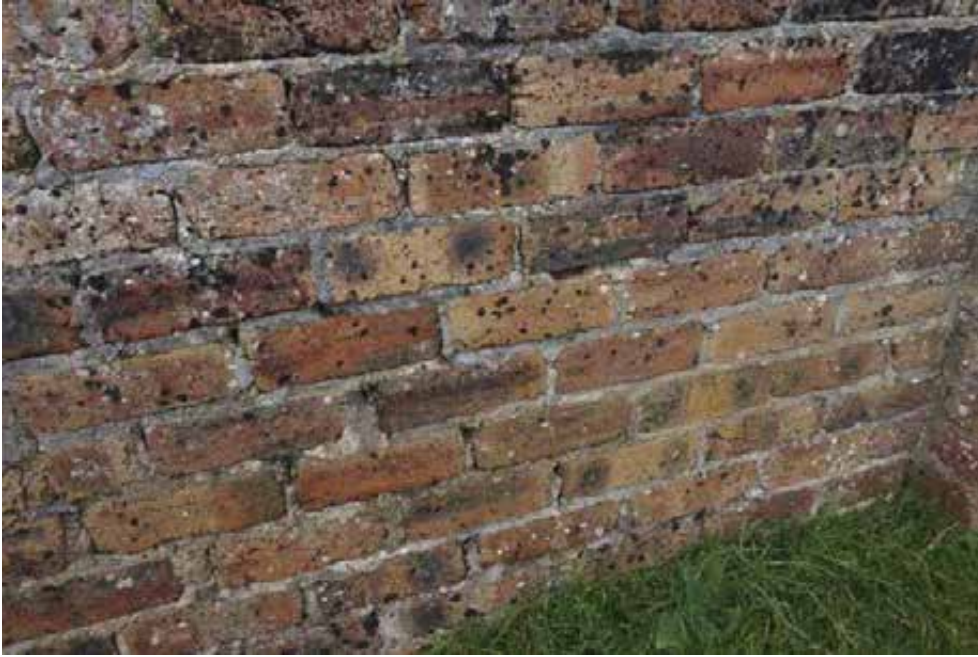
3

Localised open and failing joints visible on all wall faces.

7.	General – repoint failing mortar joints to wall faces. There should be a presumption for retaining damaged bricks, with their longevity increased by ensuring surrounding joints are repointed and consolidated. <b>£1500.00</b>	Desirable

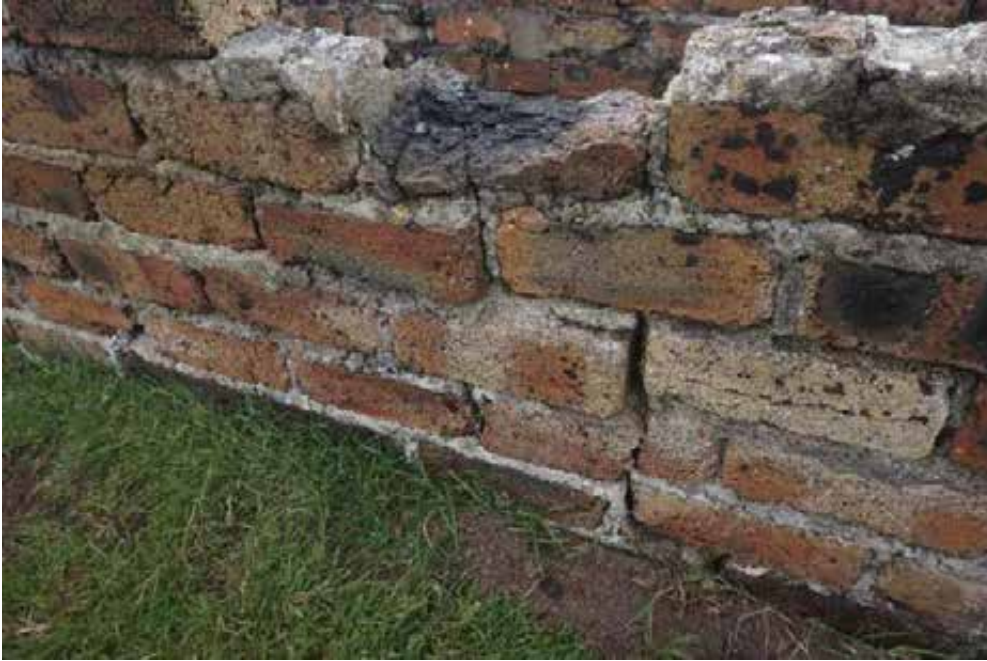
7

**Ideally, damaged wallhead brickwork should be retained, with failing surrounding joints repointed and consolidated to minimise future loss. However, localised removal and replacement of badly damaged bricks should be anticipated.**

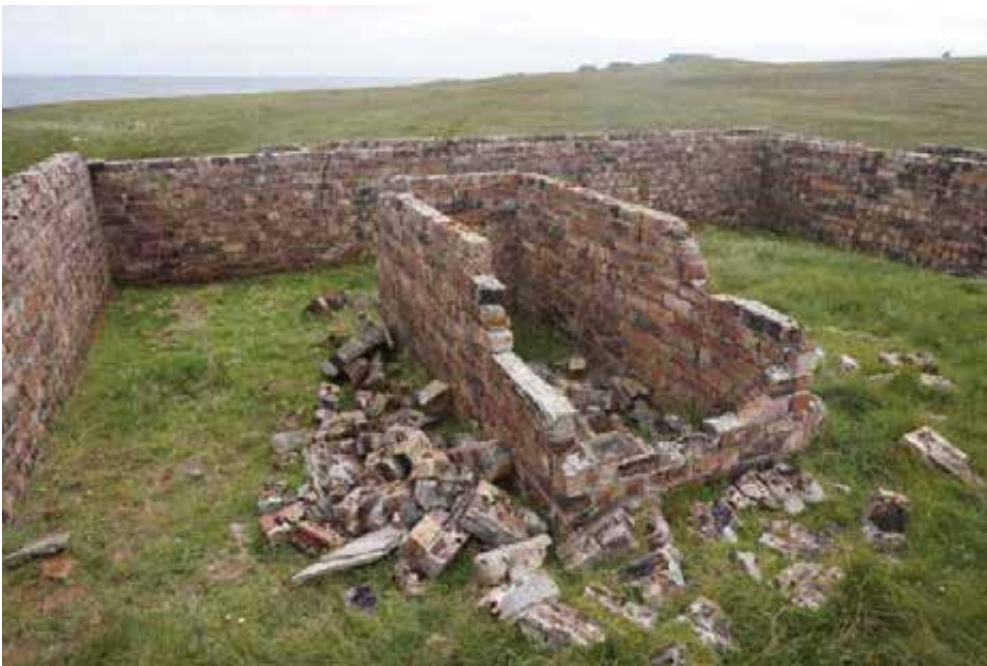
8

**After a full recording exercise, fallen and displaced brickwork should be removed to reduce health and safety risk if increased footfall to the site is anticipated in future. As with the other walls, intervention is required to make good defective joints and loose brickwork, especially to wallheads. The long walls do not have inherent stability generally. This issue should be addressed if increased footfall is expected.**

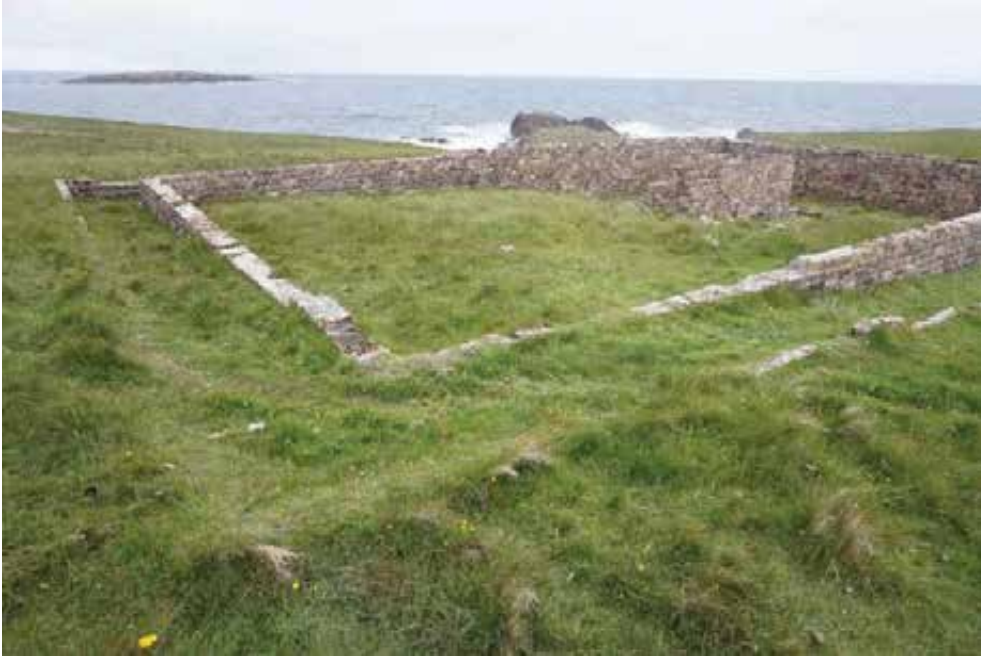
**Buried sections of brickwork should not be disturbed.**

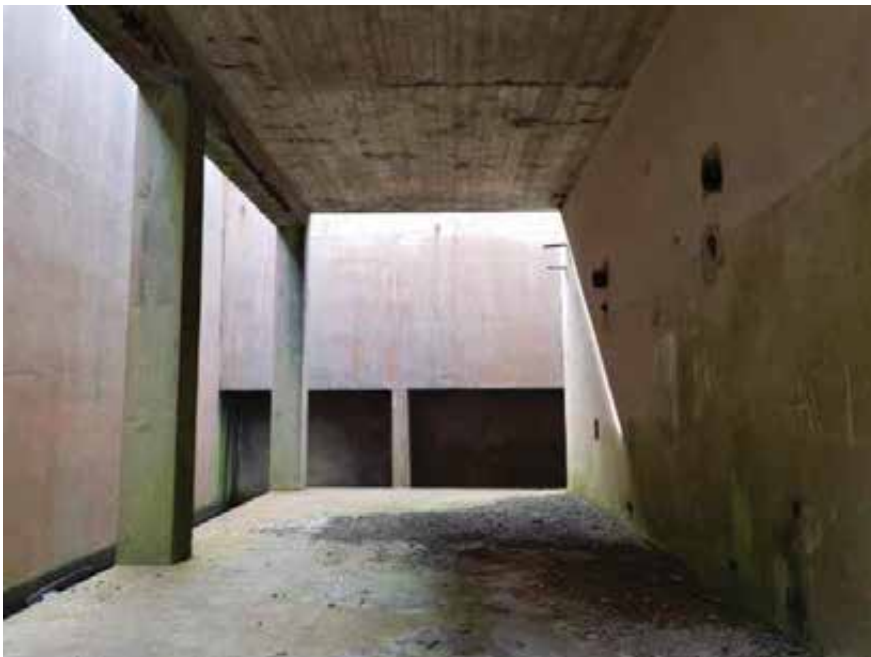
5.

Within the 'porch' to the side of the building. The RC roof slab of the building continues as the porch roof, carried by integral RC beams spanning between RC columns. The RC blast wall in the distance cantilevers over the spaces below. the left-hand (as seen) end of this wall is not connected to the incoming blast wall.

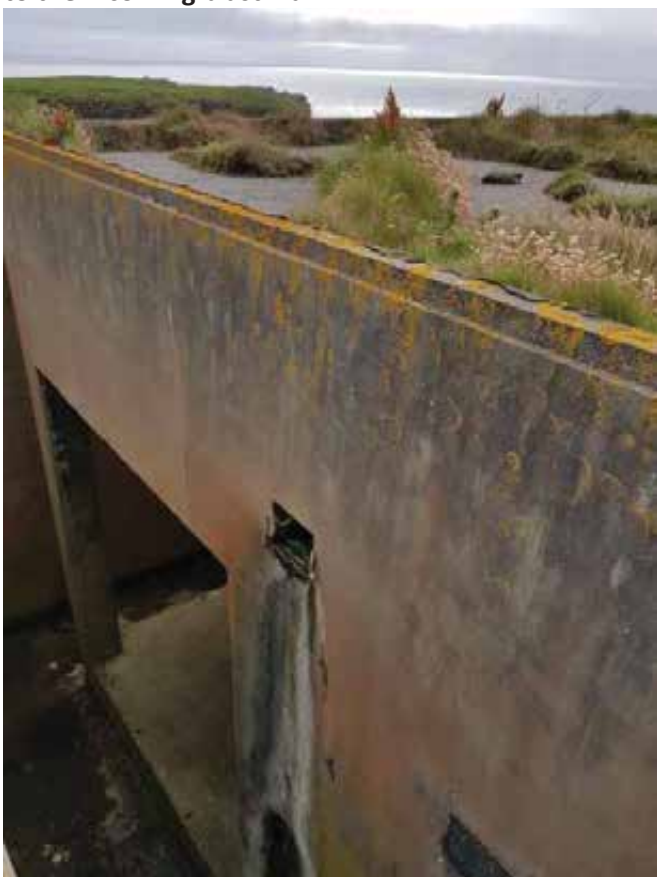
6.

Looking across the roof slab above a vertical rainwater outlet channel built into the wall. The outlet from the roof that feeds into this channel is overgrown with vegetation. Note the growth of vegetation generally across the roof – see next photo.

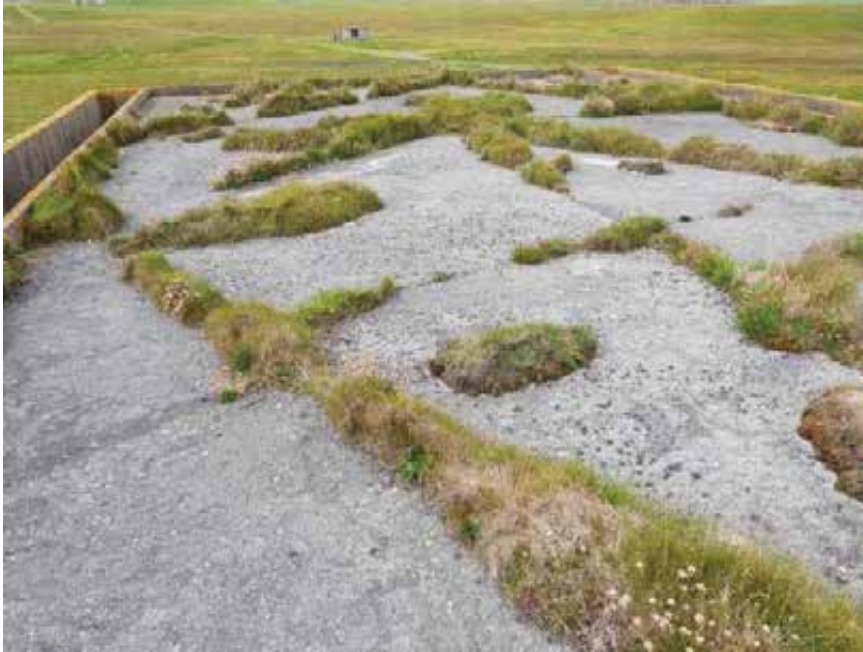
7.

General view across the roof. The roof is laid to falls. The original asphalt protective covering remains but in poor condition. The growth pattern in the vegetation is indicative of where the finishes are cracked and allowing greatest concentration of water ingress into the roof slab.

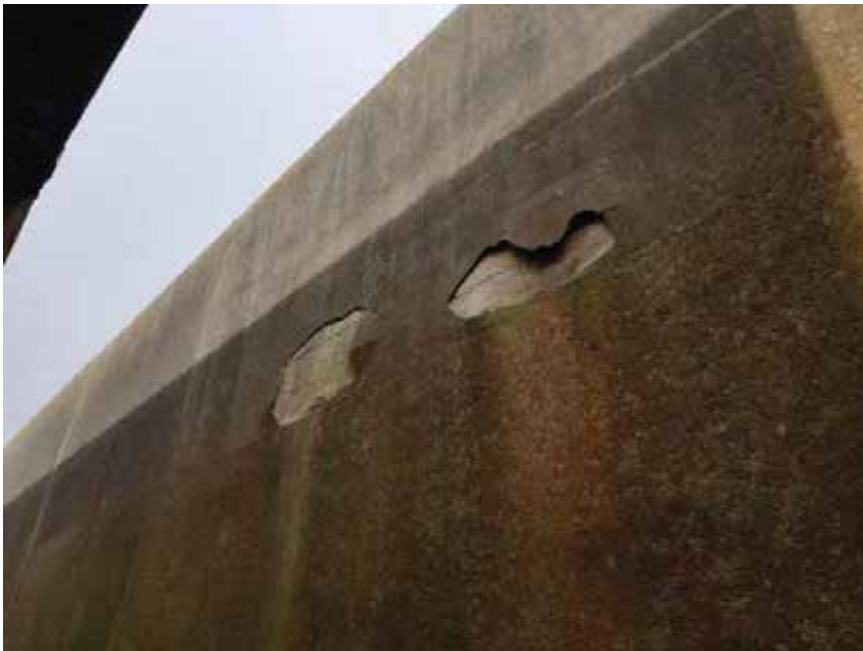
8.

Failing render from the faces of the RC blast walls. note the smooth surface of the exposed substrate, with no obvious formed key to receive the render.

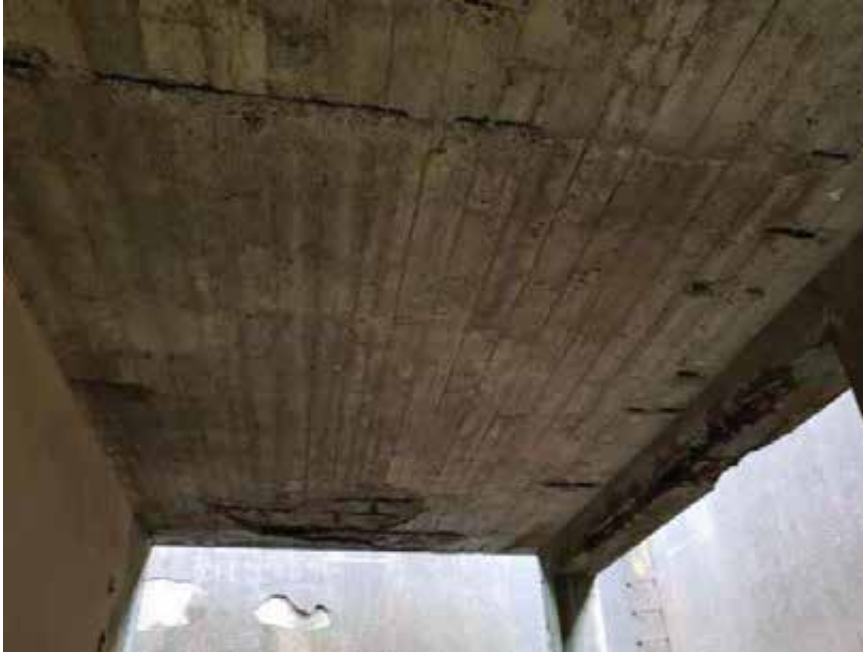
9.

**Underside of the porch roof showing areas of spalling concrete to the roof generally, concentrated at the downstand RC beams. This loss of concrete is attributable to expansive corrosion of the embedded reinforcement owing to uncontrolled water ingress throughout the concrete.**
