# Appendix 14.9 Data Interpretation Strategy

# Appendix 14.9 Draft Heritage Interpretation Strategy

## **4.2 Condition Survey**

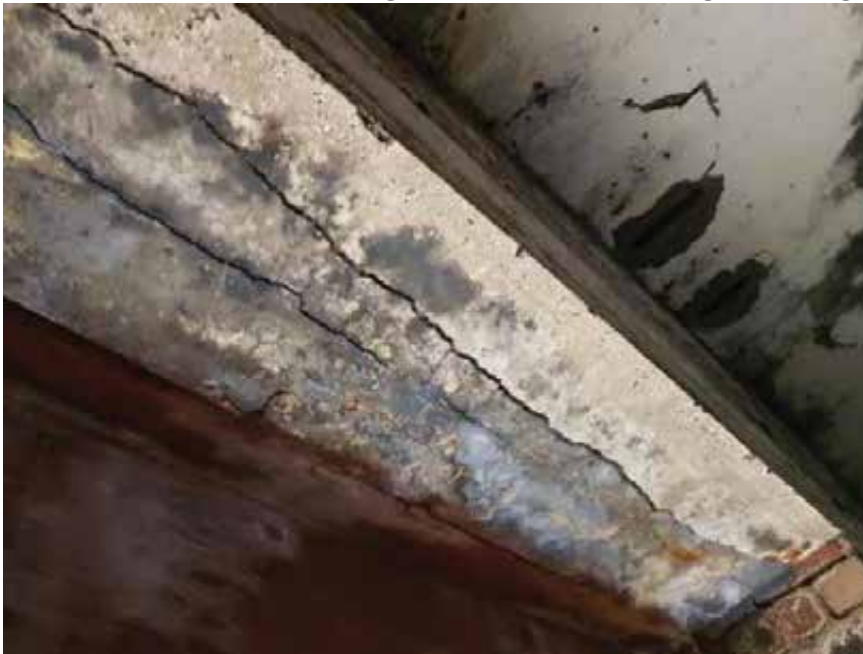
10.

**As previous – an RC lintel to the main entrance.**

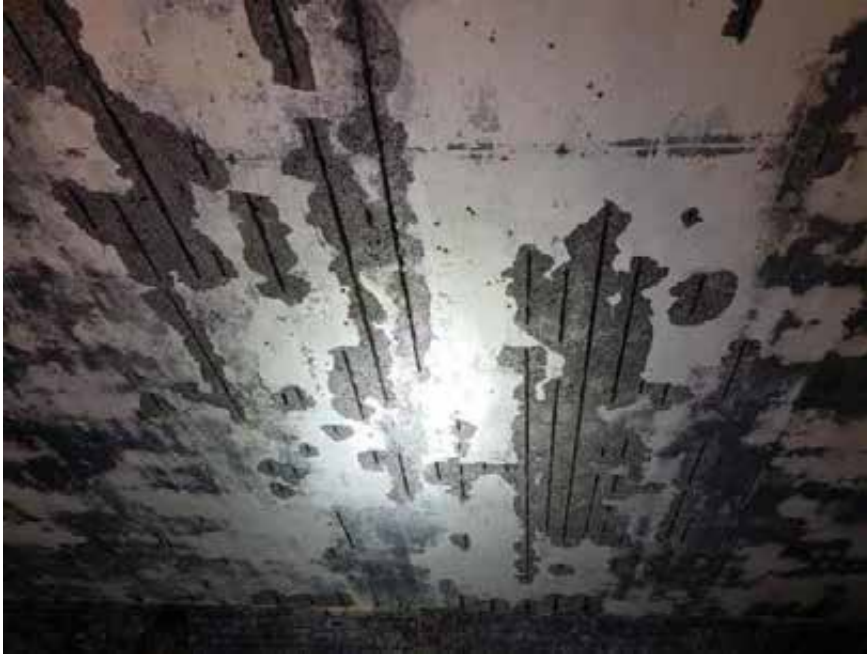
11.

**General loss of concrete from the internal soffit of the roof slab.**

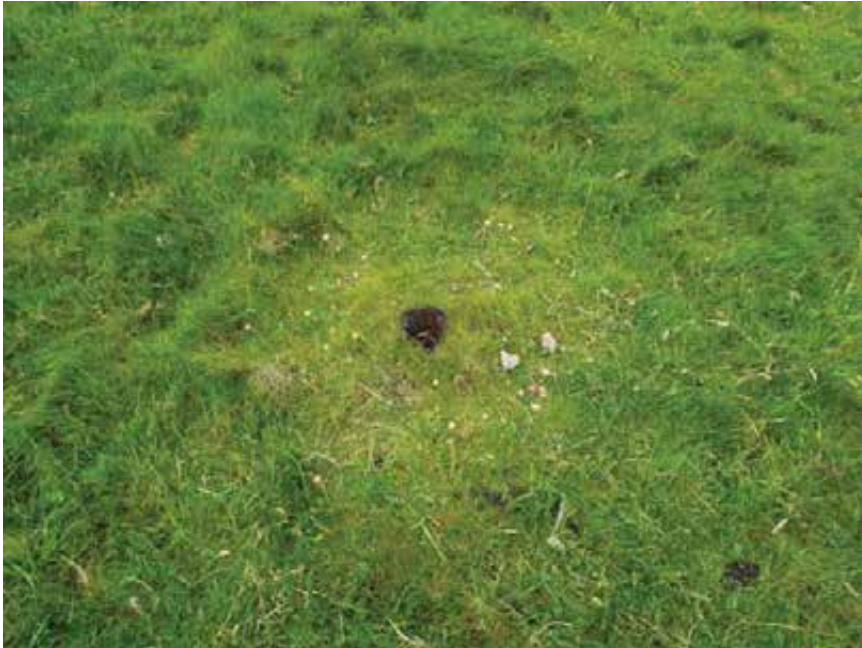
12.

**Projecting remains of a former camouflage netting support post. The posts are severely corroded with sharp jagged ends.**

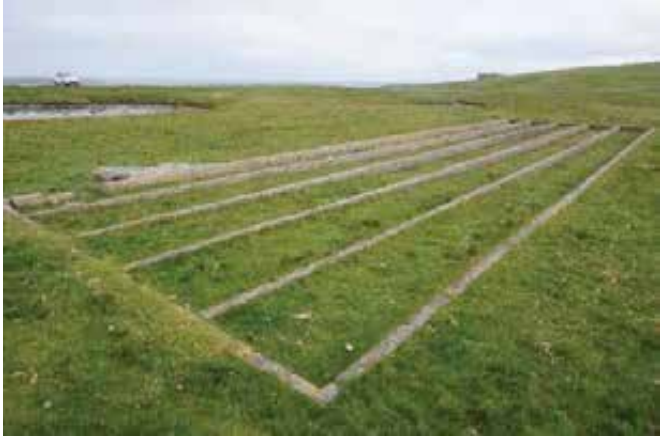
<b>Site No.</b>	94a	<b>Site Name:</b>	HLT Barracks
<b>Description:</b>		<b>General Photograph:</b>	
<p>Cast in situ concrete foundations, dwarf walls and remains of entrance step/platt. Concrete used appears poorly mixed, with poorly graded aggregate used. Sections partially buried to east and south. Ferrous fixings for timber wallplate remain</p>

<b>Condition:</b>			
<p>Fair (locally poor): Cracking visible throughout, however the stability of the walls appears unaffected. Localised cracking and spalling in the vicinity of embedded ferrous fixings. Localised damaged and displaced concrete at western end of north footing adjacent to the entrance platt. Localised spalling and disaggregation at the eastern end of one of the centre footings. The entrance platt is misaligned, with localised cracking, spalling and disaggregation, but stable.</p>			
<b>Recommendations:</b>			<b>Priority:</b>

<b>1.</b>	<p>As the structure is stable, record and monitor its condition as part of a regular inspection regime. If cracking and/or spalling significantly worsens, consider options such as crack filling and consolidation and/or burying (especially if increased footfall to the site is anticipated). The latter will also reduce any health and safety risk. <b>£5000.00 – provisional cost</b></p>		Desirable

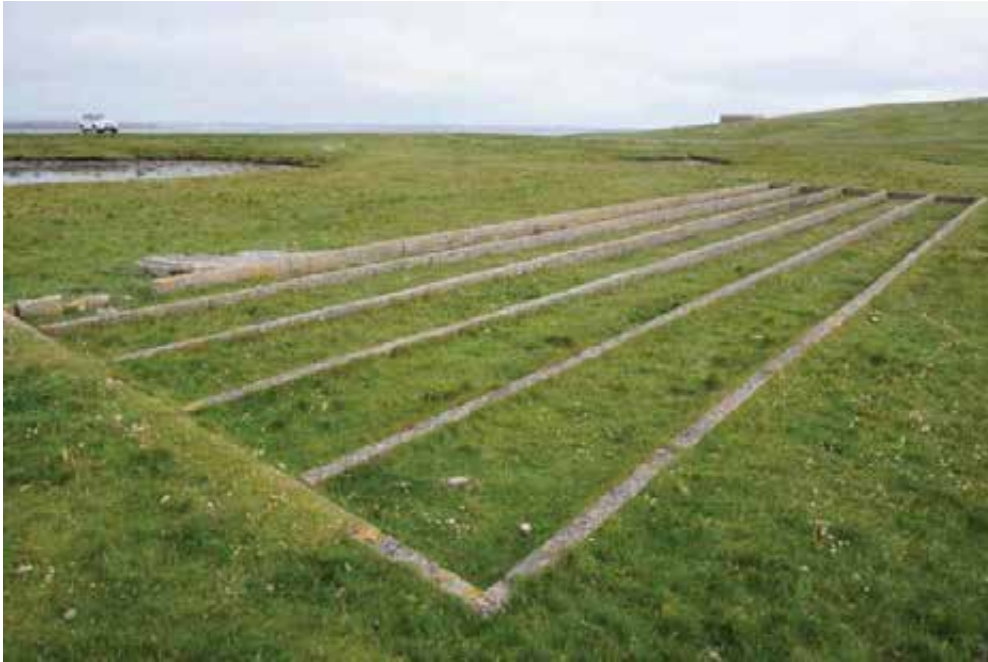
**1**

**Sections of concrete at the eastern end of the structure are partially buried. The structure is generally stable, however, if increased footfall is anticipated, localised repairs and/or wholesale burying should be considered to protect the concrete and to reduce health and safety risk.**

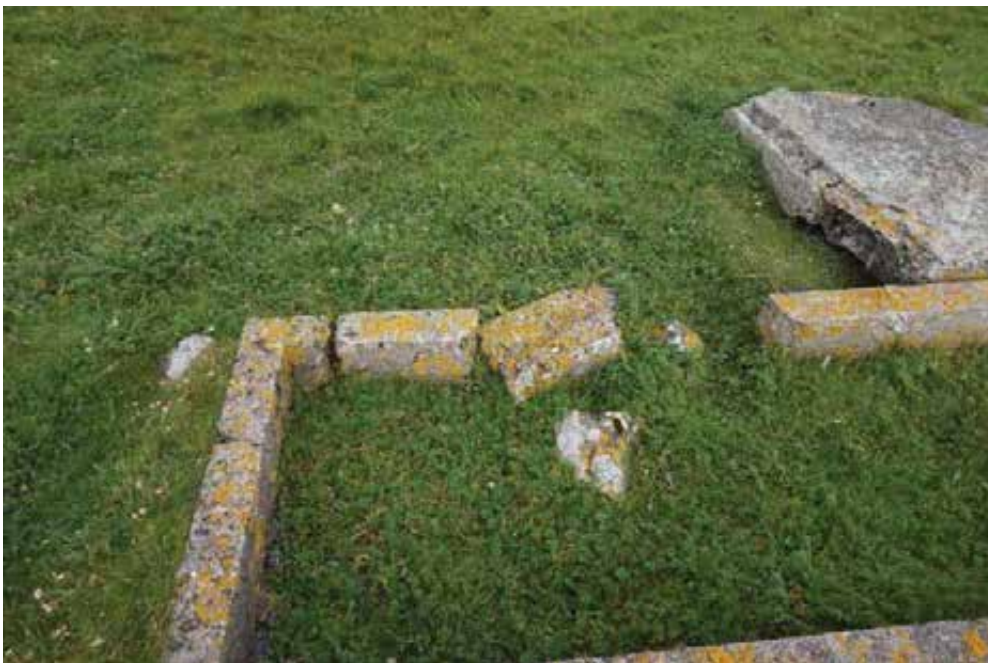
**2**

**Localised damage and displacement of the western end of the north perimeter sleeper wall.**

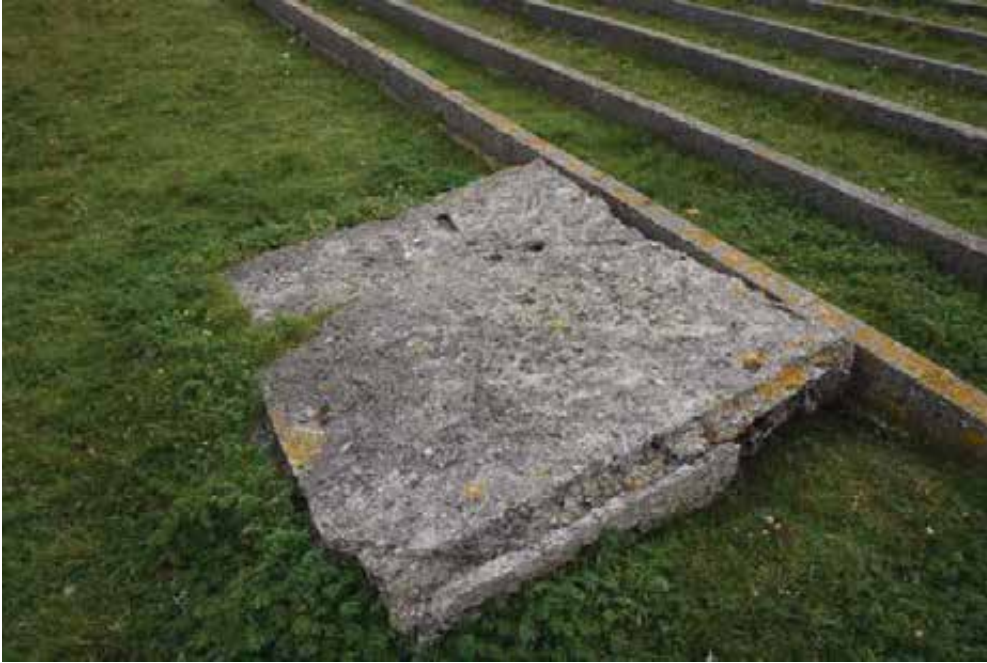
3

**The entrance platt remains stable despite misalignment and localised cracking, spalling and disaggregation.**

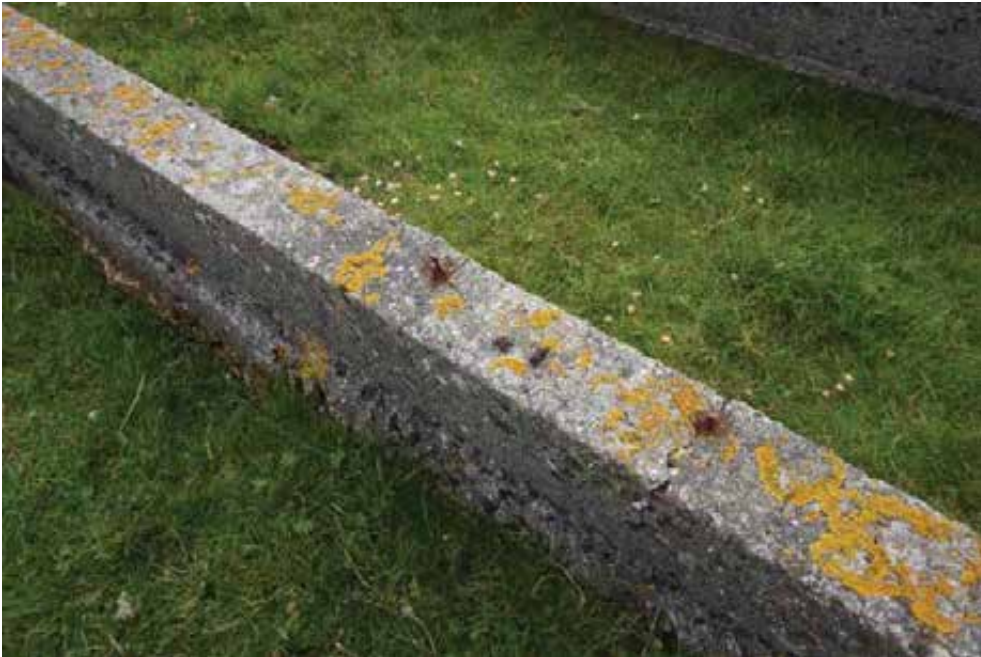
4

**Cracking and spalling in the vicinity of embedded ferrous fixings which would have been used to secure timber wallplates.**

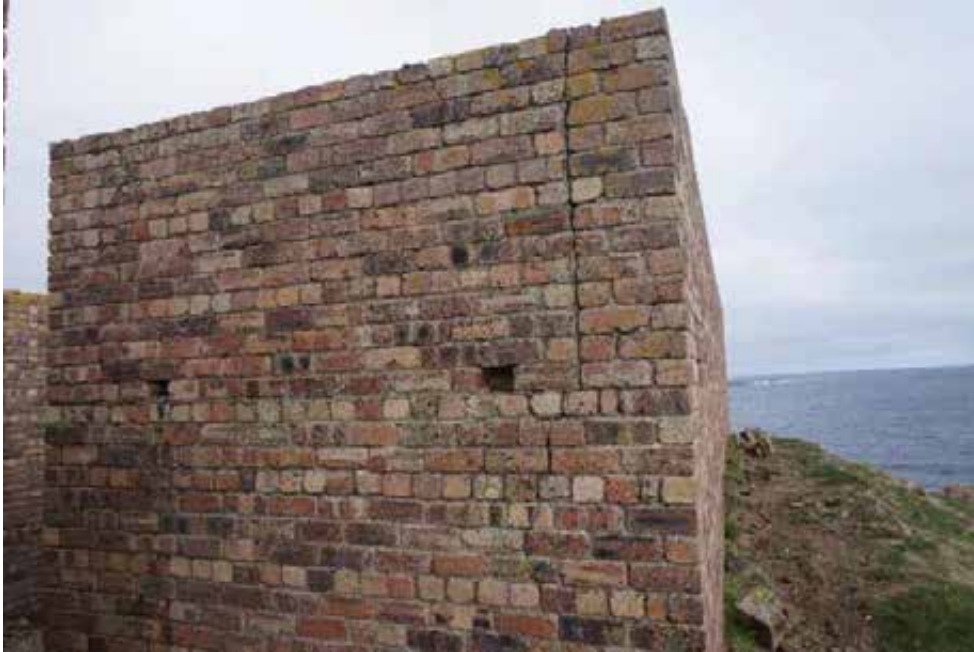
3

**Cracks at the northeast (lower image) and southeast corners where brickwork is poorly tied and are likely to be exacerbated by poor ground conditions affecting the foundations. Stitching across these cracks is recommended.**

2.	Allow structural stitching/tying of significant cracks at the northeast and southeast corners, for example coring and inserting threaded stainless steel rods, and repointing to allow monitoring prior to making decisions which may require more invasive intervention, for example, excavations and underpinning of foundations (not costed). <b>£2000.00</b>	Necessary

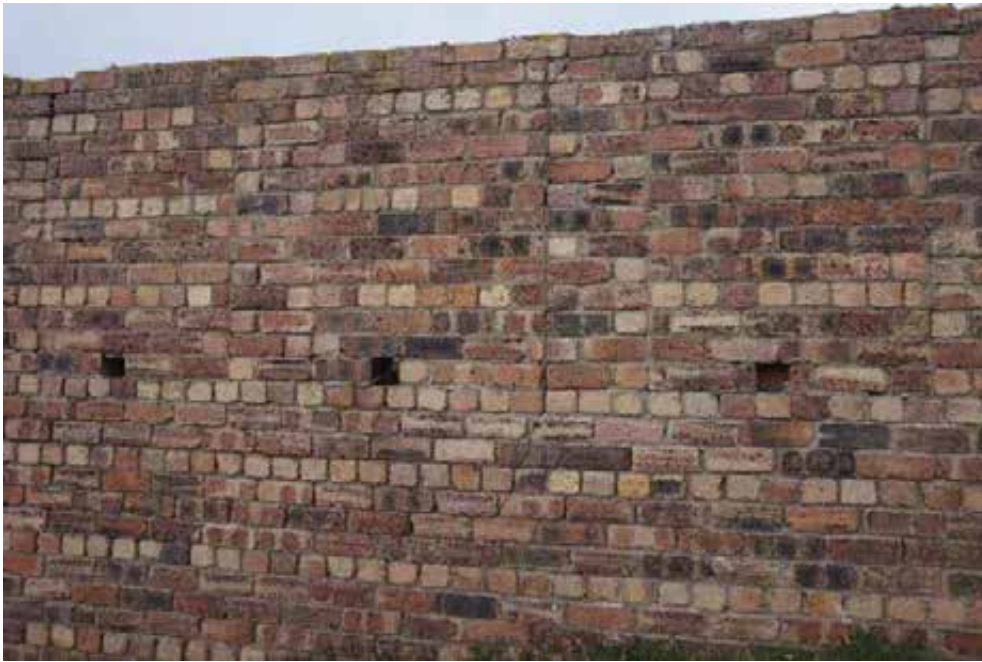
**Cracks at higher levels are aligned with the upper piers which are poorly tied to the adjacent thinner single brick thick infilled brickwork. See also Photo 2**

3.	Allow stitching/tying of cracks on wall faces, including at higher levels where thinner brickwork is poorly tied to adjacent piers, for example, raking out joints and inserting stainless steel ties (e.g. Helibar by Helifix) to bridge cracks. Repoint joints and monitor thereafter. <b>£2500.00</b>	Necessary

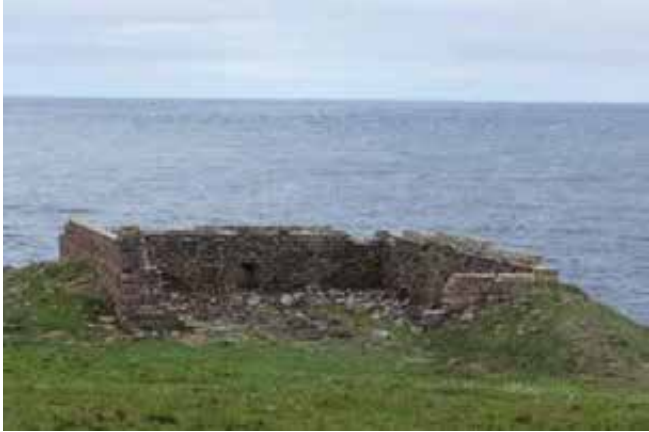
<b>Site No.</b>	98	<b>Site Name:</b>	ACH Generators
<b>Description:</b>		<b>General Photograph:</b>	
<p>Roofless remains of fire damaged lower walls. Part of Advance Home Chain that provided short term cover until the Chain Home was established. Solid brick construction, 1.5 brick thick with remains of piers to internal faces of east and west walls, part earth retaining (sloped bankings), assumed built from concrete strip foundations.</p>

<b>Condition:</b>			
<p>Poor: Badly fire damaged having previously been used by the local fire service for training drills. Upper sections of walls have collapsed with loose brickwork lying in close proximity of the structure. Surviving lower brickwork is fire damaged, with internal faces vitrified, many becoming detached from the masonry, and all joints friable. Externally, there is loose bricks to wallheads and around the south facing opening, and localised cracking, failing joints and cracks elsewhere.</p>

<b>Recommendations:</b>			<b>Priority:</b>
<b>1.</b>	<p>Following accurate recording of the structure, remove fallen brickwork to allow access for repairs and to reduce health and safety risk if increased footfall anticipated. <b>£900.00</b></p> <p>The collapsed brickwork from the east elevation, which appears to have fallen in one large intact section, could potentially be left or buried. (not costed)</p>	Necessary	
<b>2.</b>	<p>Consolidate internal faces and piers by thoroughly cleaning down and removing friable mortars and full repointing. Allow resetting loose bricks and replacing badly damaged with matching or salvaged bricks. Accept continual loss and salts damage, requiring frequent maintenance and repair, including replacing badly damaged bricks. <b>£6000.00</b></p>	Necessary	
<b>3.</b>	<p>Repoint defective skyward facing wall head joints and wall faces. Allow resetting loose bricks and replacing badly damaged with matching or salvaged bricks. Repoint cracks to allow future monitoring. <b>£3000.00</b></p>	Necessary

<b>4.</b>	<p>Consider reinstating and/or increasing height of the external sloping bankings to provide additional support to the walls after completion of recommendations above. <b>£2500.00</b></p>	Desirable

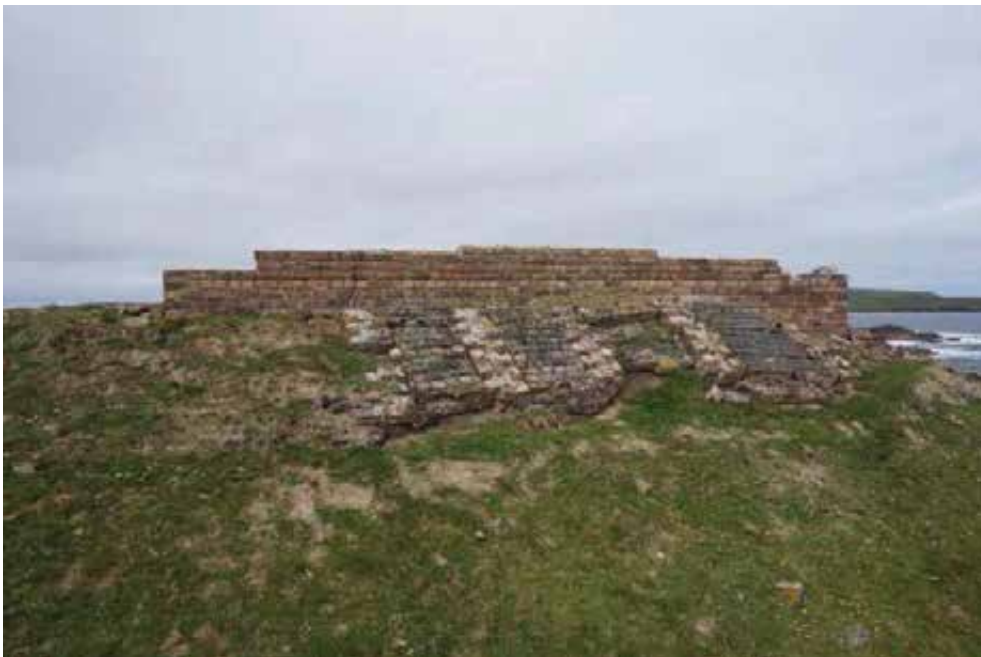
**2**

**The collapsed brickwork from the east elevation, which appears to have fallen in one large intact section, could potentially be left or buried.**

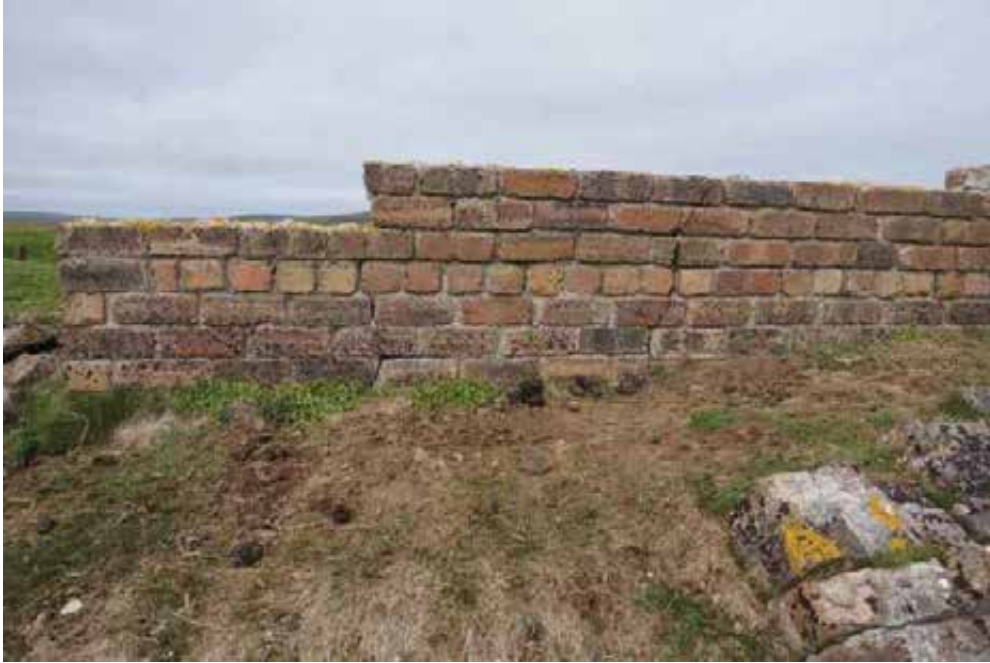
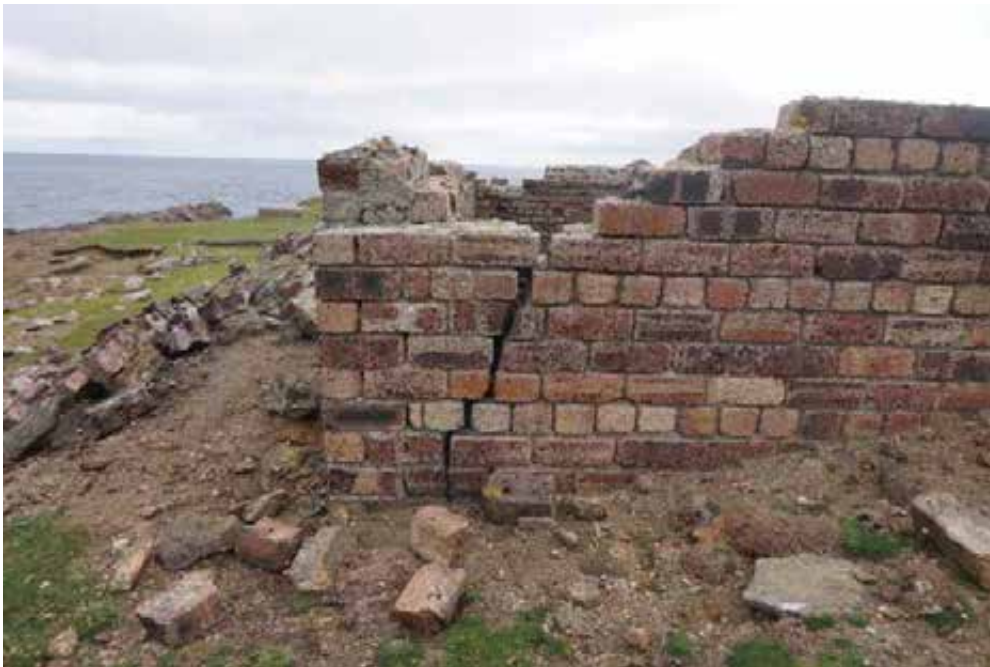
**Repoint failing joints and cracks on external faces. Consider reinstating / increasing the height of the earth banking to provide additional support to the fire damaged walls.**

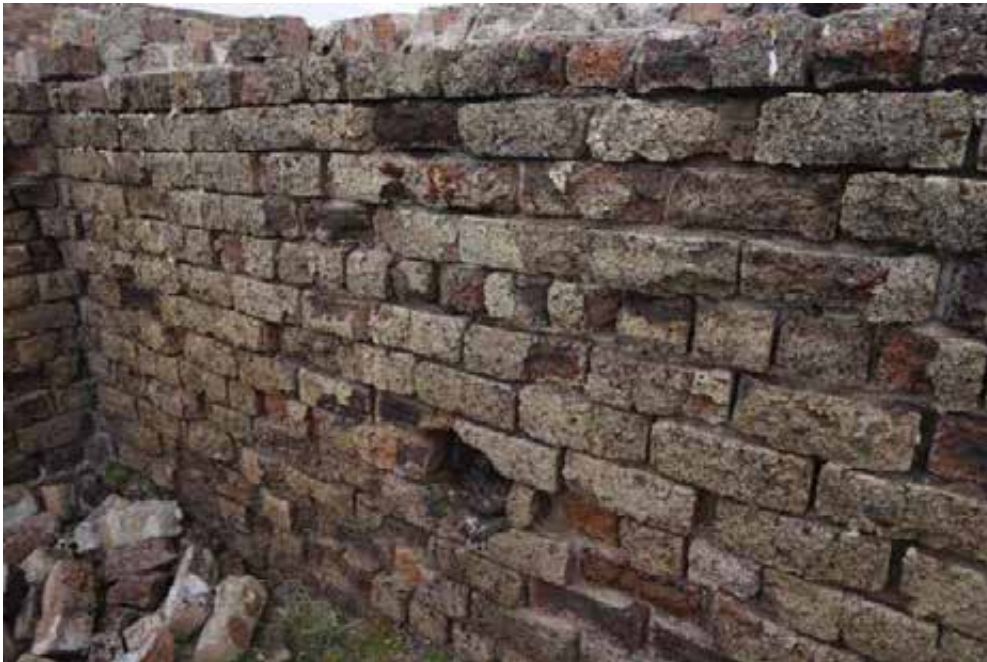
8

The internal faces are badly fire damaged, requiring extensive consolidation including repointing, resetting loose bricks and replacing badly damaged bricks.

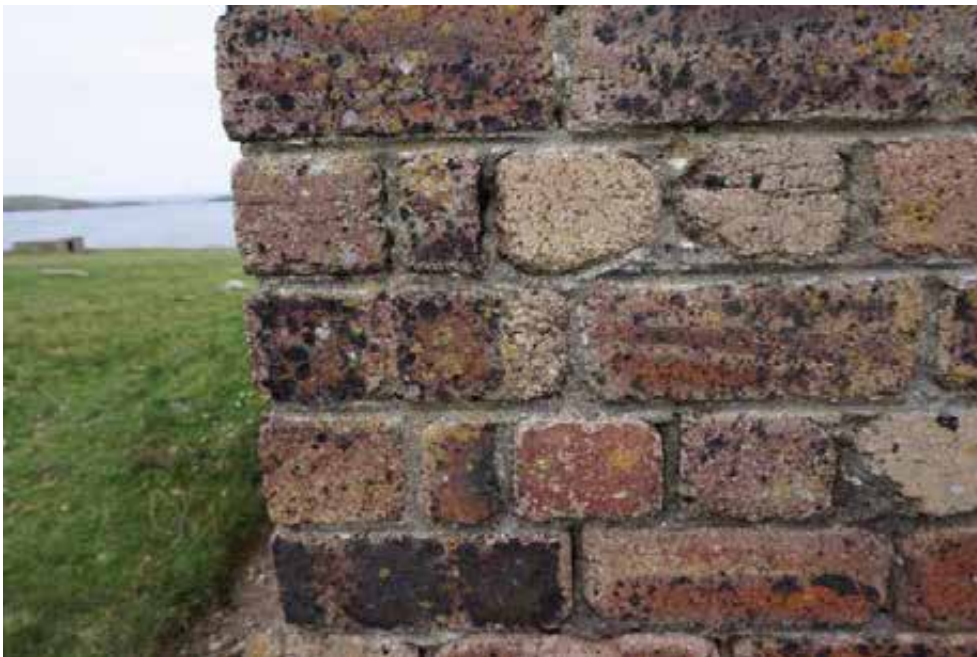
**2**

**Localised flaking wall face joints and minor cracking should be repointed.**

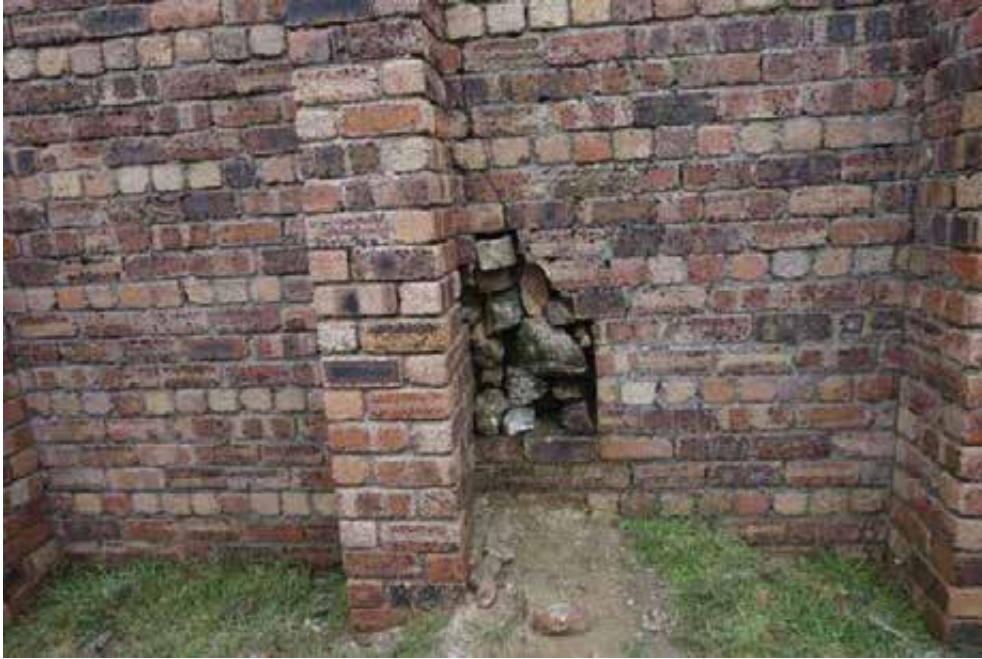
3

**A vertical crack extends from a section of missing brickwork at ground level internally on the east wall. The brickwork panels either side of the pier (seen just off-centre) are poorly tied across the pier.**

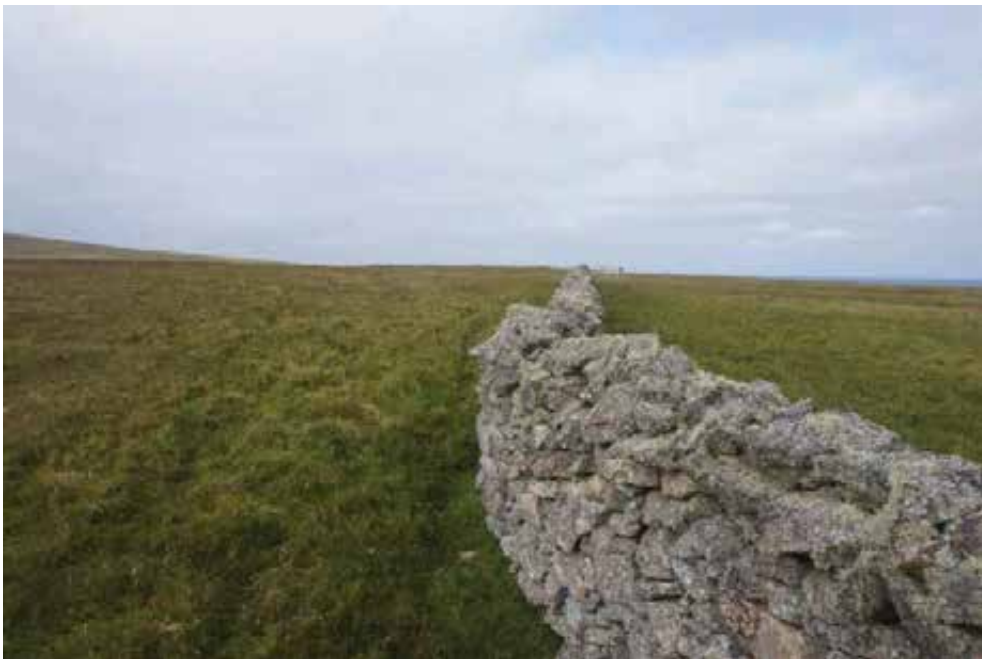
4

**Monitor the bulged section and allow repairs/rebuilding if its condition worsens.**

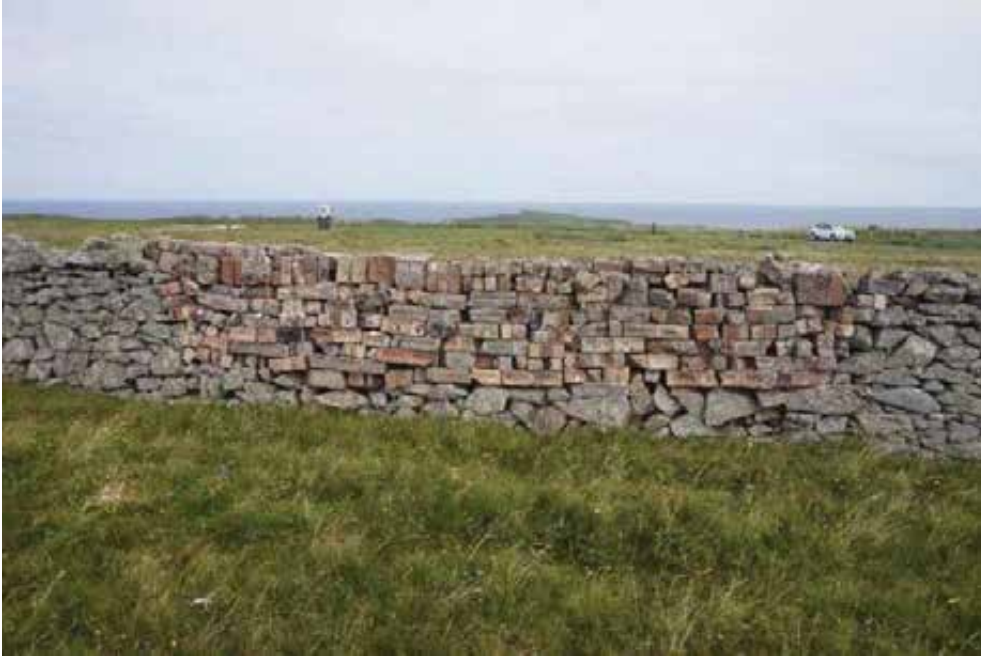
5

**The repair using salvaged bricks c.40m north of the access road remains in good condition.**

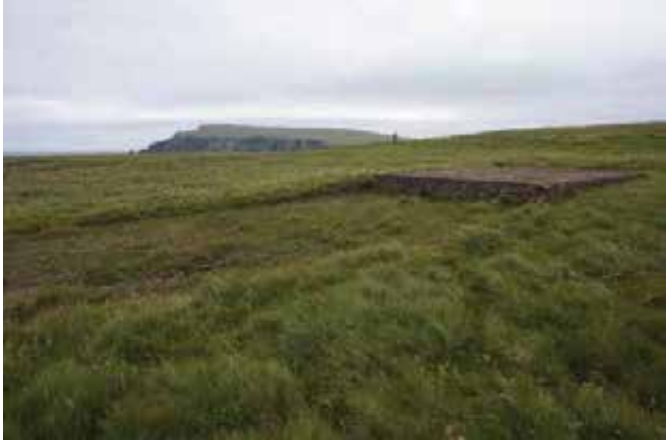
<b>Site No.</b>	107	<b>Site Name:</b>	Dining and Cookhouse
<b>Description:</b>		<b>General Photograph:</b>	
Footings and foundations comprising part buried half brick thick footings to east portion, and concrete floor base with drain outlet to south, and part buried half brick thick perimeter footings, incorporating stump bases of reinforced concrete superstructure, to west portion.

<b>Condition:</b>			
Poor: Loose and displaced brickwork throughout east portion, with failing mortar joints throughout. Cracked and disaggregated concrete floor slab supporting vegetation growth, and localised missing/damaged wallhead brickwork and failing joints to the west portion.			
<b>Recommendations:</b>			<b>Priority:</b>

1.	Record as existing and consider burying to protect footings and concrete from further damage from exposure and increased footfall. <b>£5000.00 – Provisional cost</b>		Necessary

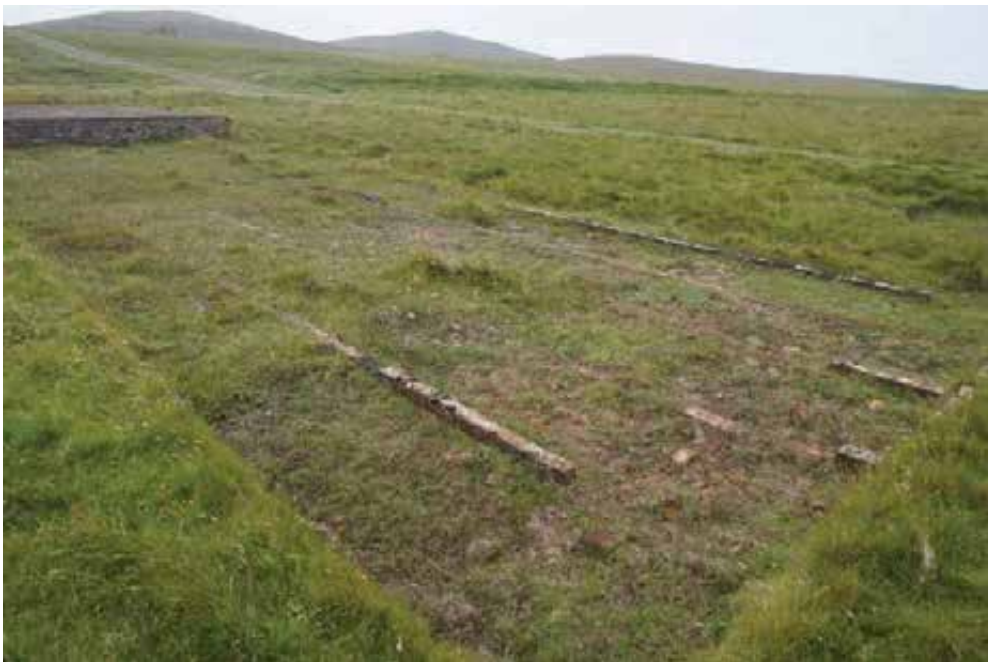
**2**

**General view from east of east portion comprising part buried brick footings.**

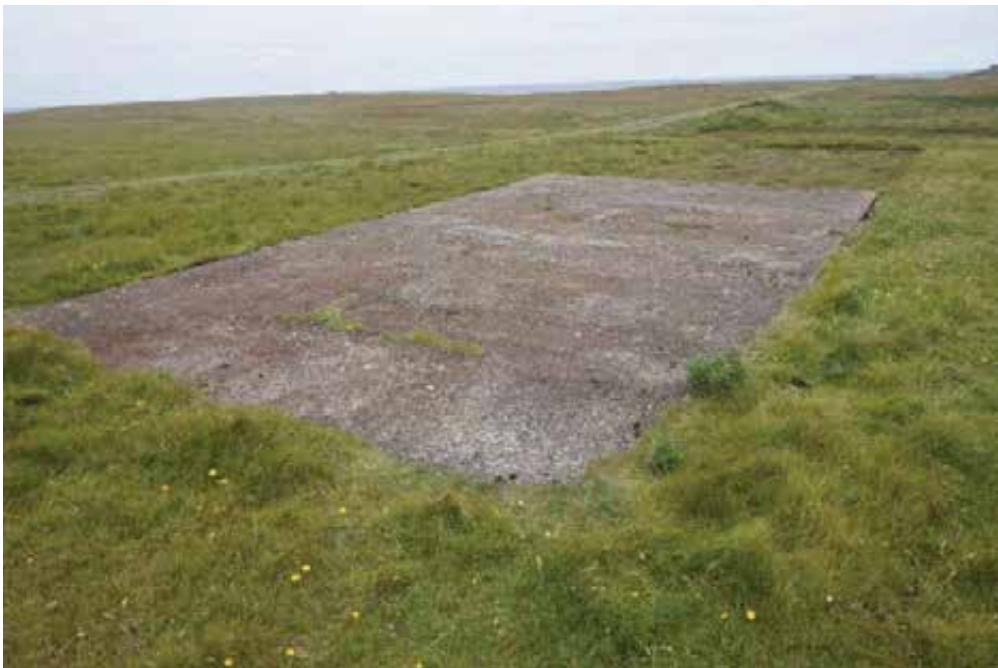
4

**General view from southwest of west portion comprising concrete floor slab surrounded by part buried brick footings.**

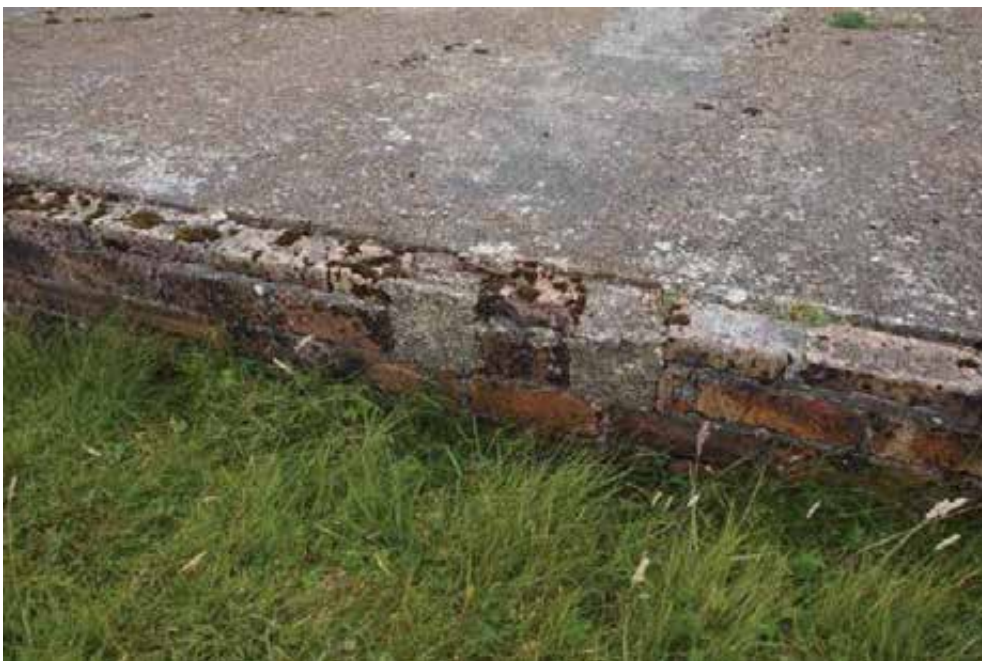
6

**Stumps of reinforced concrete superstructure visible on the footings of the north and south elevations. Note cracked and failing mortar joints.**

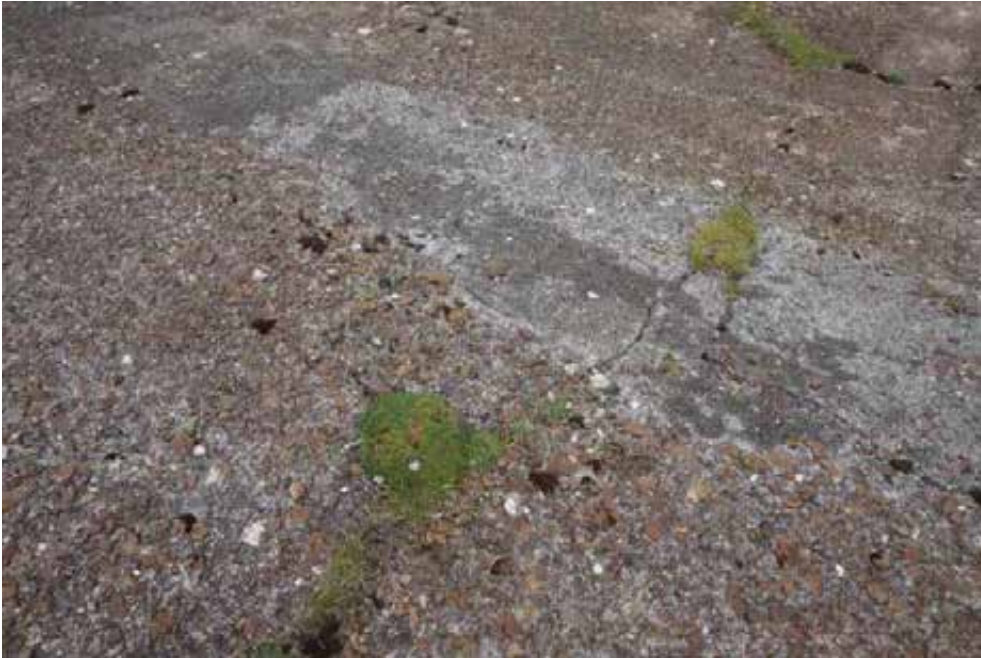
8

**Cracked and disaggregated floor slab supporting vegetation growth.**

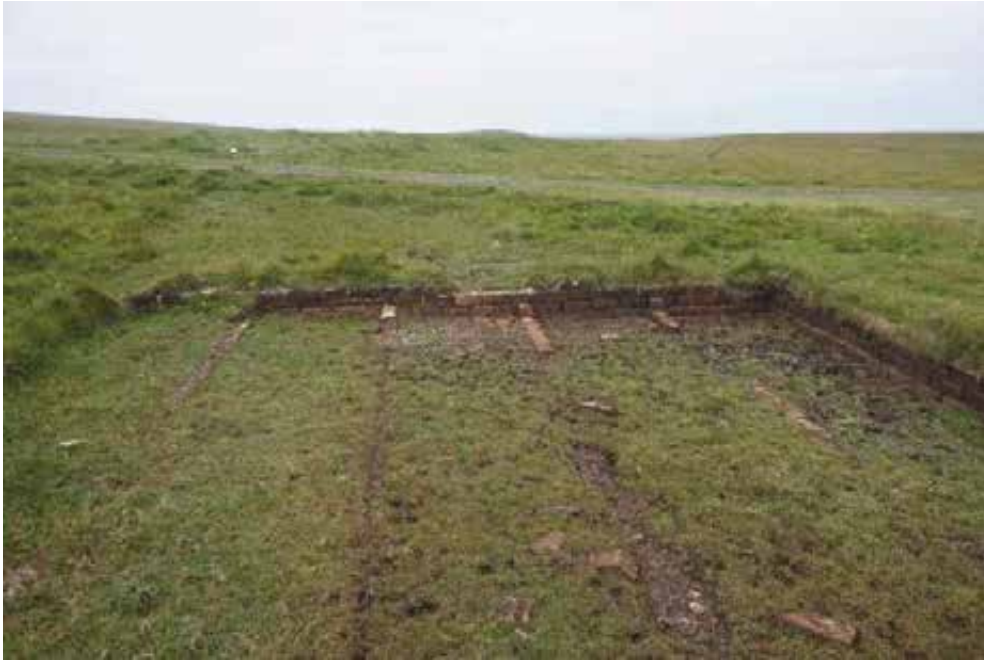
**1**

**Internal view showing part buried footings with loose bricks and failing mortar joints. Note displaced brickwork. Consideration should be given to burying them to protect them from exposure to weathering and from the impact of increased footfall to the site.**

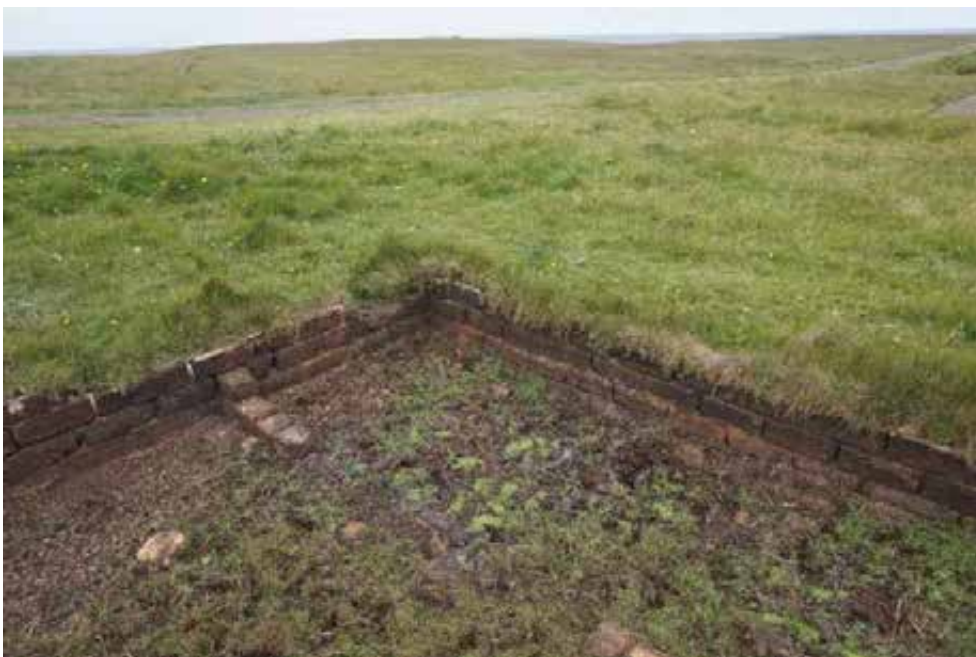
**Part buried footings with loose bricks and failing mortar joints in northeast corner.**

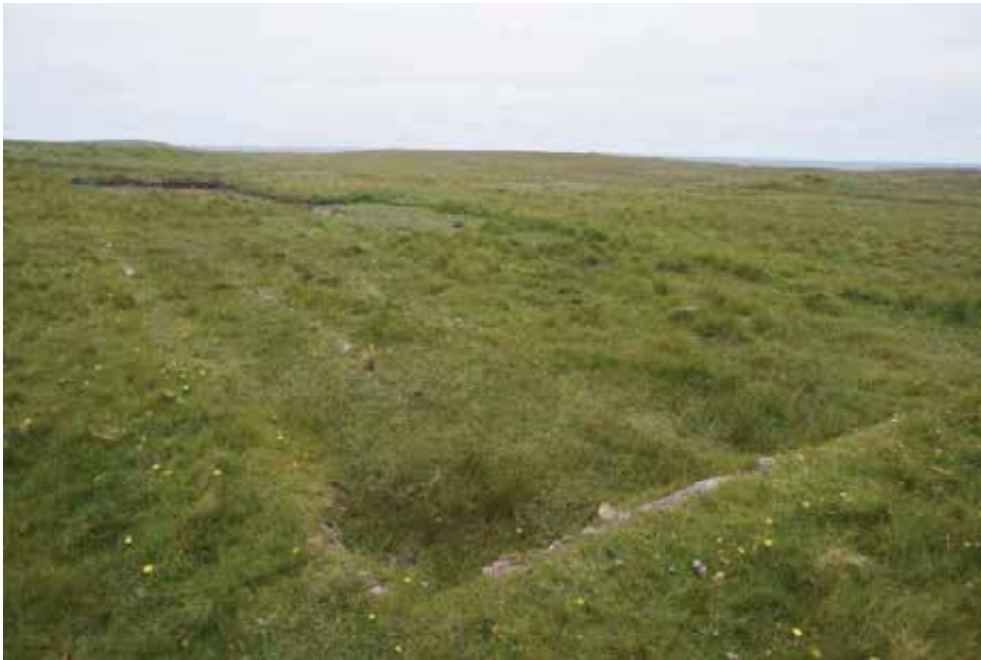
**General view from south showing mostly buried footings and foundations.**

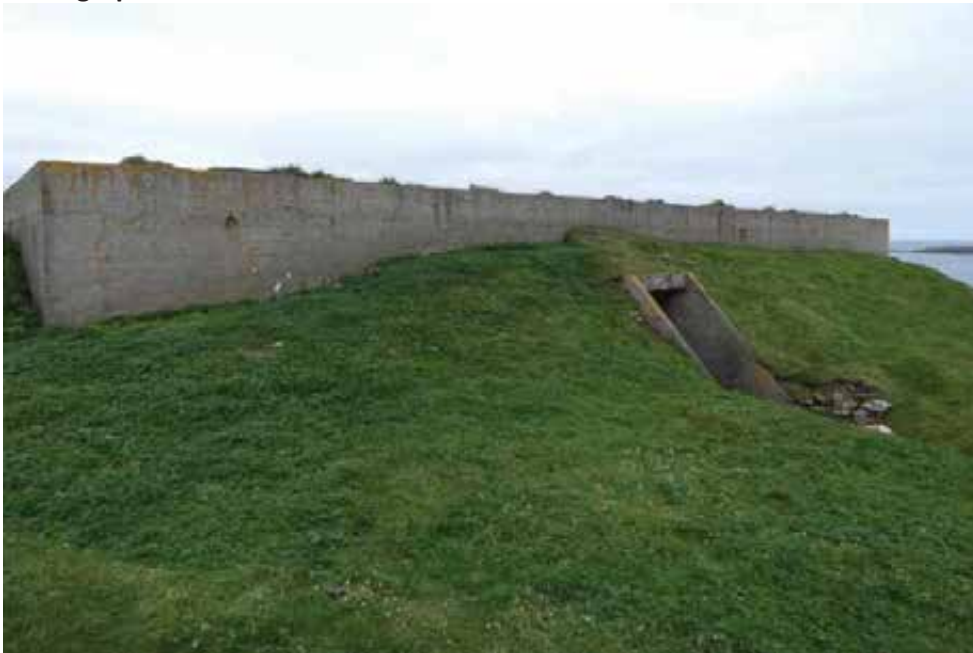
1.

General view showing the embankment against the blast walls.

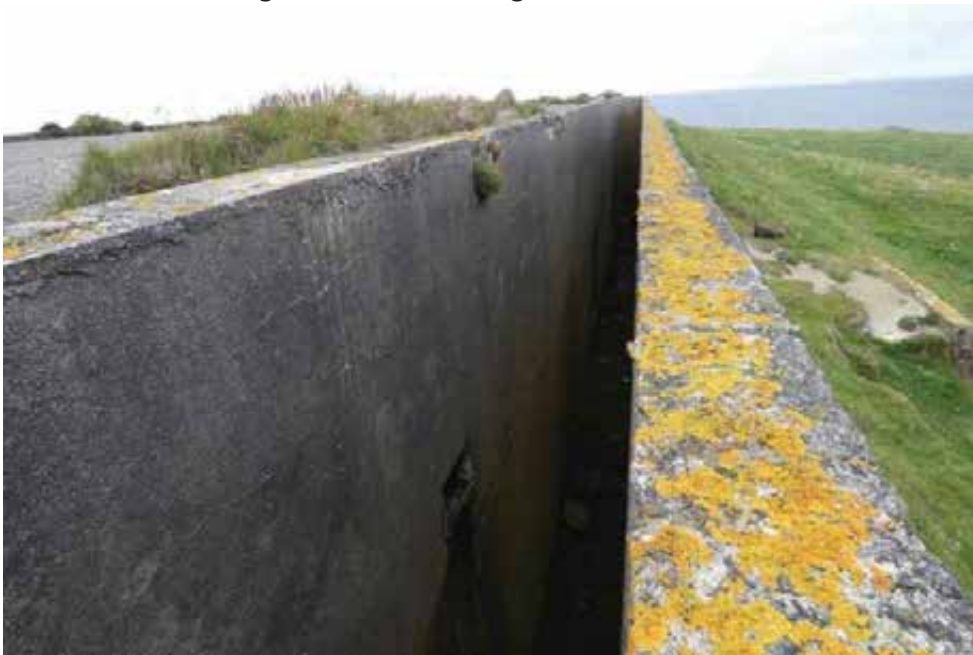
2.

From the top of the embankment looking down into the gap between blast wall and building. The discharge point from the rainwater roof outlet can be seen partway down the wall of the building. Vegetation growing from this outlet is blocking it.

4.	Renew asphalt roof membrane in its entirety, unblock all roof outlets and drainage channels from external building perimeter. Cost <b>£15,000.00</b> Improved protection against rainwater ingress will reduce the rate at which the RC substrate deteriorates.	Desirable

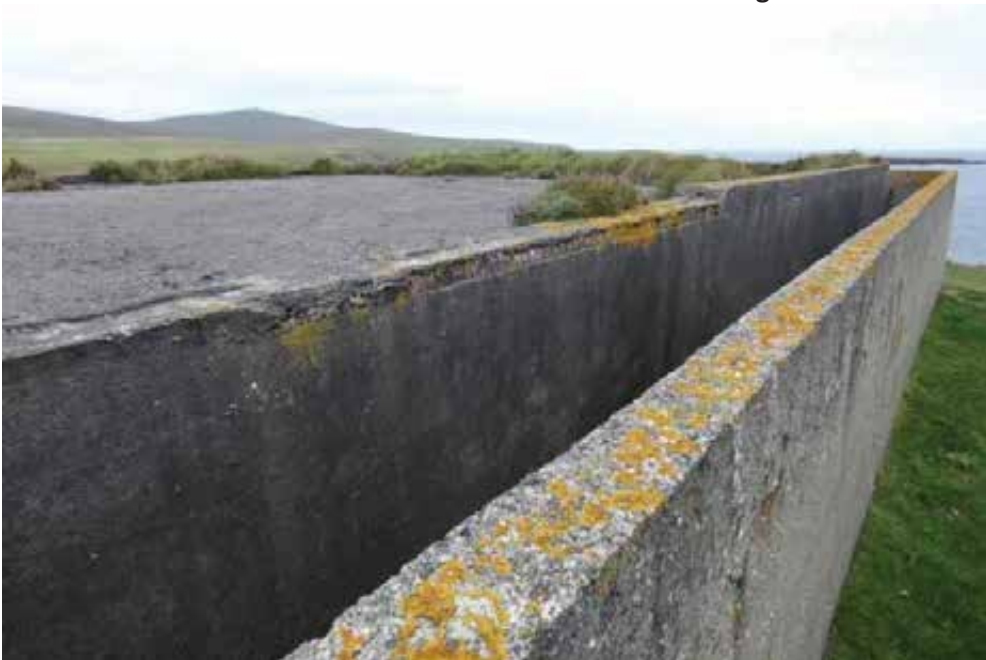
3.

Looking across the surface of the roof. Note missing parapet copes and vegetation growing on roof.

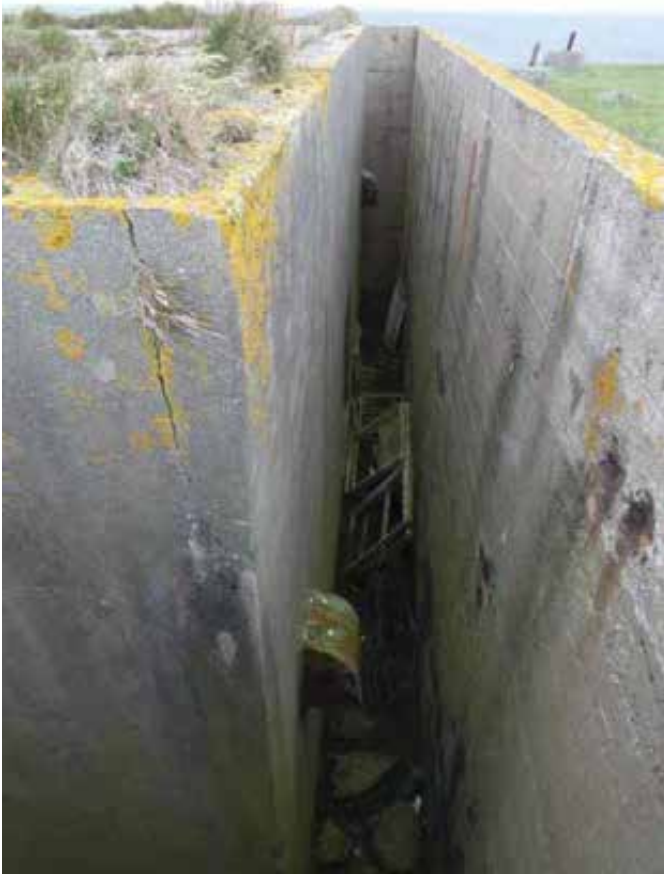
4.

**Note the debris across the floor of the perimeter lightwell. Note crack in the render of the building.**

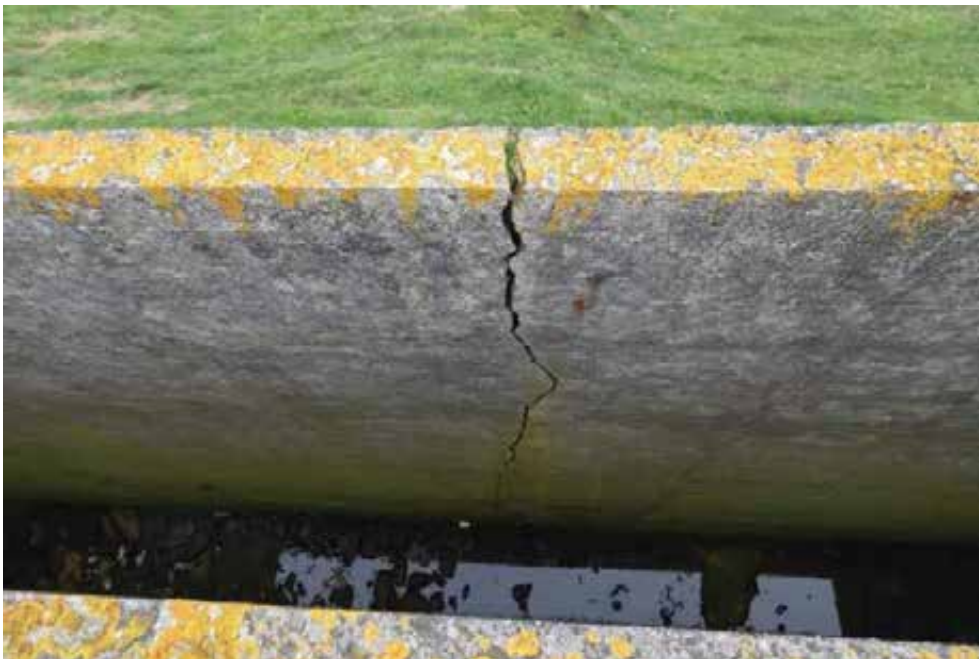
7.

<b>Condition:</b>			
<p>Fair (locally poor): Blast and tunnel walls – fair condition structurally. Vertical cracks through the walls indicative of some settlement of the foundations. Cracks are clearly old. Stability of walls not compromised significantly by the presence of these cracks.</p> <p>Roof slabs – the RC work is generally in fair condition although water penetration through the slabs is obvious, leading to cracking and delamination of plaster finishes (inside the building) and in places expansive corrosion of reinforcement and spalling concrete from soffits. Asphalt finishes in poor condition and are not preventing water ingress into slab; vegetation has taken root in areas where the asphalt is cracked. Roof outlets largely blocked. The deterioration observed will not have significantly reduced the structural integrity of the slab.</p> <p>Brick walls in fair condition although saturated. Internal paint finishes peeling and suffering from chloride attack. Spalling and missing areas of render from the walls.</p> <p>Service trenches contain debris and water.</p> <p>Loss of earth from embankment a result of burrowing and grazing activities.</p> <p>The upper courses of the external brick service duct are deteriorating, with loss and deterioration of bedding mortars and loosening / loss of brickwork.</p>

Vertical cracks in the blast walls are wider at the top of the wall than the bottom, indicating foundation movement. the provision of horizontal reinforcing bars appeared to be small.

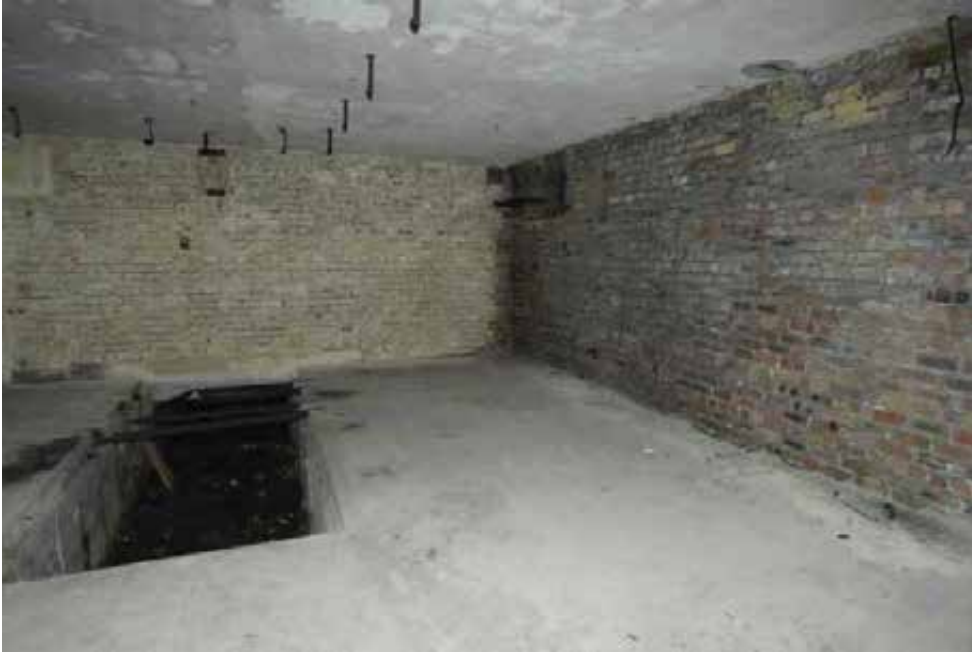
Inside the building. note the open trench in the floor and debris and water therein.

8.	Provision of lighting to the interior of the building. Not costed.	Desirable
9.	Replacement of missing earth from the embankment. Not costed.	Desirable
10.	Install decking across all floor trenches and pits. Not costed	Necessary
