# Appendix 14.9 Data Interpretation Strategy

# Appendix 14.9 Draft Heritage Interpretation Strategy

## **4.2 Condition Survey**

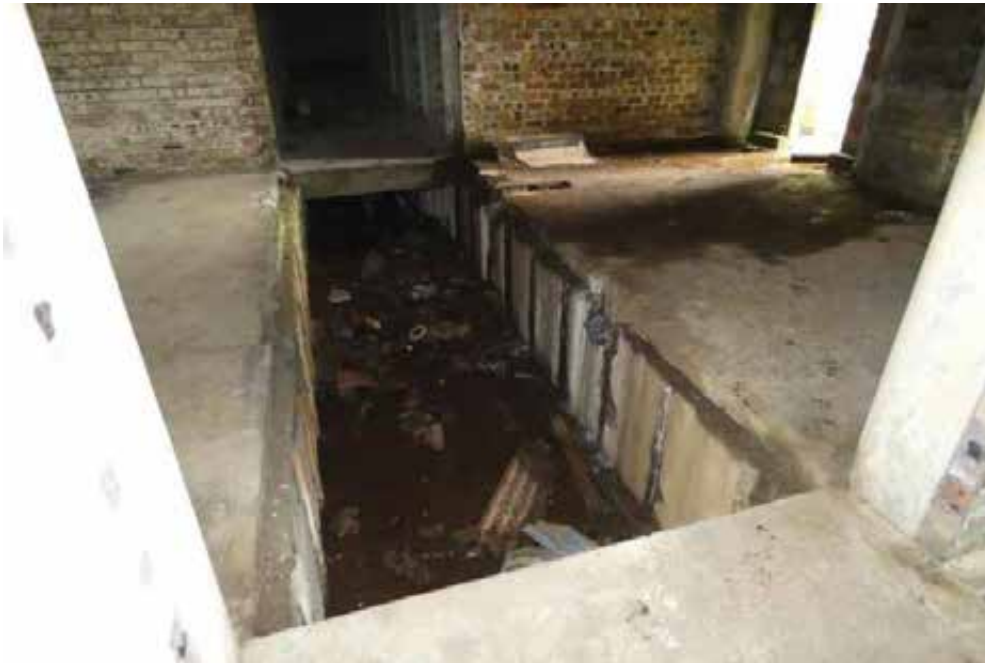
12.

As 10.

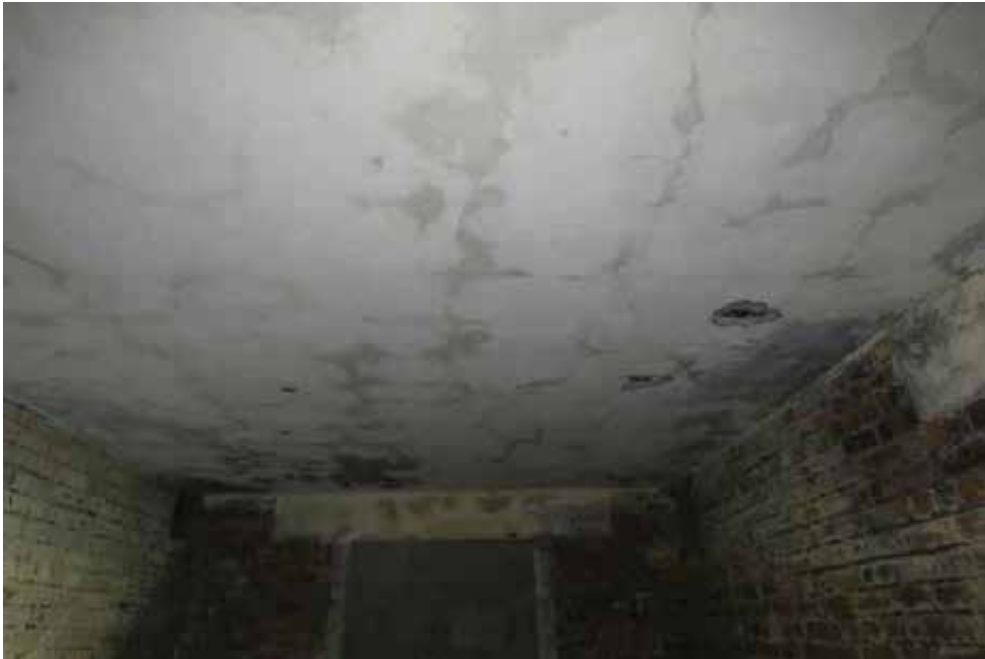
13.

Note cracking of ceiling plaster.

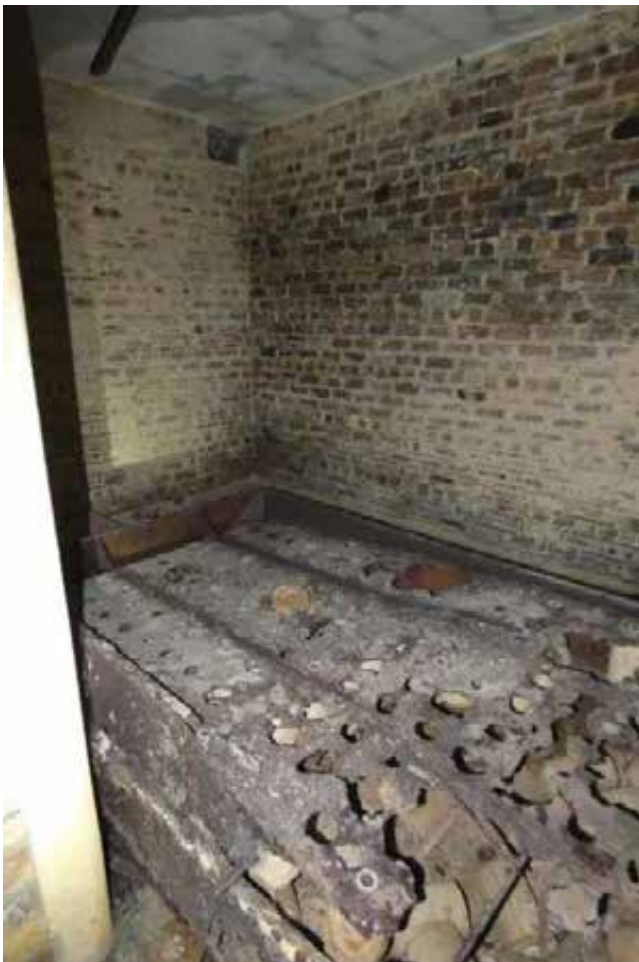
15.

Remnants of equipment survive in places.

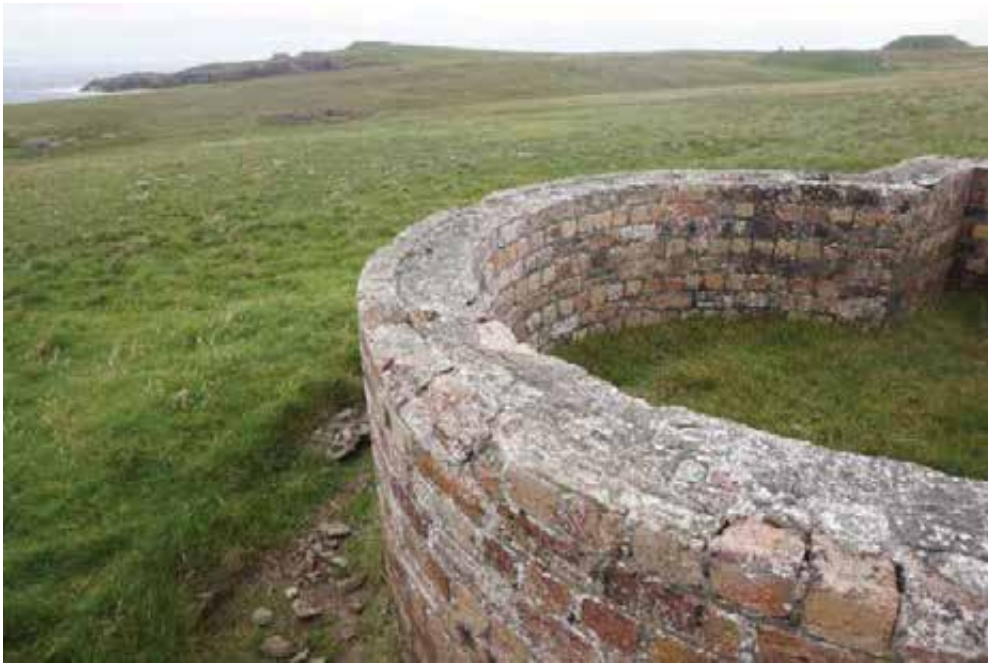
**Localised open joints and damaged brickwork to wallhead.**

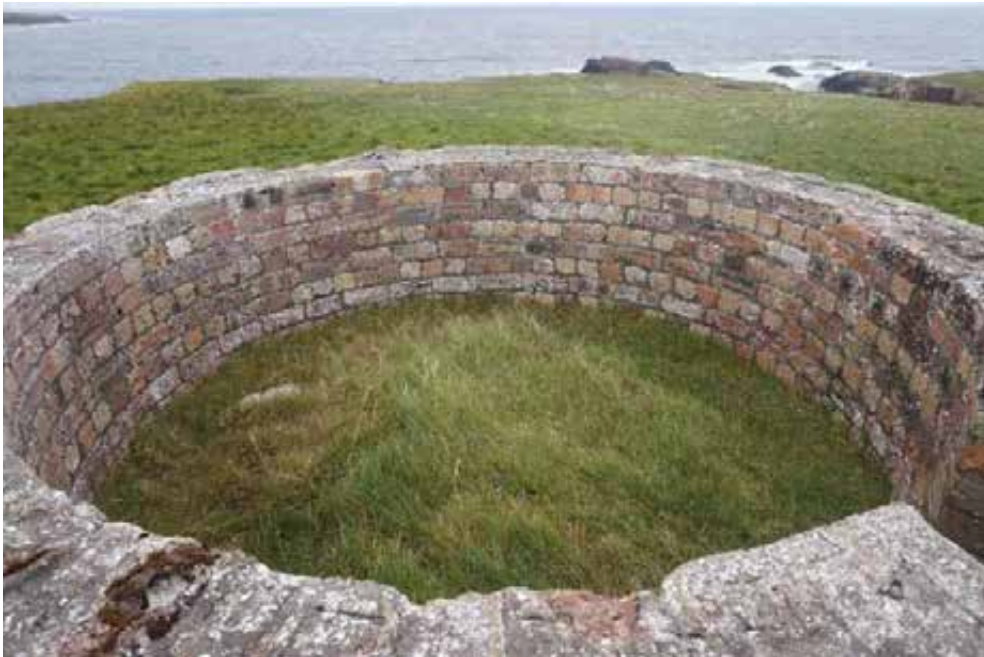
**General internal view.**

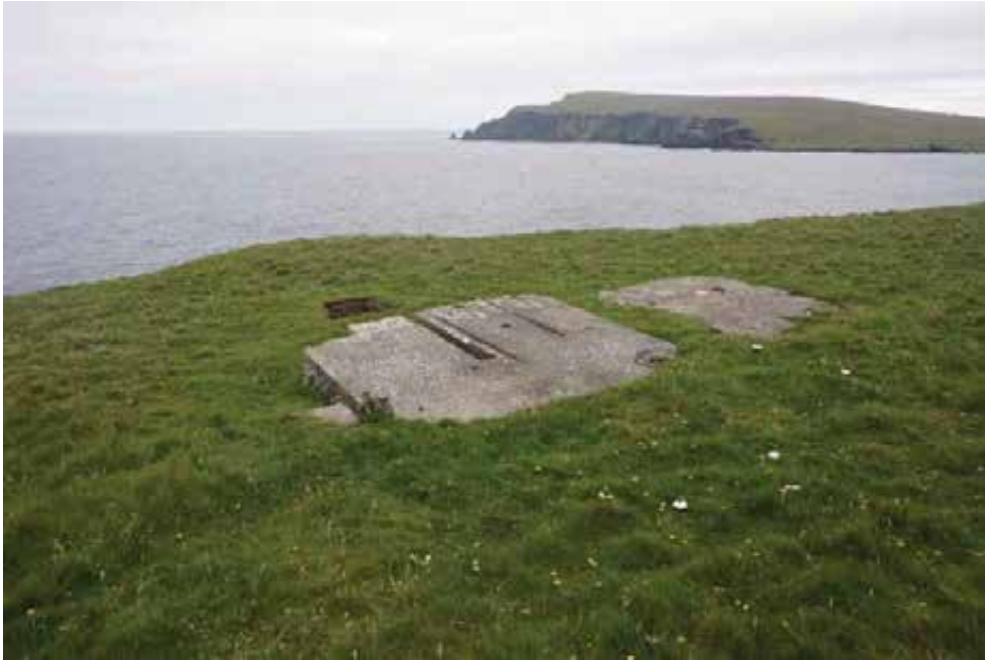
**1**

**General view from northeast.**

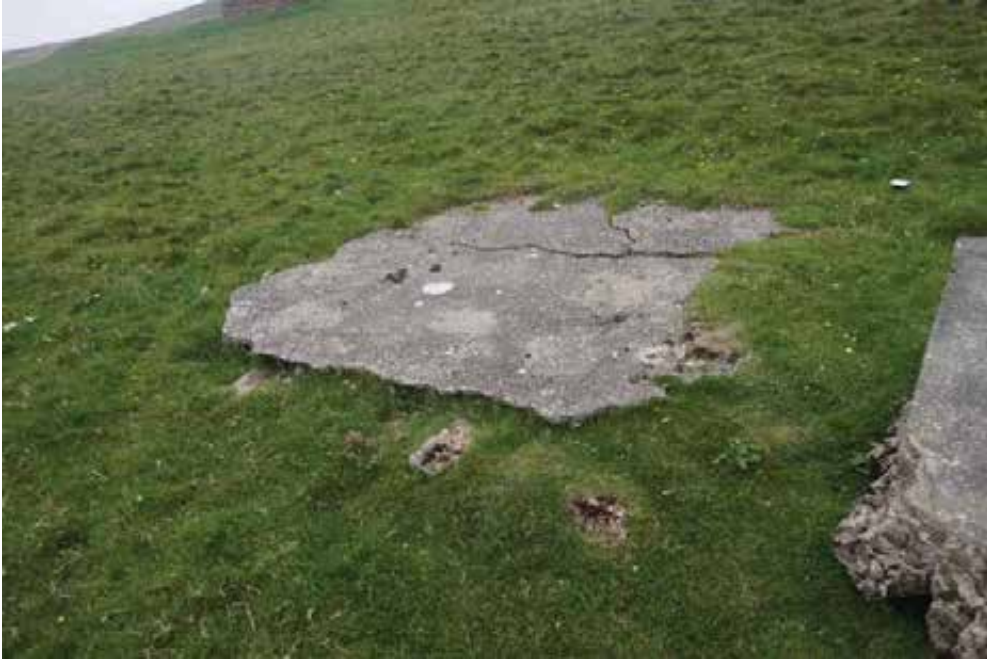
3

**West concrete base has subsided resulting in extensive cracking.**

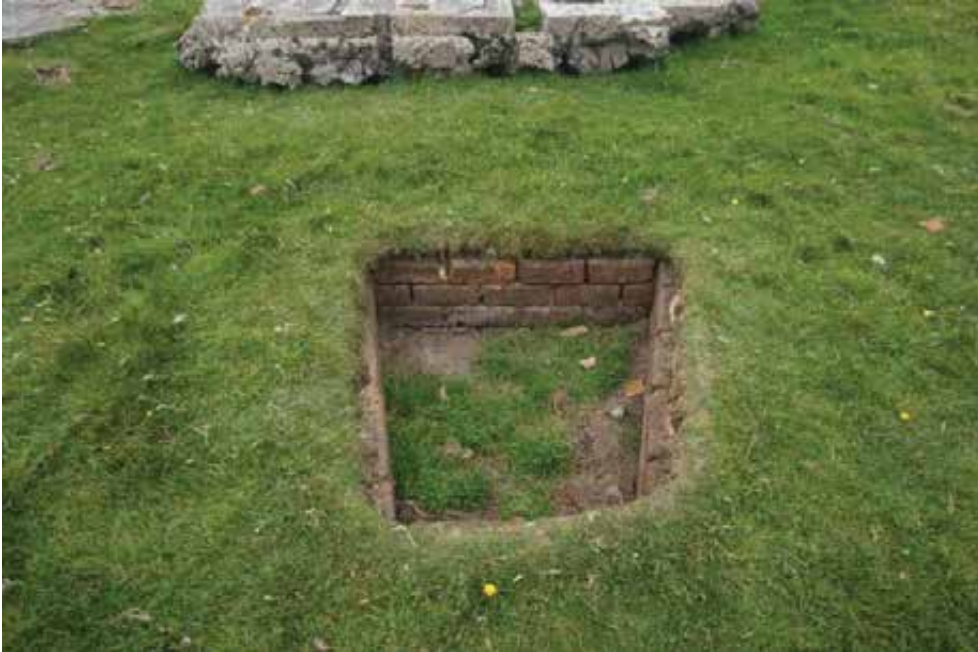
4

**Open joints and loose brickwork to wallheads of brick drainage chamber.**

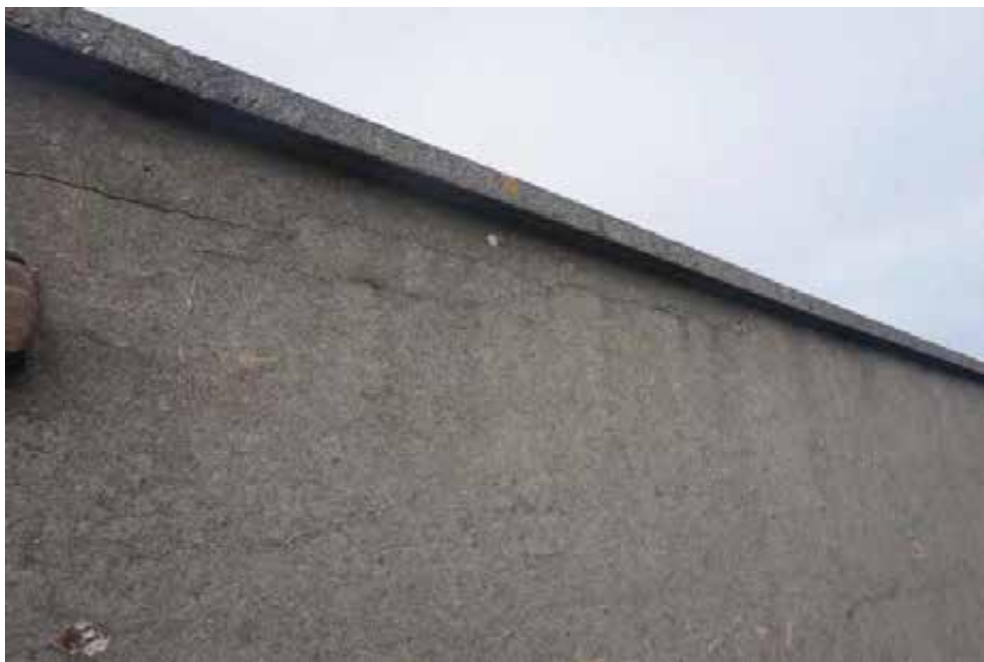
3

**Cracked and bossed render was observed externally on all elevations. Horizontal cracking at top of wall indicative of movement caused by drying shrinkage of roof slab.**

<b>Recommendations:</b>			<b>Priority:</b>
<b>1.</b>	Clear out animal faeces and erect barriers to prevent future access and remove all loose and spalling concrete. (not costed)		Necessary
<b>2.</b>	Reinstate asphalt (or similar, for example, mineral felt) roof finishes. <b>£4000.00</b>		Desirable
<b>3.</b>	Patch repair failing render externally. <b>£1500.00</b>		Desirable

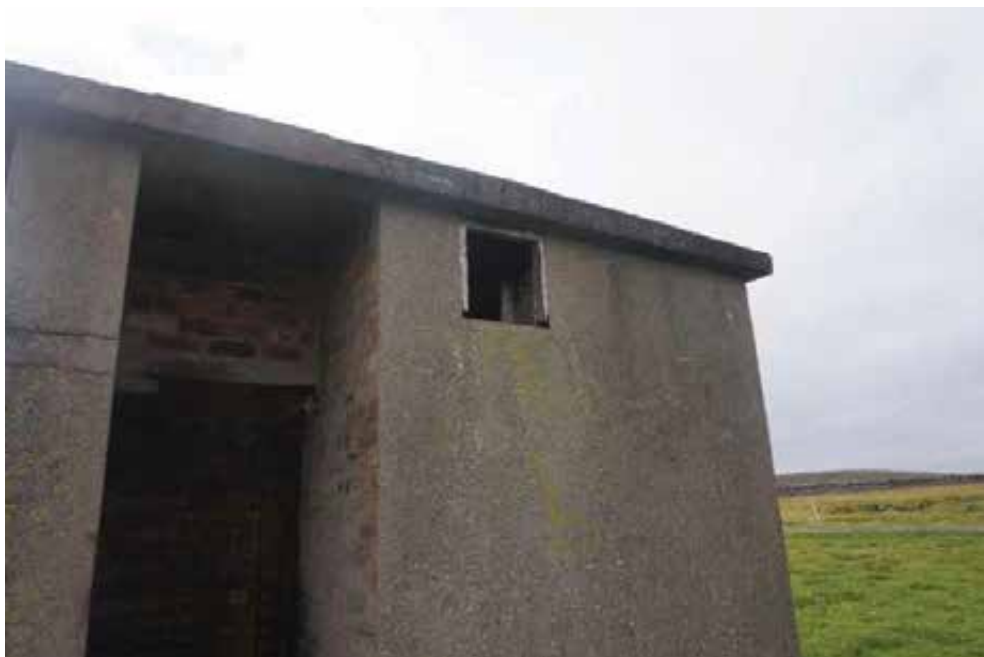
4

**Rotten timber frame to opening on the east elevation. Note loss of concrete from the underside of the RC lintol above the internal opening: removal of surviving, but cracked, concrete from that lintol necessary.**

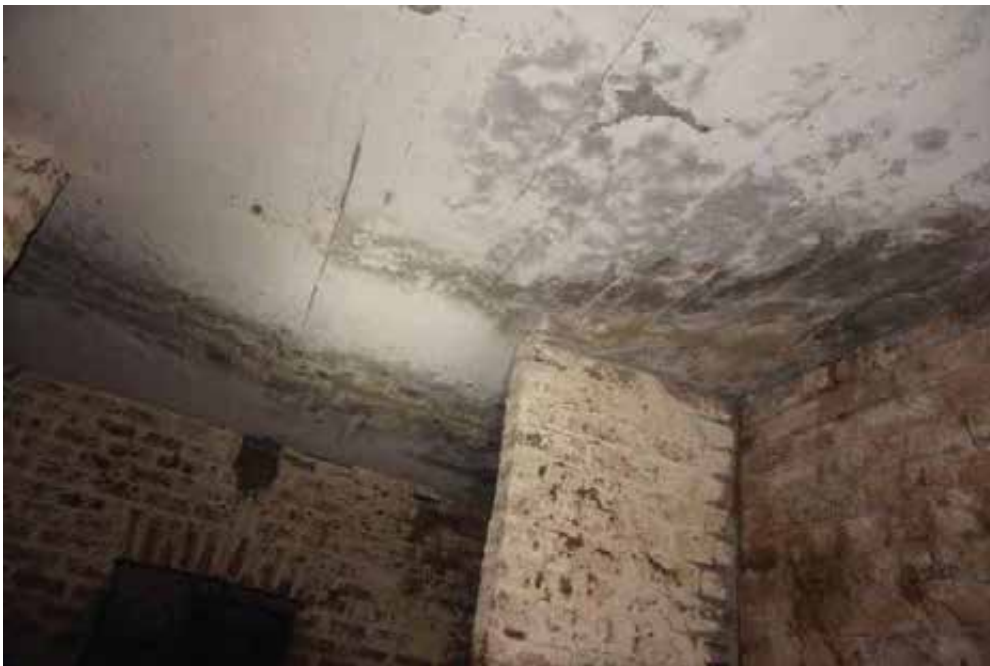
5

**Damp staining and discolouration to underside of concrete roof slab.**

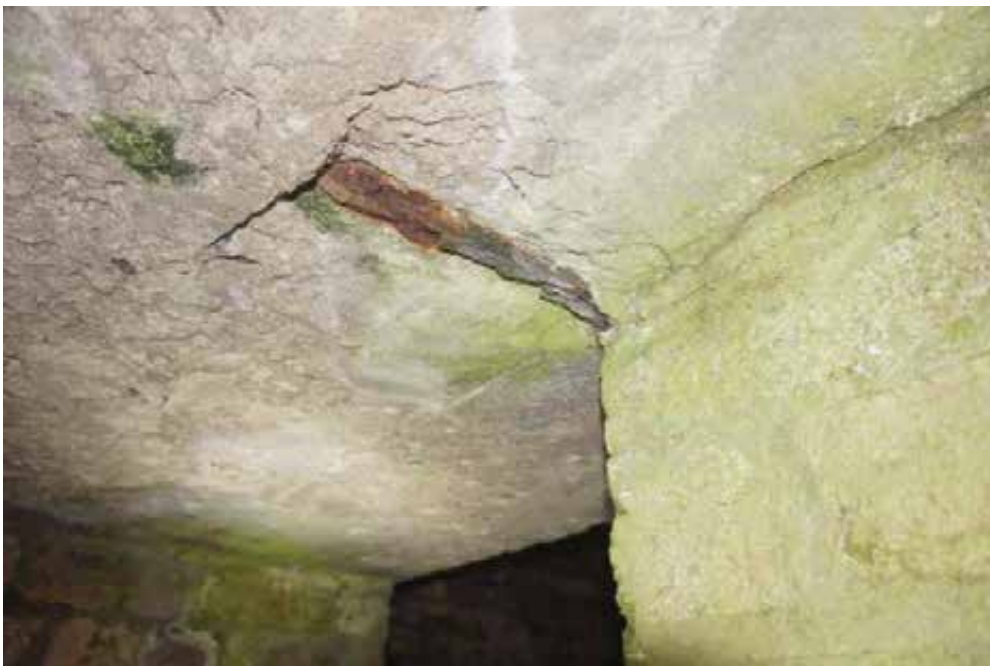
6

**Despite the lack of roof finishes, only minor corrosion of reinforcement was observed.**

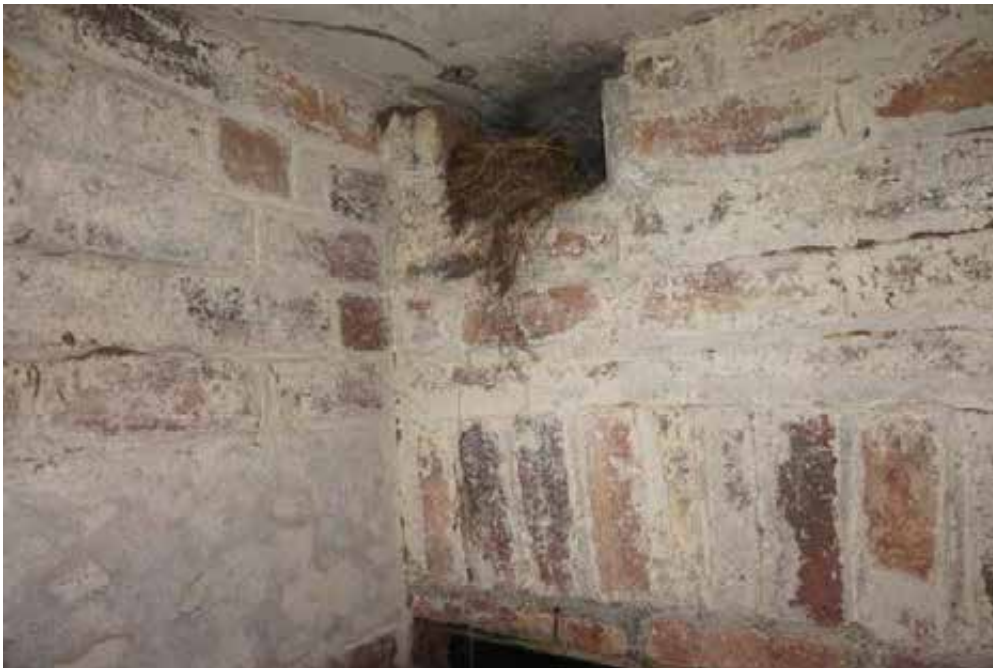
8

**Nesting birds are using the structure.**

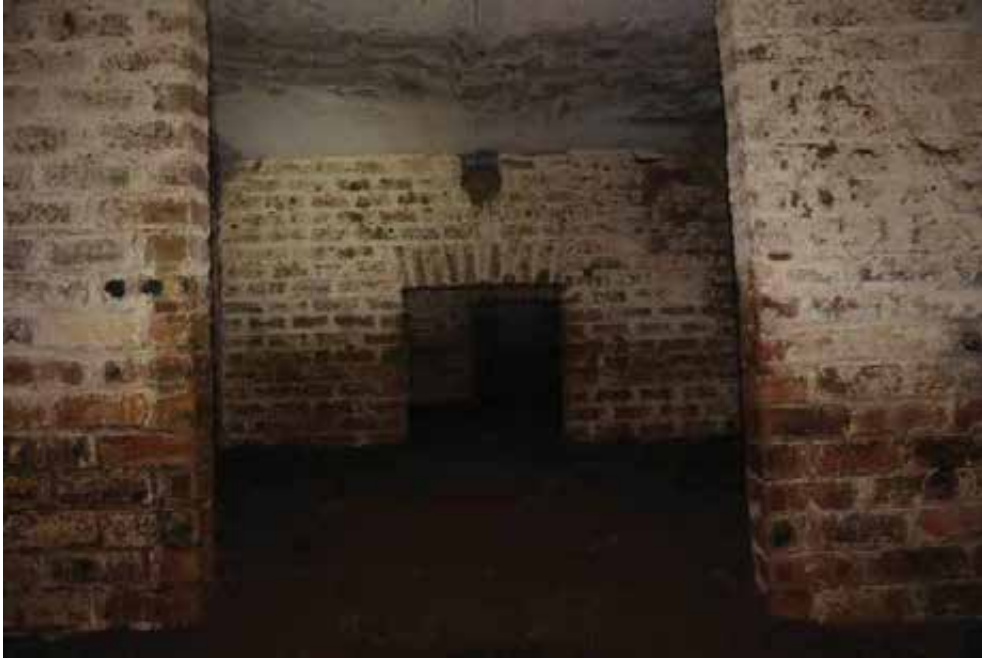
**Internal painted surfaces and damp stained and affected by salts from the large accumulations of animal faeces.**

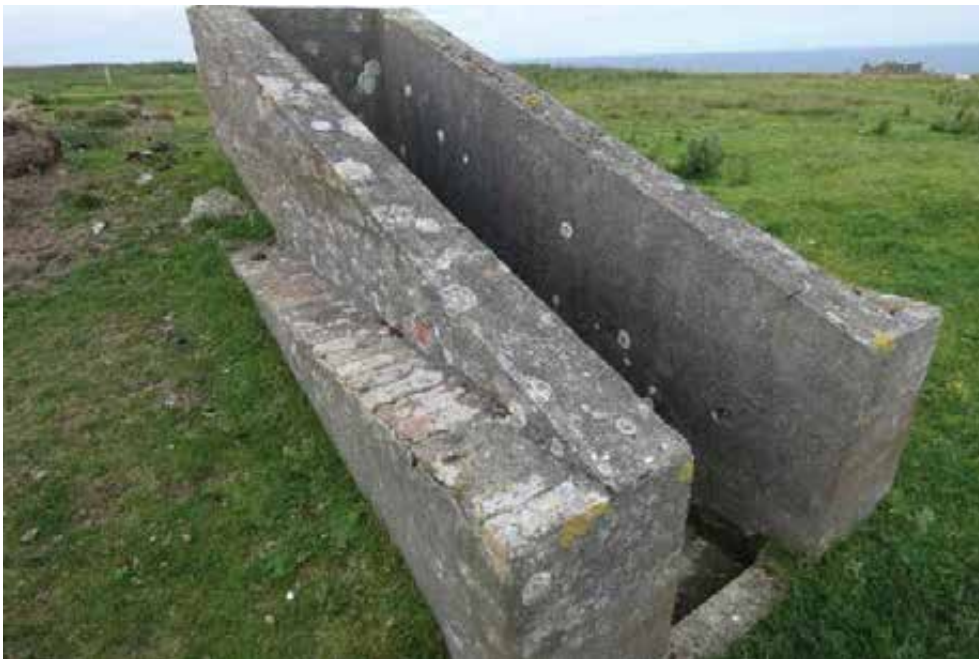
**4**

**There is only minor damage to the rendered brick tunnel entrance.**

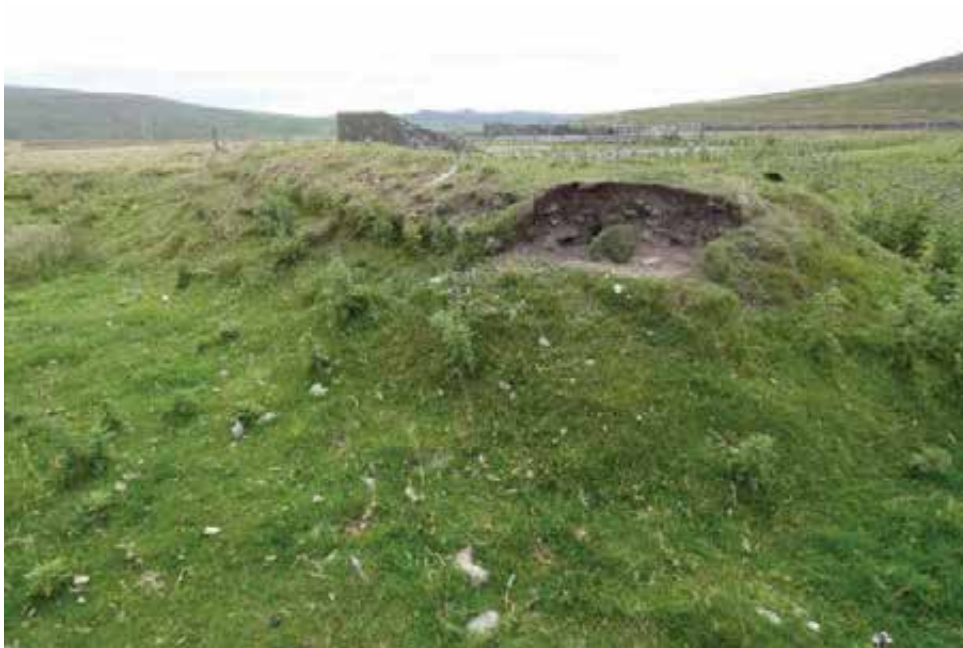
**1**

**General view from southeast. Note damage caused by grazing and burrowing animals. Replacing the missing and damaged earth and turf banking will protect the structure below.**

1.	Record and use as basis for regular inspection to assess future changes in condition.		Necessary
2.	Reinstate earth and turf to further protect buried parts of the structure. <b>£1000.00 – provisional</b>		Desirable

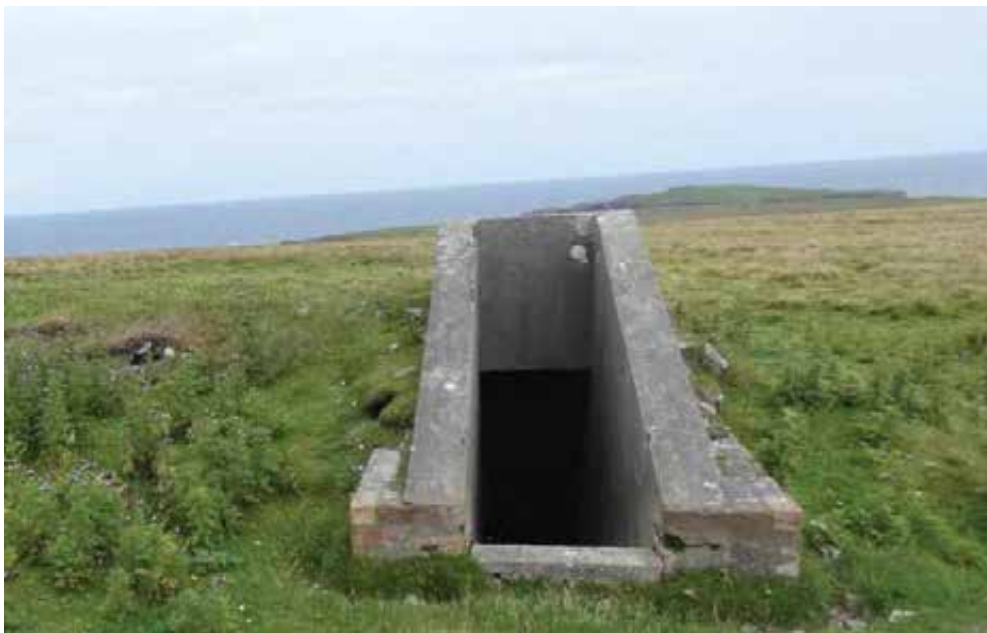
**4**

**There is only minor damage to the rendered brick tunnel entrance.**

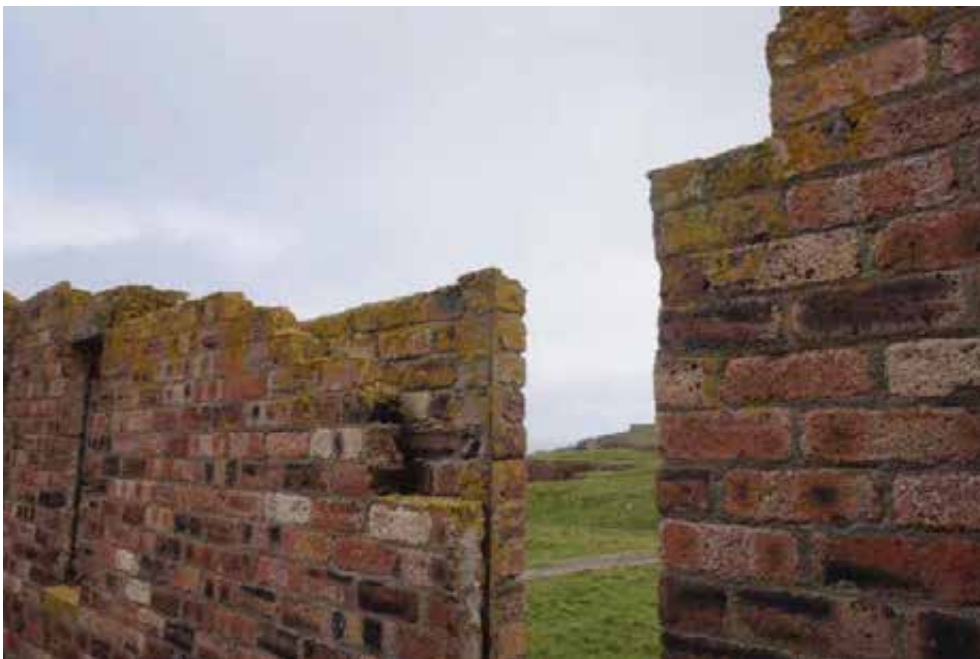
**2**

**East elevation (internal) with dislodged lintol and fallen wallhead brickwork. To prevent ingress into the cavity, consider resetting the lintol and brickwork to allow the wallhead to be capped in concrete.**

3.	To minimise future water ingress into cavity, replace missing and damaged concrete cappings to gables, and consider resetting lintol and fallen brickwork to elevations and thereafter capping wallheads in concrete. <b>£3000.00</b>		Necessary.

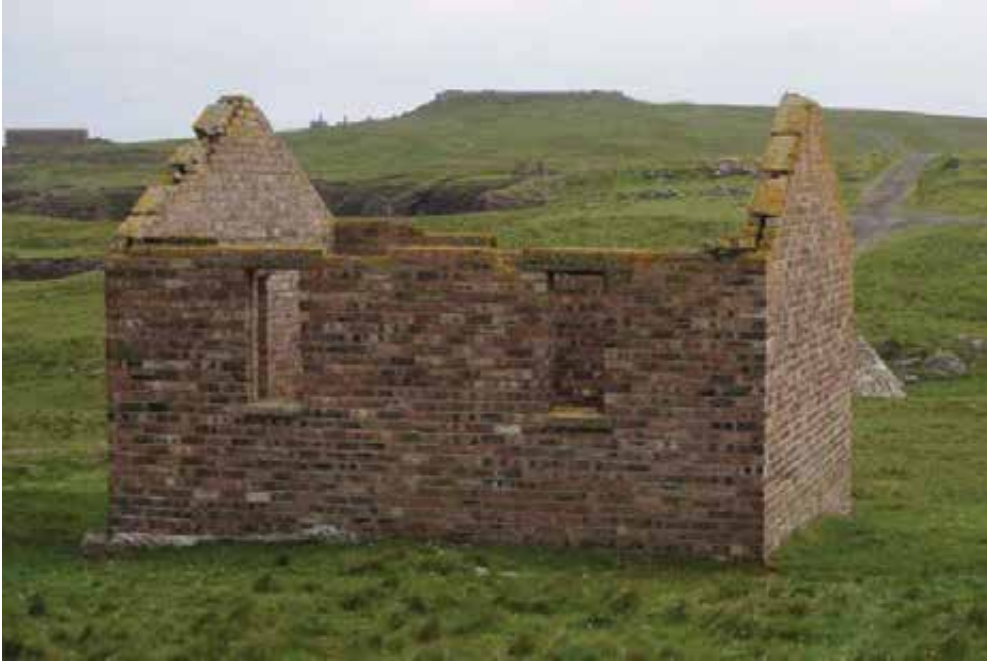
3

**West elevation with missing wallhead brickwork. Note failing cappings to gables.**

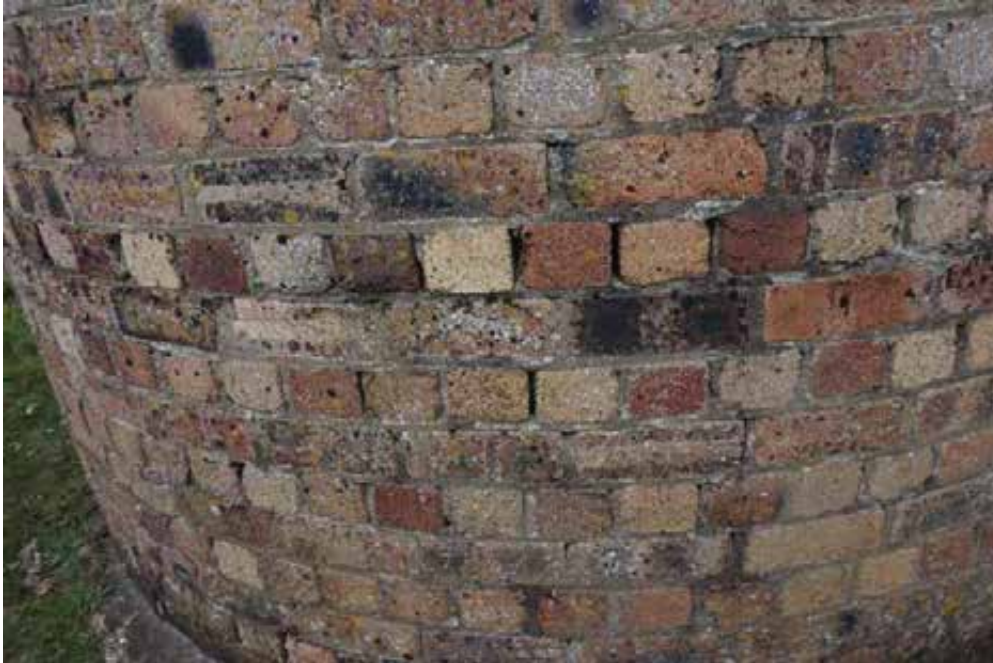
3

**Localised failing wallface joints.**

<b>Site No.</b>	145	<b>Site Name:</b>	Gun emplacement
<b>Description:</b>		<b>General Photograph:</b>	
1.5 brick thick brickworks, c.1.4m high, bedded in cement based mortar. Concrete strip foundation visible. Solid concrete floor, part obscured by soil and vegetation. Base of timber post in centre on circular interior.		 	
<b>Condition:</b>			
Fair: Minor localised open, cracked and failing mortar joints, including to exposed wallhead which is supporting vegetation growth. Minor localised damaged bricks.			
<b>Recommendations:</b>			<b>Priority:</b>
1.	Repoint open and defective joints, especially skyward facing joints. <b>£200.00</b>		Desirable

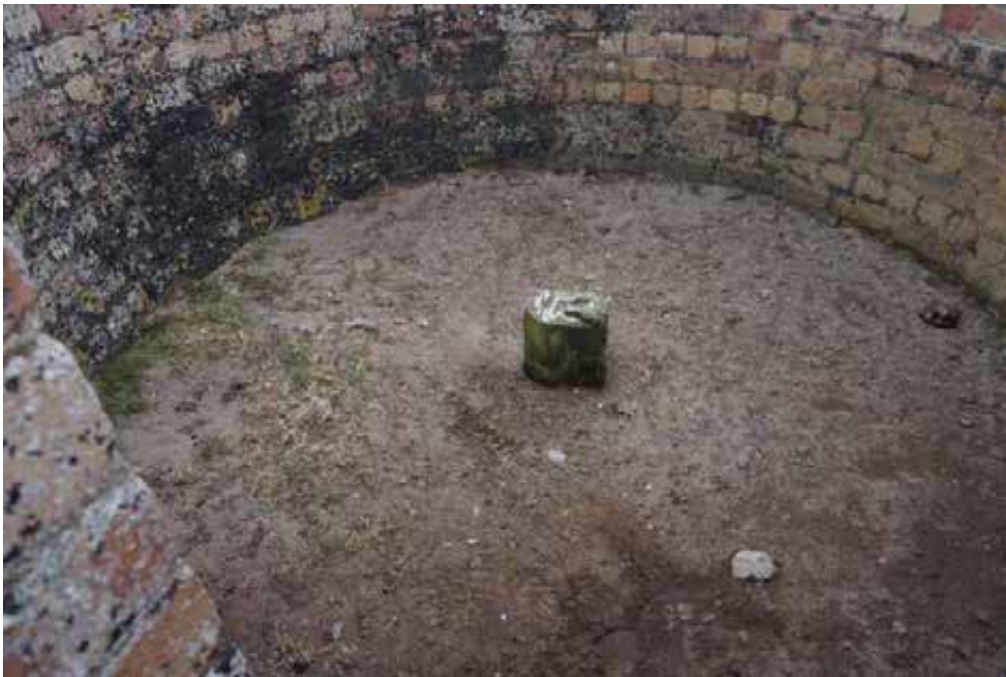
4

**Partly obscured internal floor with central timber post.**

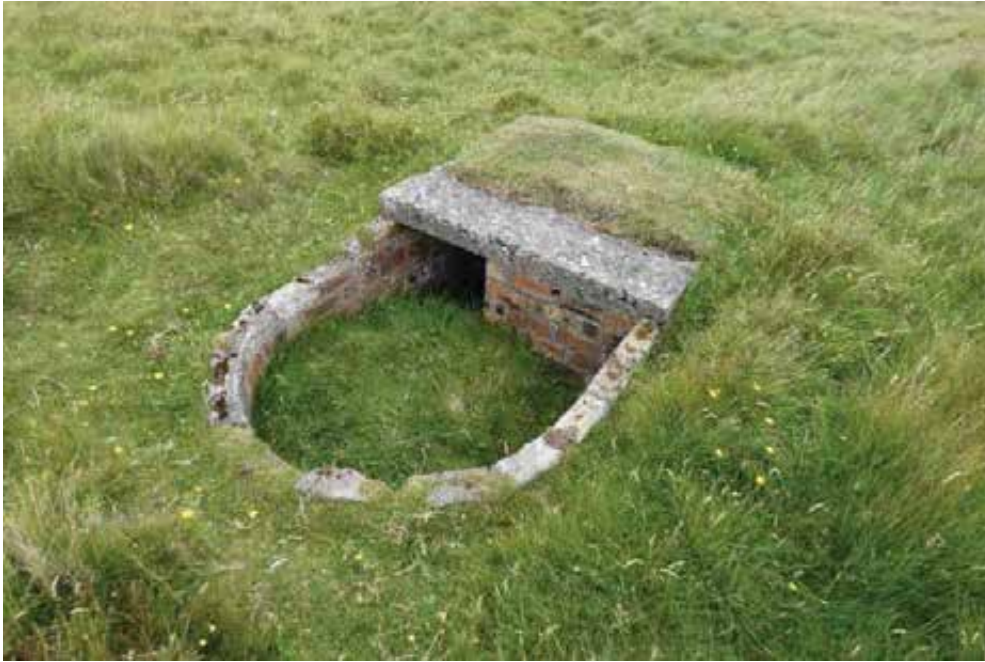
**1**

**General view. Note damaged wallhead bricks.**

1.	Record and monitor condition of concrete roof. Repoint failing brick joints. <b>£100.00</b>		Desirable
2.	Clean out all flood water and clean internal surfaces of the structure. Establish management policy for regular removal of water from inside the structure. Not costed.		Necessary

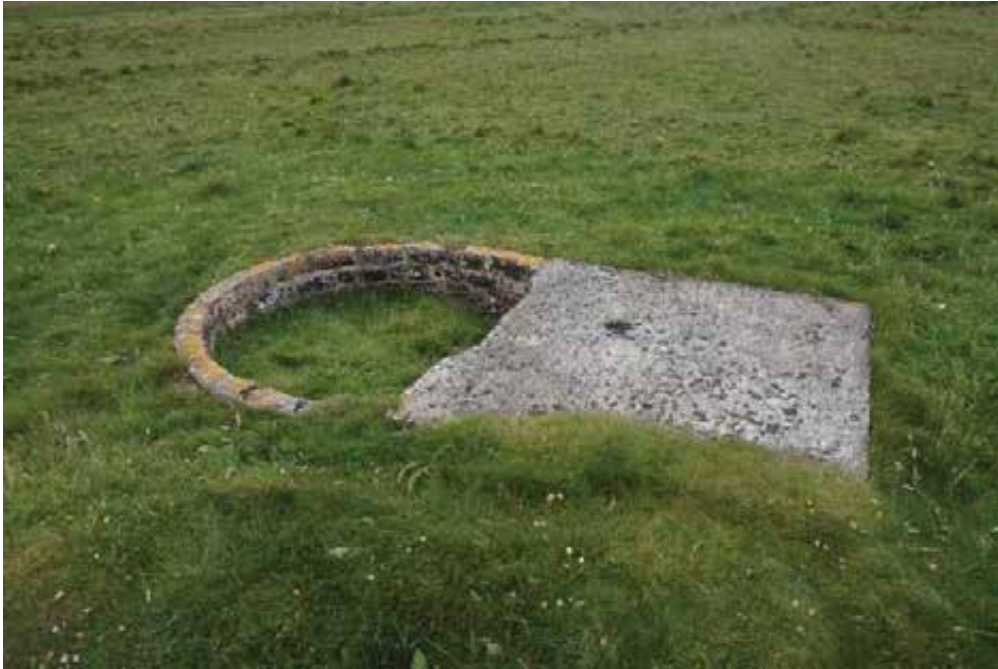
**1**

**The concrete roof is partly covered with turf.**

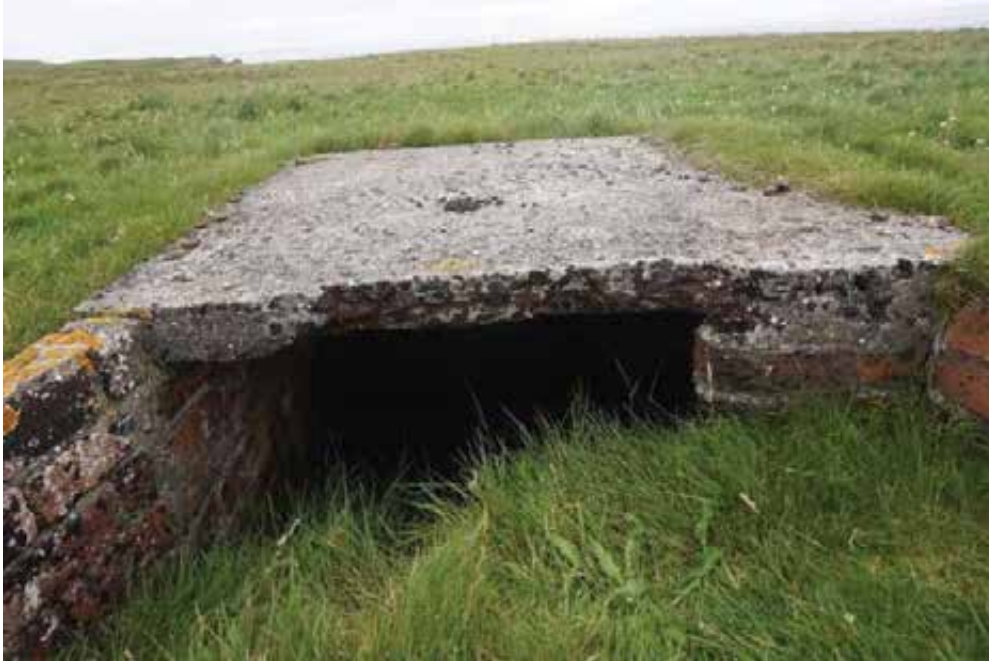
3

The concrete roof slab is currently stable, however, its condition should be monitored as part of future inspections.

1.	Record and monitor condition of concrete roof. Repoint failing joints around wallhead of curved end. <b>£100.00</b>		Desirable
2.	Clean out all flood water and clean internal surfaces of the structure. Establish management policy for regular removal of water from inside the structure. Not costed.		Necessary

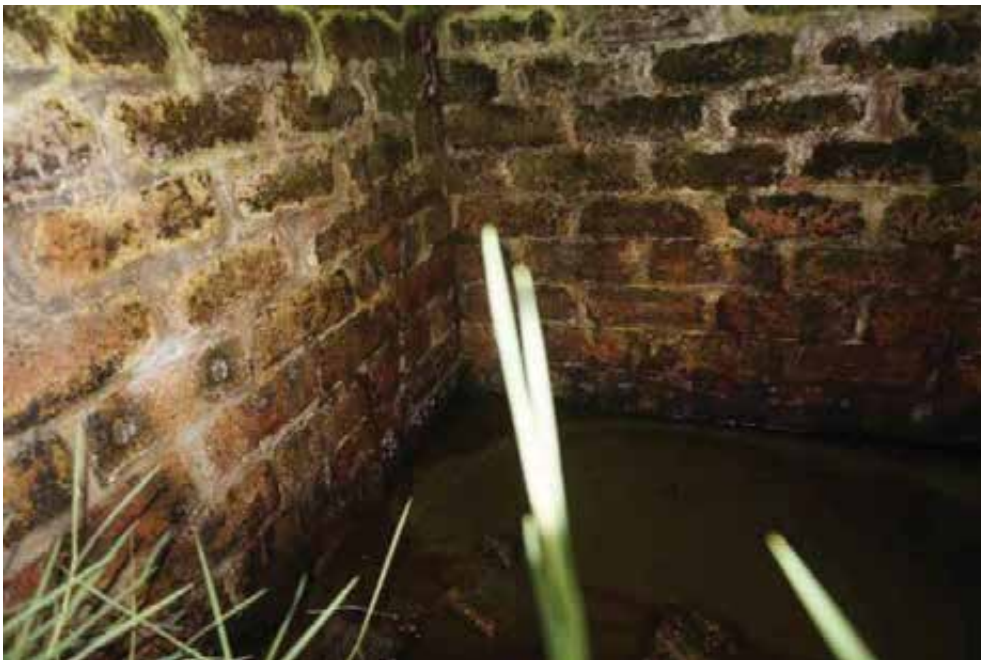
4

Flooded covered area, with displaced bricks.

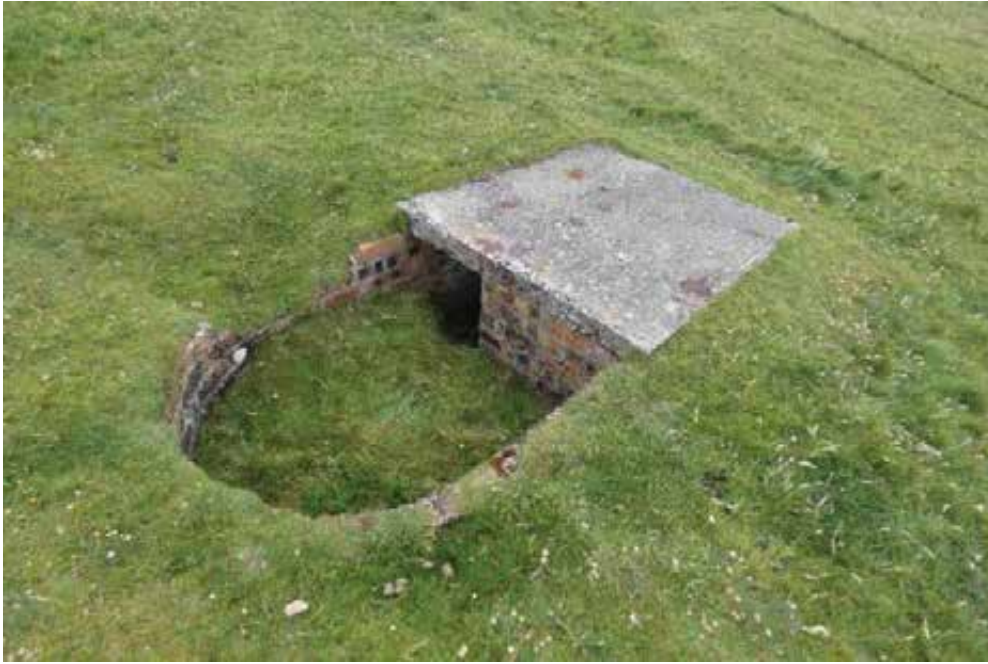
**1**

**Missing wallhead brick work and defective mortar joints. Minor concrete spalling at slab edge.**

1.	Record and monitor condition of concrete roof. Repoint failing joints around wallhead of curved end. <b>£100.00</b>		Desirable
2.	Clean out all flood water and debris and clean internal surfaces of the structure. Establish management policy for regular removal of water from inside the structure. Not costed.		Necessary

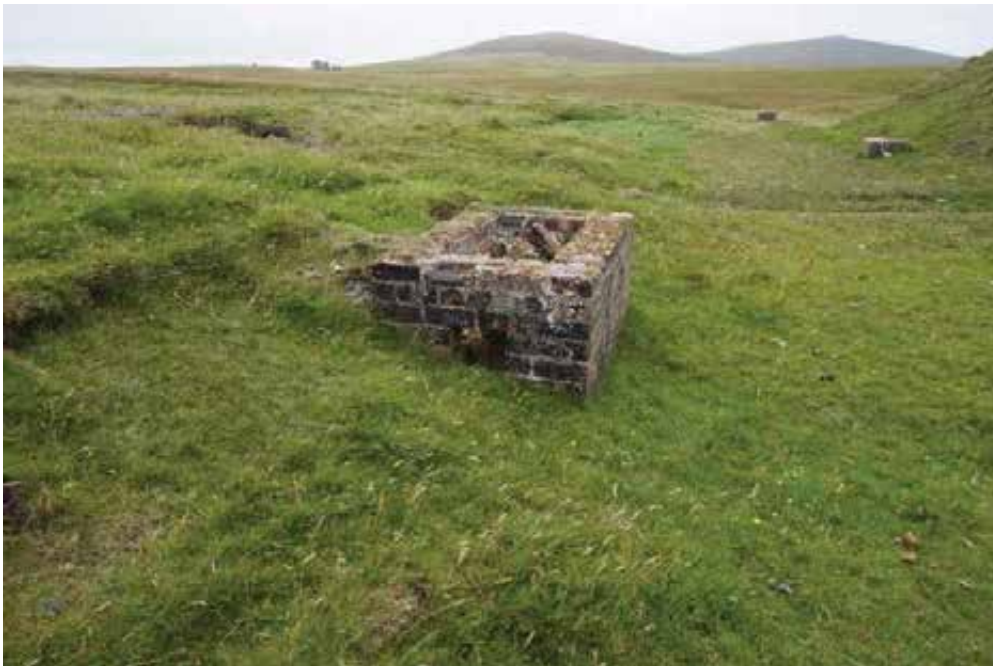
**2**

**View from east showing small opening at ground level.**

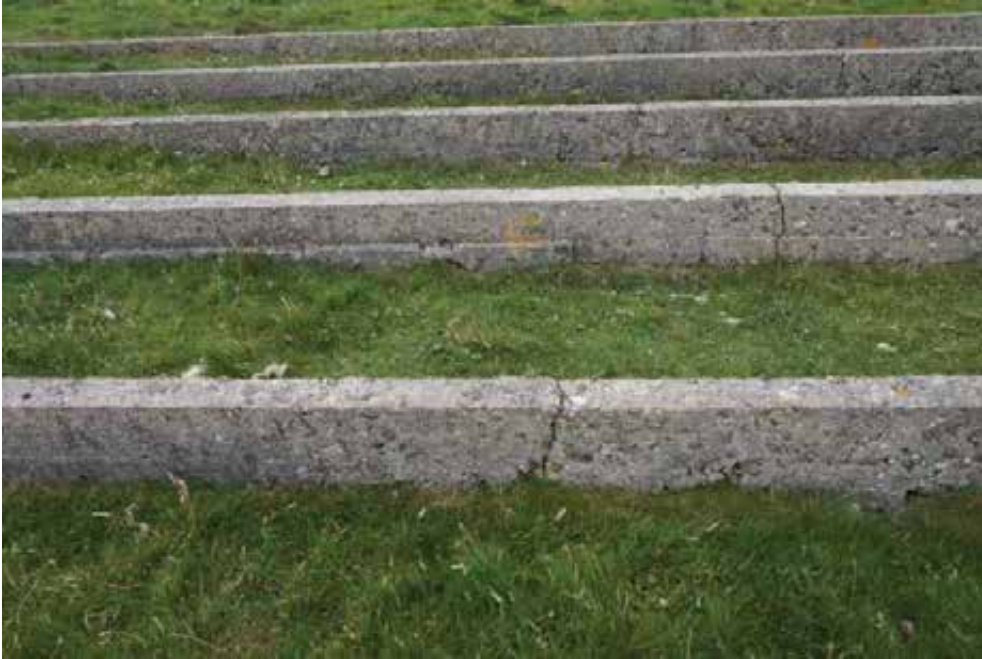
3

Despite the cracking which was observed throughout, the stability of the concrete walls appears unaffected.

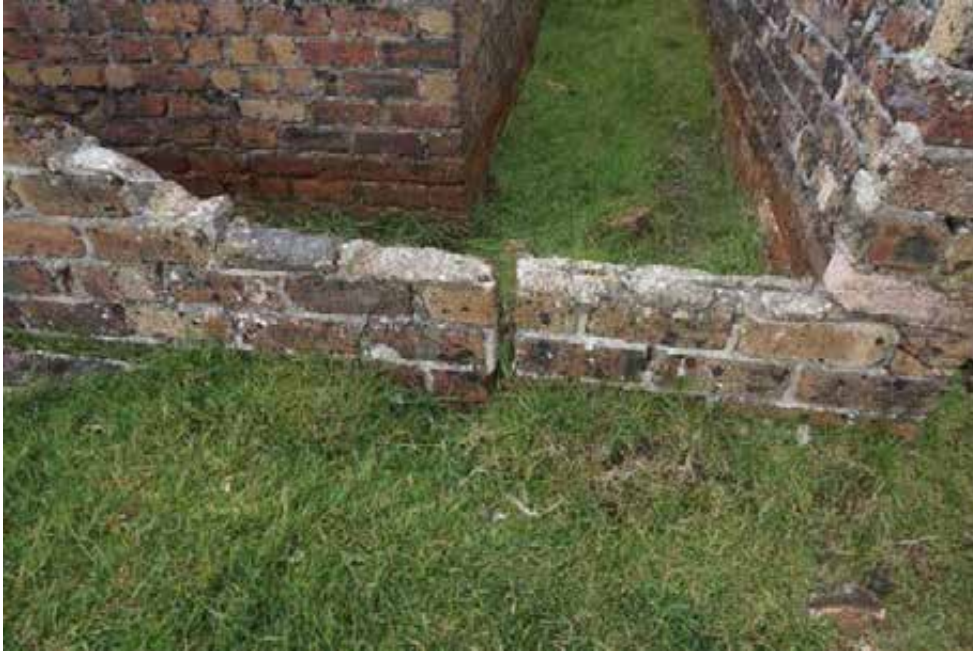
5

**Cracked brickwork to the east facing half brick thick outer skin adjacent to the leaning north wall.**

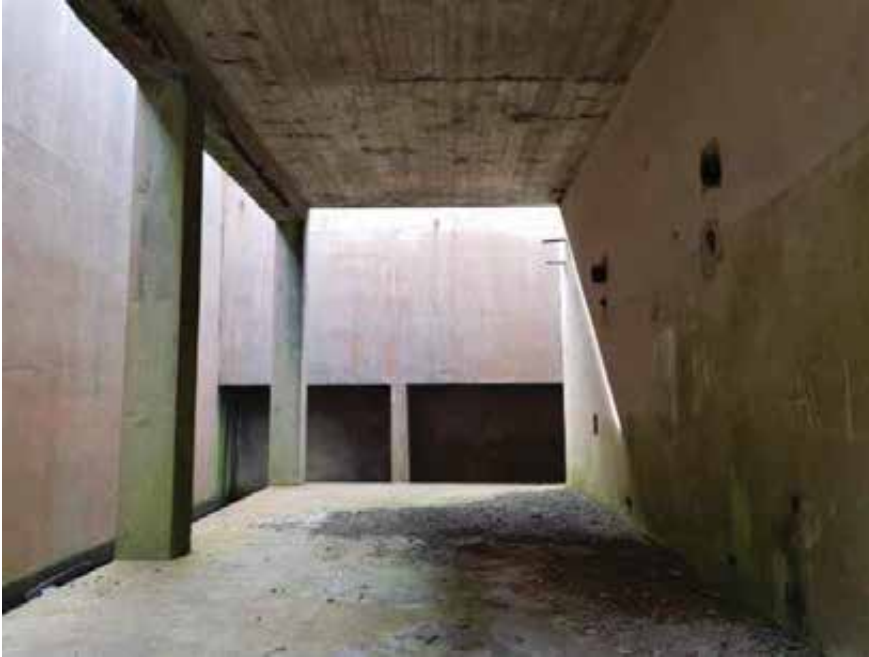
5.

Within the 'porch' to the side of the building. The RC roof slab of the building continues as the porch roof, carried by integral RC beams spanning between RC columns. The RC blast wall in the distance cantilevers over the spaces below. the left-hand (as seen) end of this wall is not connected to the incoming blast wall.

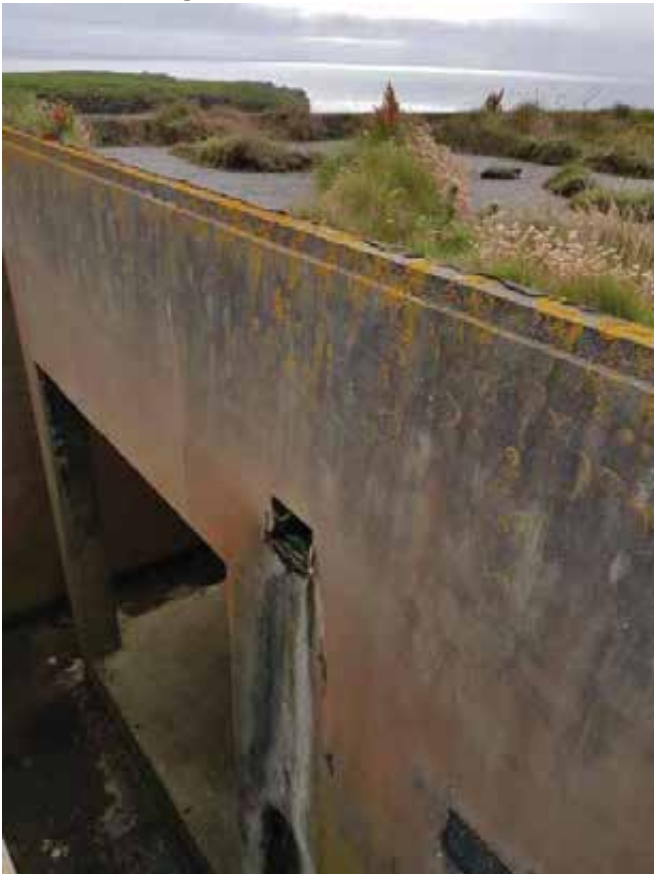
6.

Looking across the roof slab above a vertical rainwater outlet channel built into the wall. The outlet from the roof that feeds into this channel is overgrown with vegetation. Note the growth of vegetation generally across the roof – see next photo.

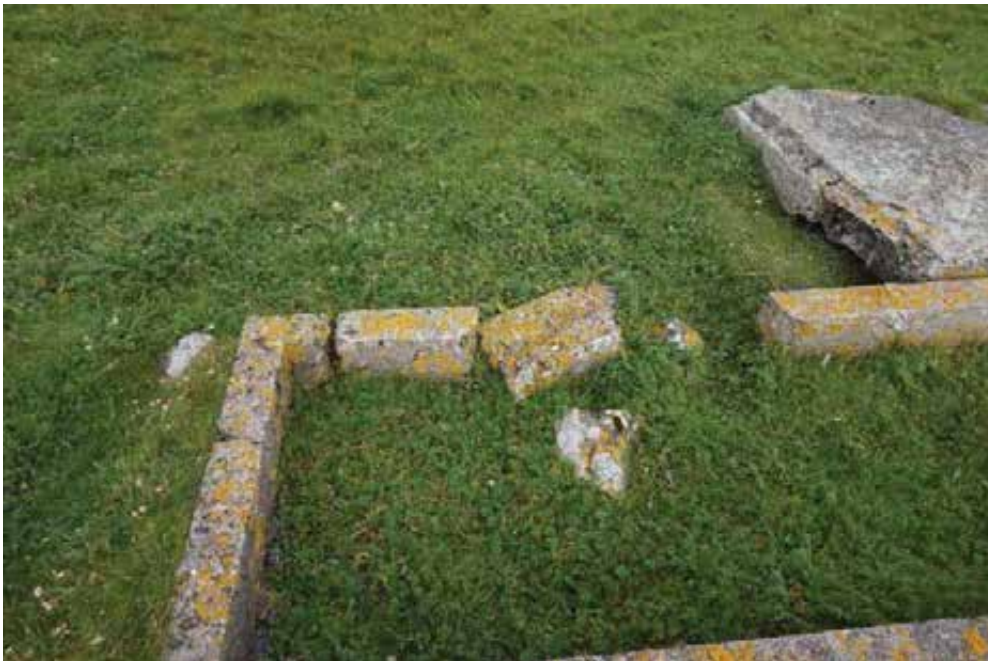
**2**

**Localised damage and displacement of the western end of the north perimeter sleeper wall.**

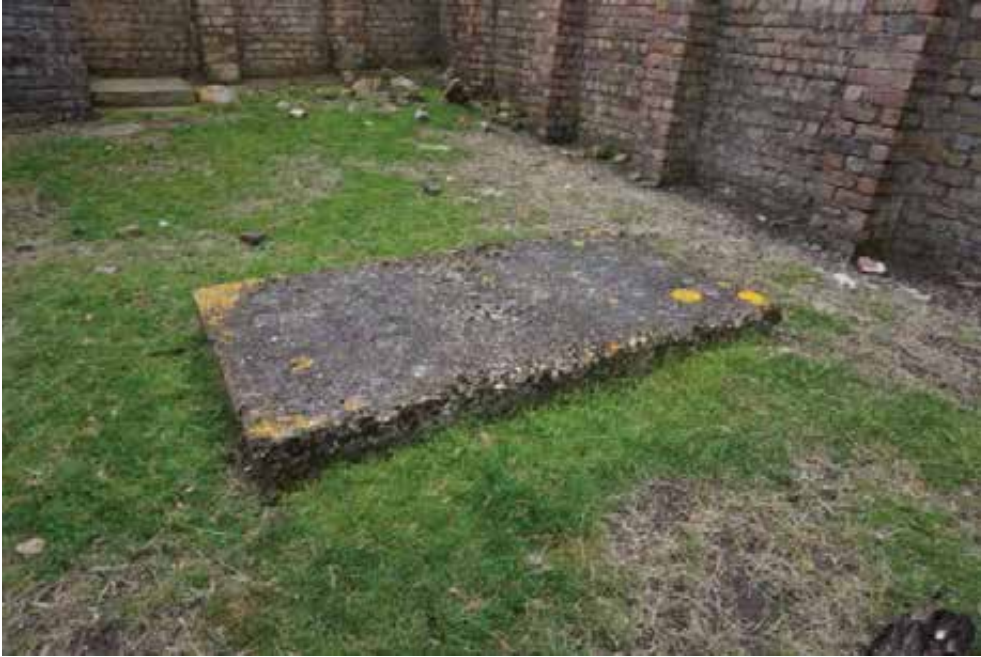
7

**The concrete base internally is in good condition.**
