# Appendix 14.9 Data Interpretation Strategy

# Appendix 14.9 Draft Heritage Interpretation Strategy

## **4.2 Condition Survey**

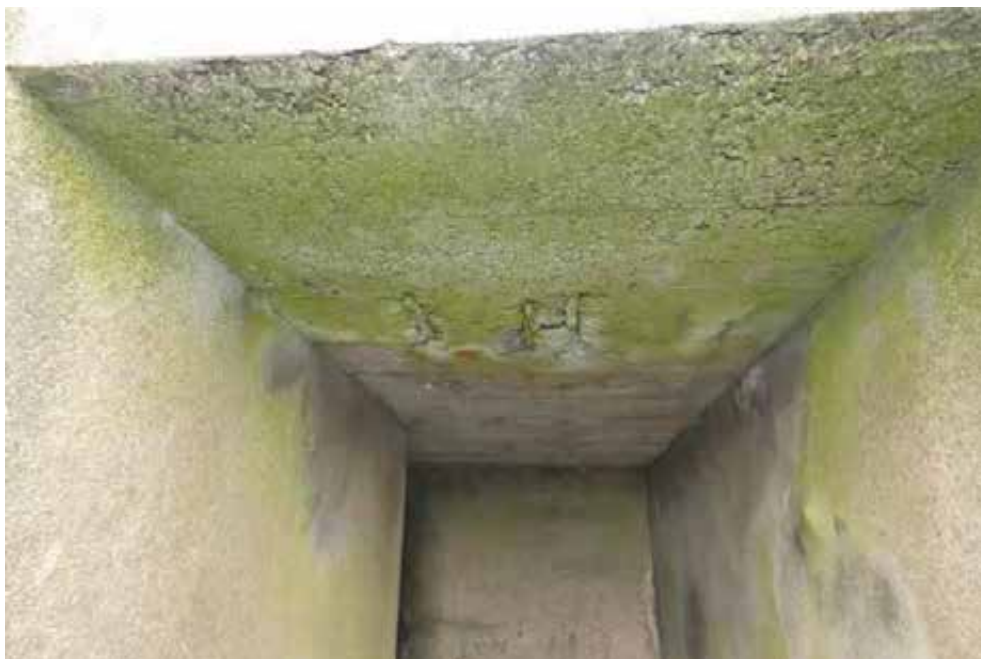
3

**Localised spalling to the soffit of the roof slab exposing reinforcement.**

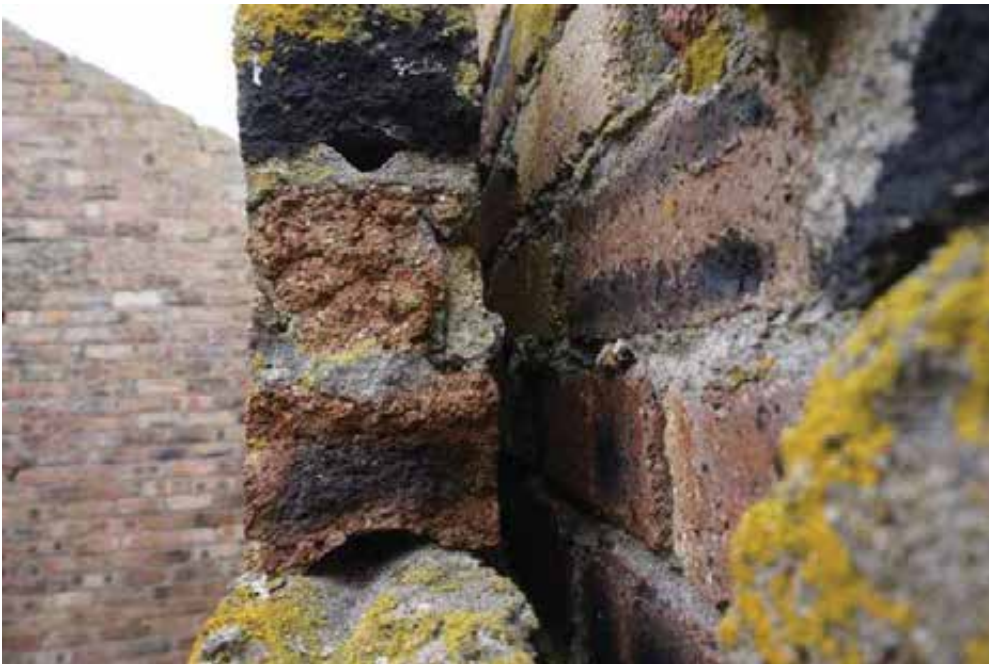
6

**The brickwork is poorly tied. Cavity ties should be retrofitted to ensure future stability.**

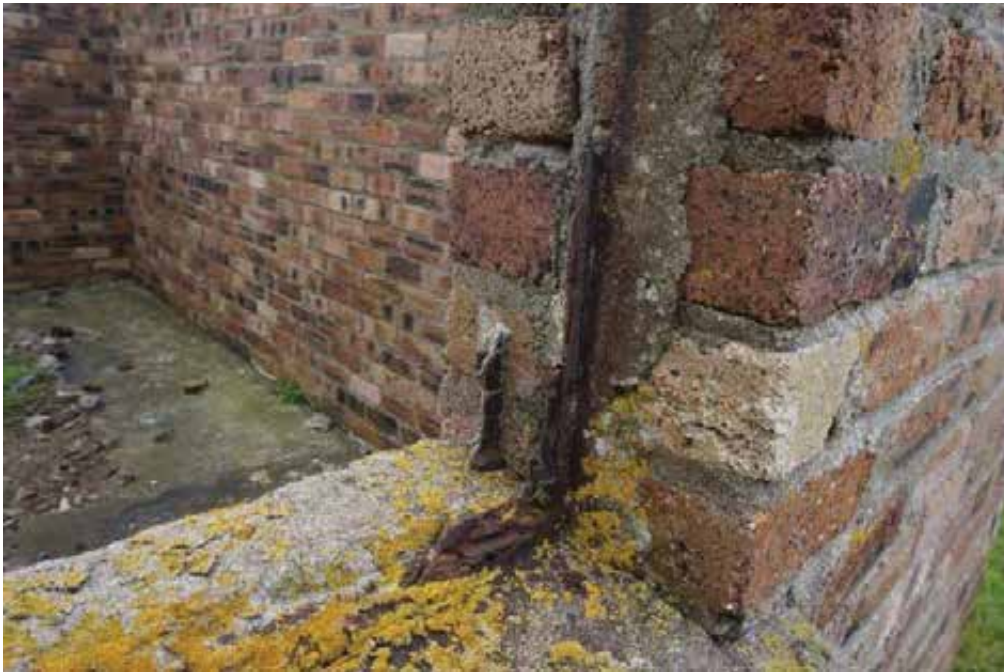
8

**Evidence for metal window frames survives within window checks.**

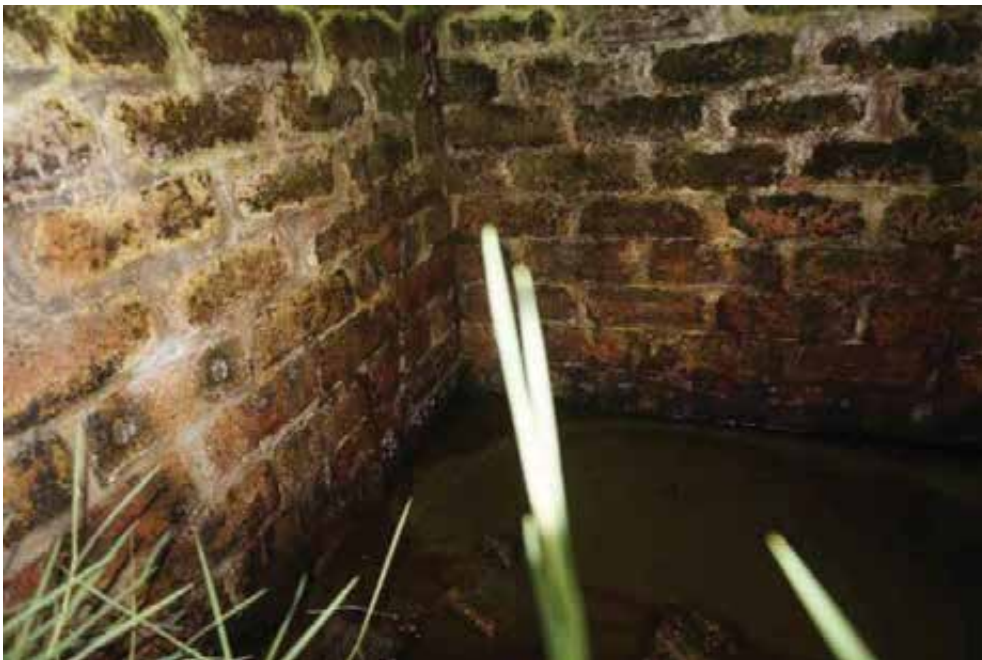
4

Flooded covered area, with displaced bricks.

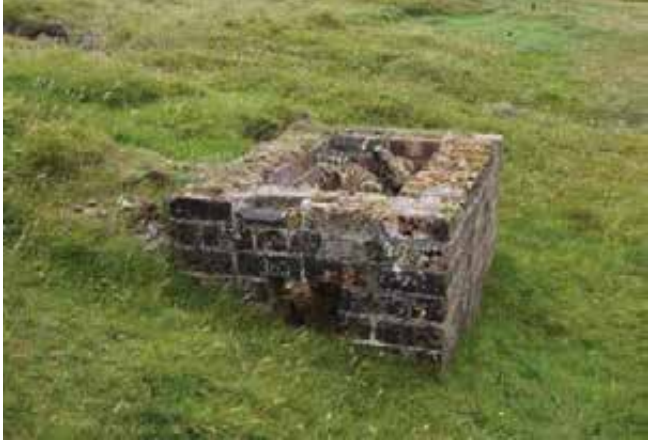
<b>Site No.</b>	302	<b>Site Name:</b>	Brick structure
<b>Description:</b>		<b>General Photograph:</b>	
<p>Small single brick thick structure, partly earth retaining, up to c.800mm high exposed brickwork, and c.1.0m wide by c.1.5m long. Opening at ground level on east face. Partly infilled with rubble.</p>

<b>Condition:</b>			
<p>Fair: Minor localised open, cracked and failing mortar joints, including to exposed wallhead which is supporting vegetation growth. Minor localised damaged bricks.</p>			
<b>Recommendations:</b>			<b>Priority:</b>
<b>1.</b>	Repoint open and defective joints, especially skyward facing joints. <b>£50.00</b>	Desirable
